**OREGON PUBLIC LAND CORNER REPORT / RESTORATION REPORT**  
Tillamook County Surveyor's Office

<b>SECTION:</b> Meander Corner Sections 31 and 32	<b>TOWNSHIP</b> 4 South	<b>RANGE</b> 10 West
<b>COUNTY:</b> Tillamook		<b>DATE:</b> 05-10-15
<b>CORNER DESIGNATION:</b> The Meander Corner common to Sections 31 and 32, T. 4 S., R. 10 W., W.M.		<b>(Please check one)</b>
		<input type="checkbox"/> Condition Report Only
		<input type="checkbox"/> Restoration
		<input checked="" type="checkbox"/> Rewitness
		<input type="checkbox"/> Unrecorded
		<input type="checkbox"/> Reset at surface
		<input checked="" type="checkbox"/> Referenced Out
<b>Previous Rewitnesses, Restorations and Surveys, etc:</b> See maps B-1759, B-3323, P-335, Tillamook County Survey Records; Tillamook County Corner Rewitness Card number 795; Tillamook County Corner Book 6, Page 422; Tillamook County Rewitness Records.		
<b>Found Monument(s) and Accessories (Condition &amp; Source):</b> Found the 10" cast iron monument case and the 3" Tillamook county brass cap to be covered by asphalt pavement. This corner is positioned between two high speed curves on Brooten County Road making it very dangerous and difficult to work on.

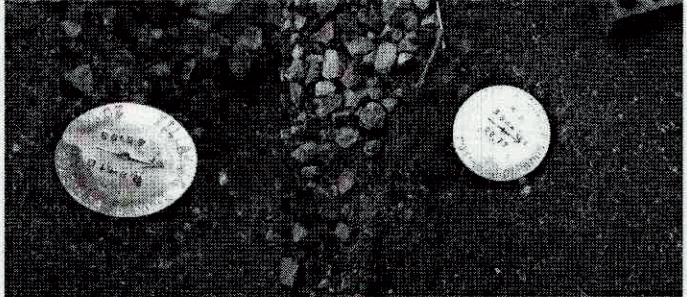
<div style="display: flex; justify-content: space-around;"> <div style="text-align: center;">A.)</div> <div style="text-align: center;">B.)</div> </div>

Found a nail, no brass Tillamook County washer in a scribed triangle on the side of power pole number 321506 which bears South 8° West 61.30' at position, Power pole number was #060000 (Rewitness Book 6, Page 422); The 84" hat section post set at North 72° East 10.6' is gone (Rewitness Book 6, Page 422); Found the rotten 30" x 7' high Spruce stump, axe marks visible, no scribing visible, which bears South 17° West 60.40' at position (Rewitness Book 6, Page 422); Rotten 28" x 8' high Spruce stump, scribing visible, which bears South 97.45' (Rewitness Book 6, Page 422) is now gone.		
<b>Monument Set (Procedures and Description):</b> We referenced the position of the found 3" diameter Tillamook County Brass cap at the Meander Corner. See Rewitness Book 6, page 422, Tillamook County Rewitness Records for the information regarding the setting of the 3" diameter brass cap. Reference monument 'A' stamped "Tillamook County Surveyor 2015 R M N 6-51 E 45.93".  Reference monument 'B' stamped "Tillamook County Surveyor 2015 R M S 84-19 E 22.77".	<b>Pictures of Set Monuments:</b>

<b>New accessories set:</b> Set 2 – 2 ½" diameter Tillamook County Surveyor aluminum caps stamped as shown above.		
<b>New Bearing Trees set:</b> No new bearing trees were set.		
<b>Location &amp; Comments:</b> The corner is located in the westbound lane of Brooten County road.		
<b>Firm / Agency</b> Address: TILLAMOOK COUNTY SURVEYOR'S OFFICE 201 Laurel Avenue Tillamook, Oregon 97141		<b>SURVEYOR'S SEAL</b>
<b>Party Chief:</b> Joe Jensen, P.L.S. 60067, Survey Supervisor
