OREGON PUBLIC LAND CORNER REPORT / RESTORATION REPORT
Tillamook County Surveyor's Office

SECTION: 25 & 36	TOWNSHIP: 2 South	RANGE: 7 West
COUNTY: Tillamook		DATE: May 11, 2021
CORNER DESIGNATION: The 1/4 corner common to Section 25 and Section 36, Township 2 South, Range 7 West, W.M., Tillamook County, Oregon	(Please check one)	
	<input type="checkbox"/> Condition Report Only	
	<input type="checkbox"/> Restoration	
	<input checked="" type="checkbox"/> Rewitness	
	<input type="checkbox"/> Unrecorded	
	<input type="checkbox"/> Reset at surface	
<input type="checkbox"/> Referenced Out		
Previous Rewitnesses, Restorations and Surveys, etc BLM Field Notes: OR -R0345 Page 227; B-3087, Tillamook County Survey Records; Rewitness Book 8, Page 062;		
Found Monument(s) and Accessories (Condition & Source): Found a 2-3/8" brass cap on a 1-1/4" iron pipe per B-3087, level with the surface. This monument was found leaning slightly, likely due to recent logging. I located the 1/2" iron rod subsurface monument set by B-3087 and plumbed the 2-3/8" brass cap over it. Distances to bearing trees were measured to existing nails at side center. Found 19" Douglas Fir stump, 6 feet tall, with a healed fa

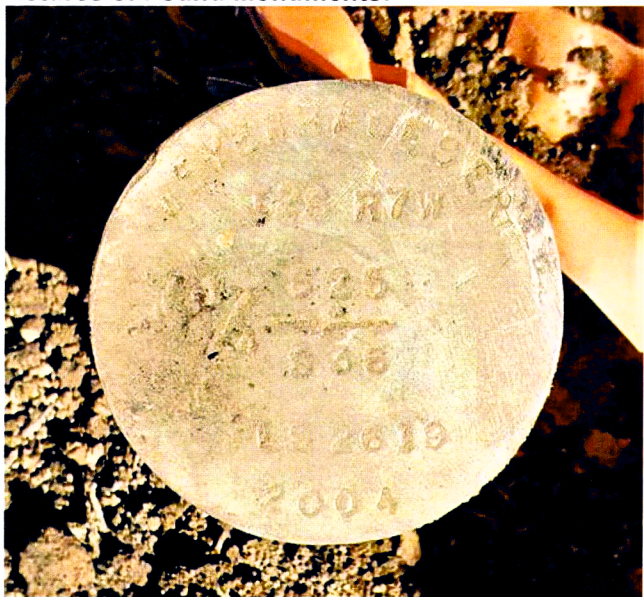
Monument Set (Procedures and Description): No new monument was set. The brass cap and pipe previously established by B-3087 was reset over the 1/2" iron rod subsurface monument. An orange carsonite paddle was set alongside.	Pictures of Found Monuments:
