OREGON PUBLIC LAND CORNER REPORT / RESTORATION REPORT
Tillamook County Surveyor's Office

| CORNER DESIGNATION: Quarter Corner common to Sections 17 and 20, Township 1 South, Range 9 West; Willamette Meridian. | | (Please check one) |
| | | <input checked="" type="checkbox"/> Condition Report Only |

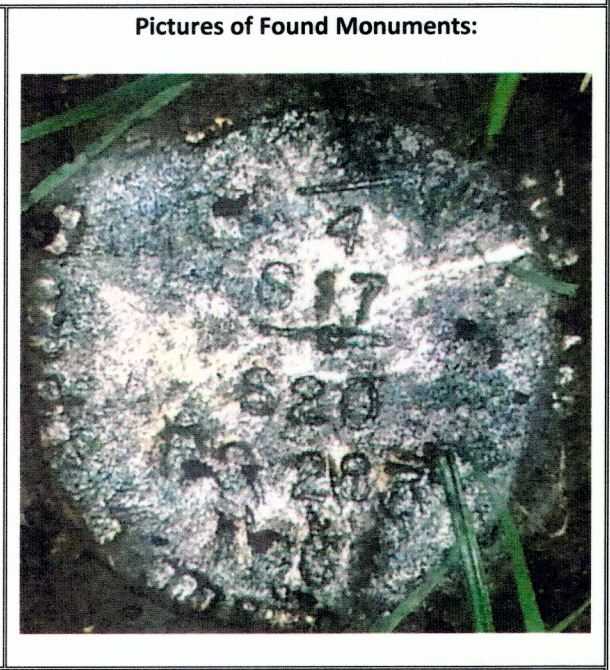
History, condition, and sources:
 In 1857 Henry Meldrum while under contract for the General land office set a post for the South quarter of Section 17 and referenced the corner with 2 bearing trees. In 1949 (Rewitness Bk. 1 pg. 80) W.E. Anderson reset the ¼ corner by subdivision between the two section corners with a 3" iron pipe and referenced the corner with 2 bearing trees. In 1967 (B-535) while breaking down section 17 Harold Russell Found a 2 ½" Iron pipe for the corner. In 1969 (Rewitness card #202) the Tillamook County Survey Office found a 1 ½" iron pipe with a tack which they set a 2" iron pipe with a Tillamook County brass cap stamped as shown hereon over the top of the existing monument and added two more references. In 2022 The Tillamook County Surveyors office found the corner 2' below the surface of the field in good condition and stamped as shown hereon.

Not Found: (Rewitness card #202) 36" Maple S 65° E 110.60'
 Found: (Rewitness card #202) 60" Spruce North 111.66'
 Not Found: (Rewitness card #202) 96" Hat Section post with yellow metal location tag North 25'

New accessories set:
 Installed hat section post with yellow metal location tag North 66° West 50.2' in East-West Fence.
