## OREGON PUBLIC LAND CORNER REPORT / RESTORATION REPORT Tillamook County Surveyor's Office

SECTION: 13, 18, 24 and 19	TOWNSHIP: 2 South	RANGE: 9 and 10 West		
COUNTY: Tillamook		DATE: 02/22/2023		
CORNER DESIGNATION: Section corner common to sections 13 and 24, Township 2 South, Range 10 West, and Sections 18 and 19, Township 2 South, Range 9 West; Willamette Meridian.		(Please check one)		
			Condition Report Only	
			Restoration	
		x	Rewitness	
			Unrecorded	
			Reset at surface	
			Referenced Out

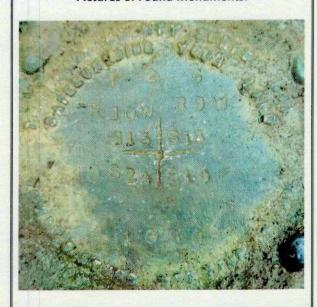
## Pictures of Found Monuments:

History, condition, and sources: Under G.L.O. contract # 67 corner post was set and 4 bearing trees were established. In 1915 corner was reestablished by Reitze, Storey and Duffy engineers on Tillamook County Surveyors map (F-19-25). In 1949 Robert Walker reestablished corner on T.C.S.M. (B-156). In 1954 W.E. Anderson, Tillamook County Surveyor deemed corner incorrect on T.C.S.M. (B-317). He set a 2" iron pipe with wood plug and nail. In 1951 bearing trees were established for the corner set by Robert Walker in Tillamook County Surveyors Rewitness Bk. 1 pg. 95 by W.E. Anderson and Francis L. Smith and retied as bearing trees to Andersons' corner in 1972 in Tillamook County Surveyors Rewitness Bk. 5 pg. 218. In 1990 Tillamook County Surveyors set a 1 ½" iron pipe with a 3" Dia. Tillamook County Surveyors Brass Cap in a 10" concrete cylinder 18" deep from ties made on T.C.S.M.(B-1429). In 2023 (Field Bk. MR 14 pg.41), Tillamook County Survey Office visited the corner and found a 3" Tillamook County Brass Cap in concrete marked "T2S R10W R9W S13 S18 S24 S19 1990" as shown hereon in good condition.
