OREGON PUBLIC LAND CORNER REPORT / RESTORATION REPORT
Tillamook County Surveyor's Office

SECTION: 25, 30, 31 & 36	TOWNSHIP: 1 South	RANGE: 9 & 10 West
--------------------------	-------------------	--------------------

CORNER DESIGNATION: Section Corner of T.1South R9West Sec. 30 & 31; R10West Sec. 25 & 36.	(Please check one)
	<input type="checkbox"/> Condition Report Only
	<input type="checkbox"/> Restoration
	<input type="checkbox"/> Rewitness
	<input type="checkbox"/> Unrecorded
	<input checked="" type="checkbox"/> Referenced Out

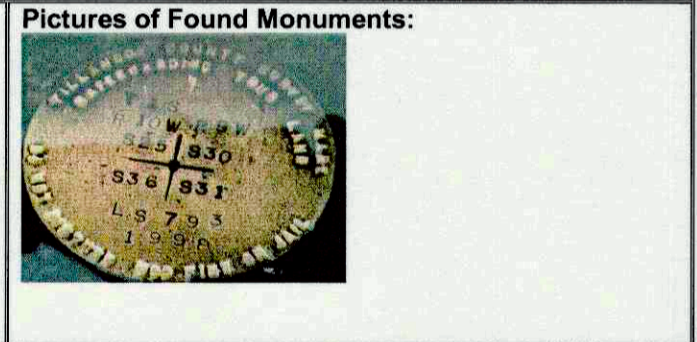
Found Tillamook County Brass Cap stamped "T1S R10W R9W S25 S30 S36 S31 LS 793 1998" Flush with the surface of Tillamook River Loop Rd. See reference on A-7455 Tillamook County Records.

(Map A-7455 (1998)- X in NW corner of metal storm drain rim S70°E 7.17'; found at record position
(Rewitness Book 6 Pg. 432 (1989)- Lead plug in curb N 3°E 58.72'; now gone.
(Rewitness Book 6 Pg. 432 (1989)- Lead plug S30°E 105.09; now gone.
(Rewitness Book 6 Pg. 432 (1989)- Power Pole #368800 S42°W 98.19'; now gone.
(Rewitness Book 6 Pg. 432 (1989)- South East Corner of Barn Tavern N 34°W 99.63'; Found now corner of South East entrance N33°W 99.67'

Location & Comments: The monument is located in the North bound lane of Tillamook River Loop Rd. Approx. ±105 ft. North from the NW corner of the Les Schwab Building. Monument is flush with the road surface.

New accessories set:
1 inch Brass Disk Stamped "Till. Co. Surveyor" N 13° 42' East 89.66'
3 1/2" NGS Bench Mark stamped "T 274 RESET 1993", set in concrete curb N7°40'W 164.67'
Nail with washer stamped "Till Co. Surveyor" set ±24" from bottom of PUD power pole #368801 S19°14'W 105.93'
North West Corner of Les Schwab building S19°E 105.46'
