TILLAMOOK COUNTY REWITNESS #73

MEANDER COR. SEC. 4T3 T 2N R 10 W., WM.

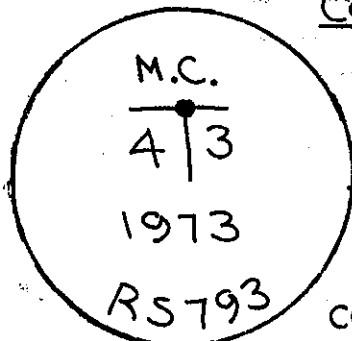
CONDITION	FOUND:
BADLY RUSTED	1" IRON PIPE ± 8" HIGH
UPROOTED	5" HEM N55°W 9 IKS GLO PAGE 35
FOUND REMAINS OF STUMP	26" SPR N80°E 7 IKS GLO PAGE 35
FOUND UPROOTED	20" HEM N80°E 2D ⁸ W.E. ANDERSON FIELD NOTES

I SET 2½" IRON PIPE WITH 3" BRASS CAP IN 8" TILE AND
 CONCRETE OVER FOUND 1" IRON PIPE
 *70 " Hat Section S. ± 3² FT.

COMMENTS: I PLACED (2) 8" DIA. X 12" HIGH TILE WITH
 90 LBS. CONCRETE MIX AT THIS CORNER. I CLEARED AN AREA
 AROUND THE CORNER OF 25 FEET IN DIAMETER. A SMALL
 BROOK IS ± 21° EAST OF CORNER. -- WATCH OUT FOR A 3 FOOT DIA. X
 2½ FOOT HOLE AT THE BROOK. IN THE PRESENCE OF:
