Neskowin Coastal Hazard Area Permit #851-21-000130-PLNG: Kircher

NOTICE OF ADMINISTRATIVE REVIEW Date of Notice: October 22, 2021

**Geologic Hazards and Geotechnical Investigation Report
Tax Lot 4400, Map 5S-11-35DA
Tillamook County, Oregon**

Project #Y174044

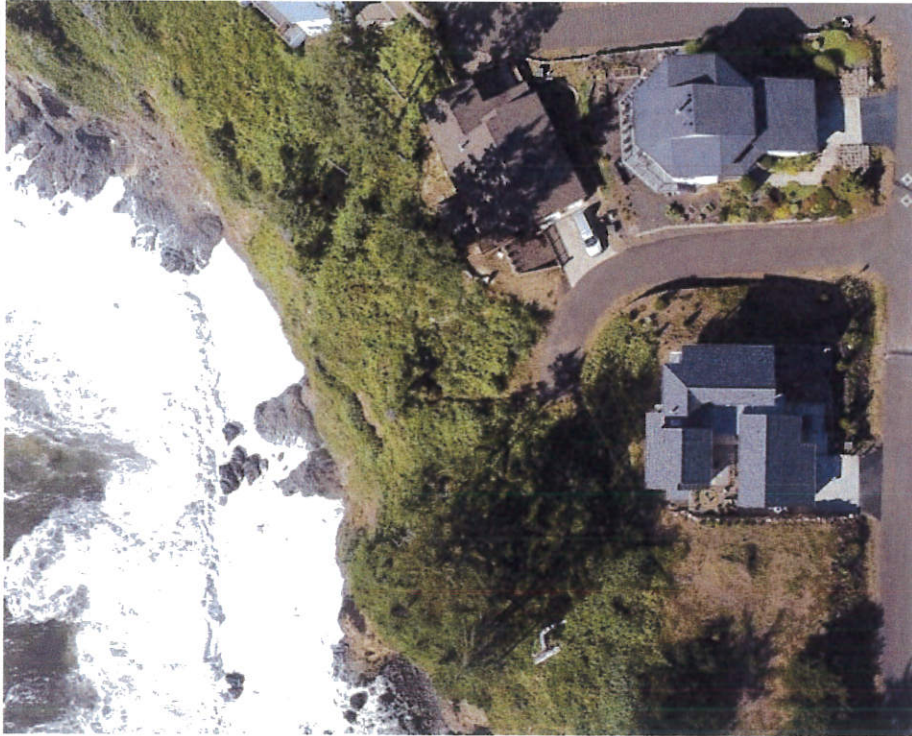
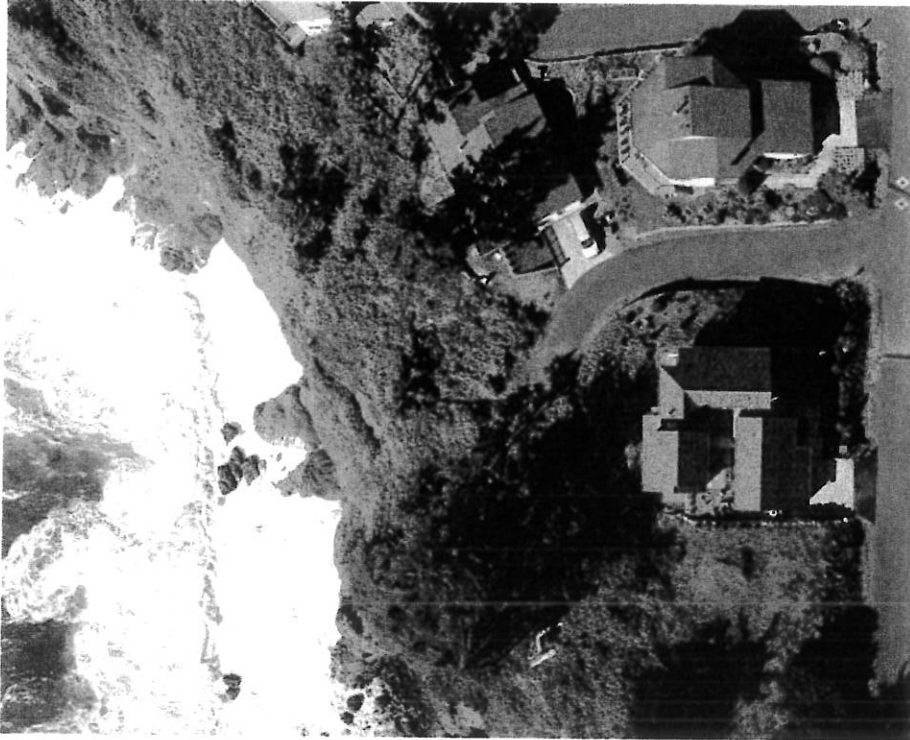
Photo 3 - Oblique aerial photograph of the site, nearby lots and the Pacific Ocean to the west.

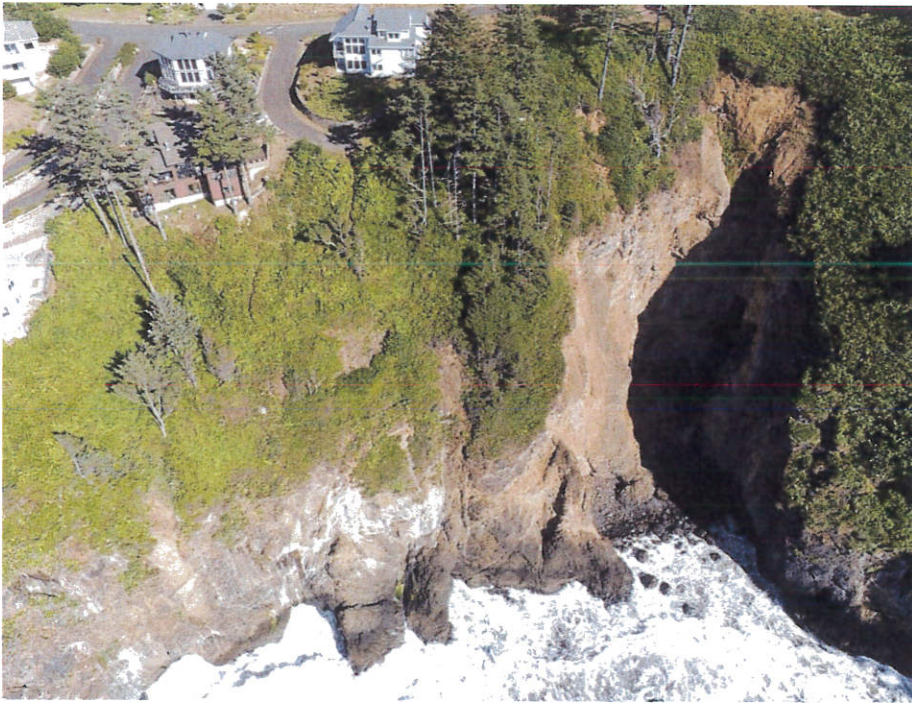
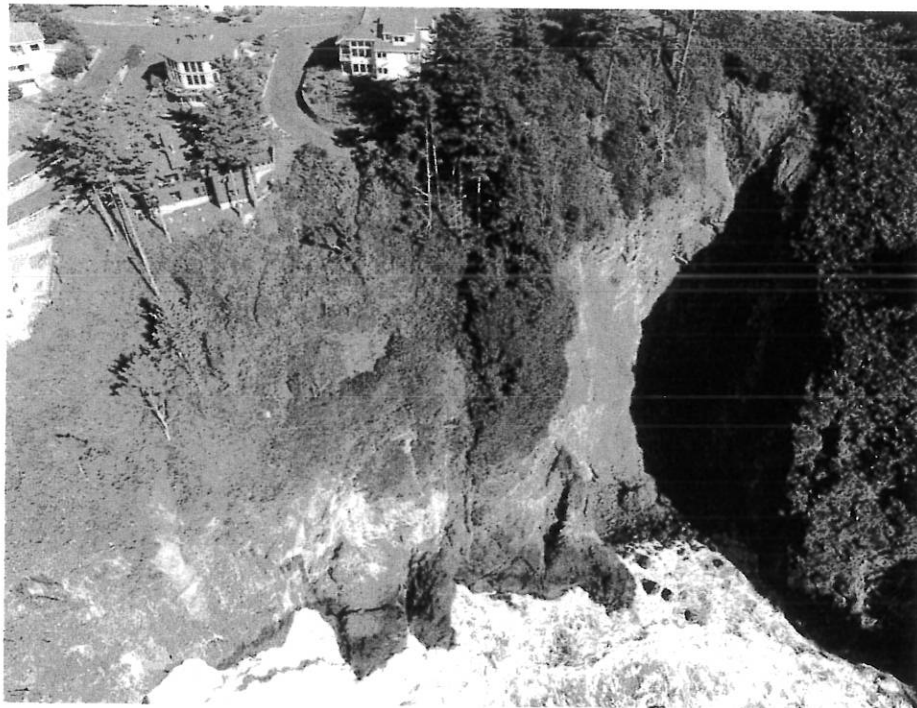
The seaward front of the property is a hard basalt breccia bluff. The bluff face is unvegetated in the swash zone and aerial imagery shows that the basalt breccia is fractured and variably weathered. The bluff face below the site appears to be more resistant to wave attack than immediately north where waves are undercutting the bluff

face, and to the south where undercutting presumably caused a bluff failure at an unknown time in the past. The rock at the subject lot is a large block of much harder rock than adjacent sites. Additional observations are addressed and illustrated in Sections 3.3 and 3.5, and Appendix A

Photo 4 - Oblique aerial photograph of the bluff in the area of the site.

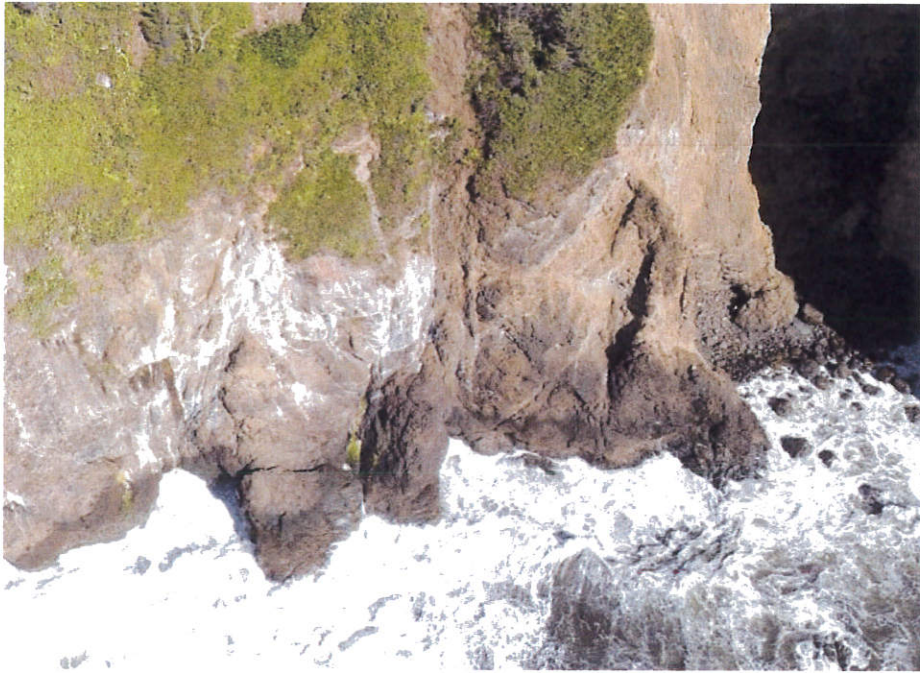
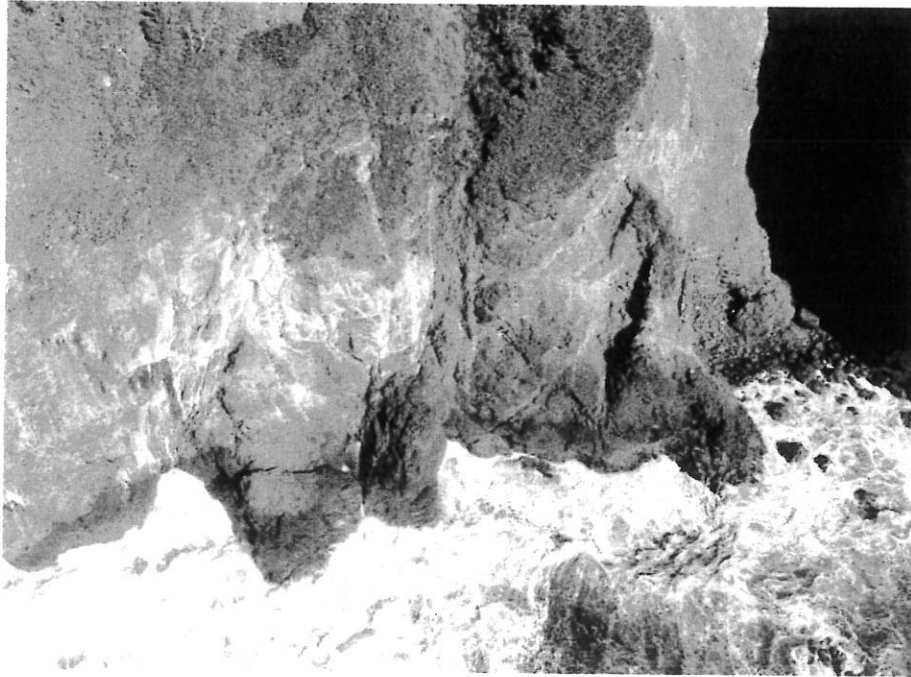
No drift logs or flotsam were observed in aerial imagery of the property or on the small pocket beach immediately south of the site (Appendix A).

We observed no sand on the beach in aerial photographs taken August 16, 2017 at the seaward edge of the property (Appendix A). A thin veneer of sand can develop as seen in some of the aerial photography. We estimate that the beach sand rarely, if ever, exceeds a depth of 7 feet.

Photo 5 - Oblique aerial photograph of the base of the bluff below the site.

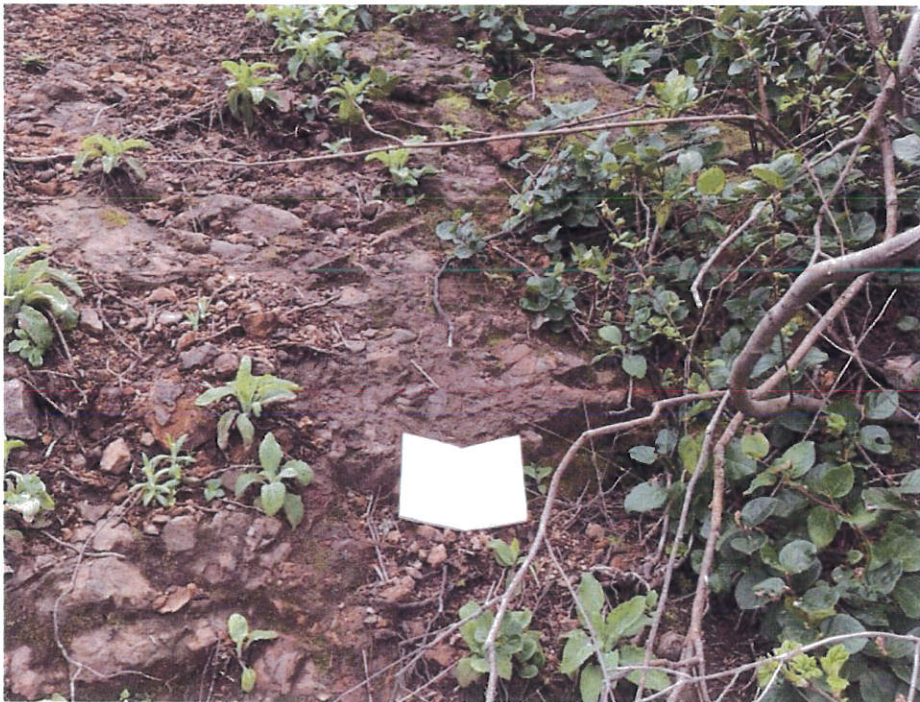
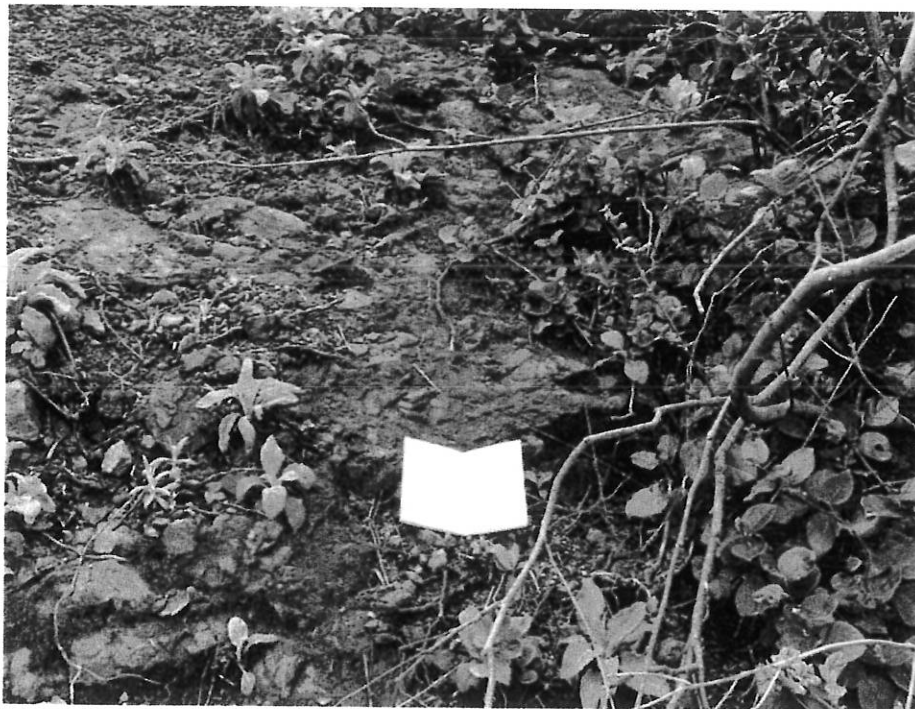
Photo 6 - Close-up view of basalt breccia exposed upslope to the east of the site.

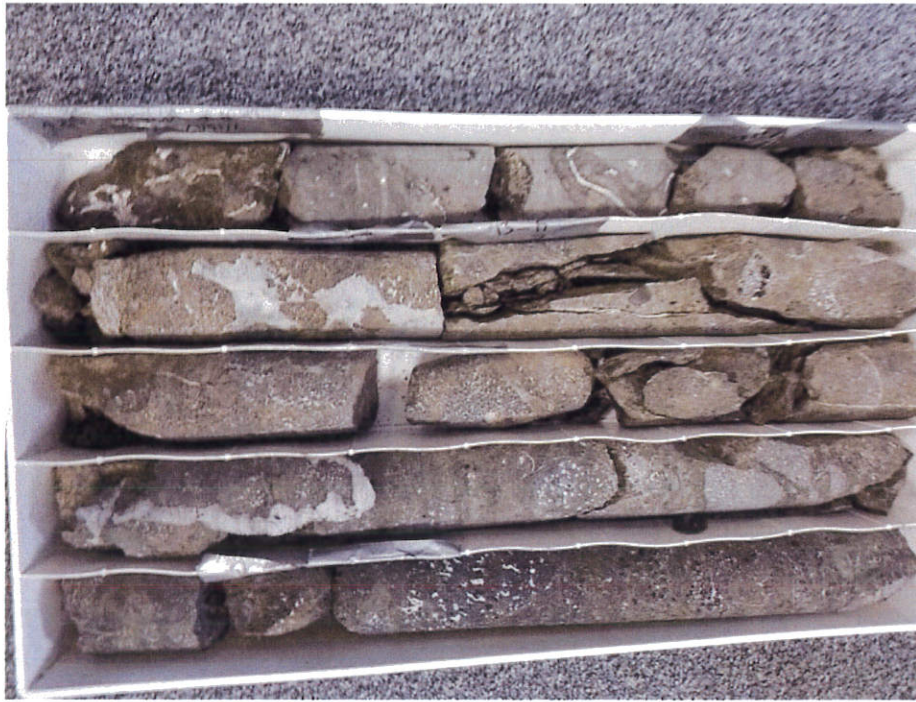
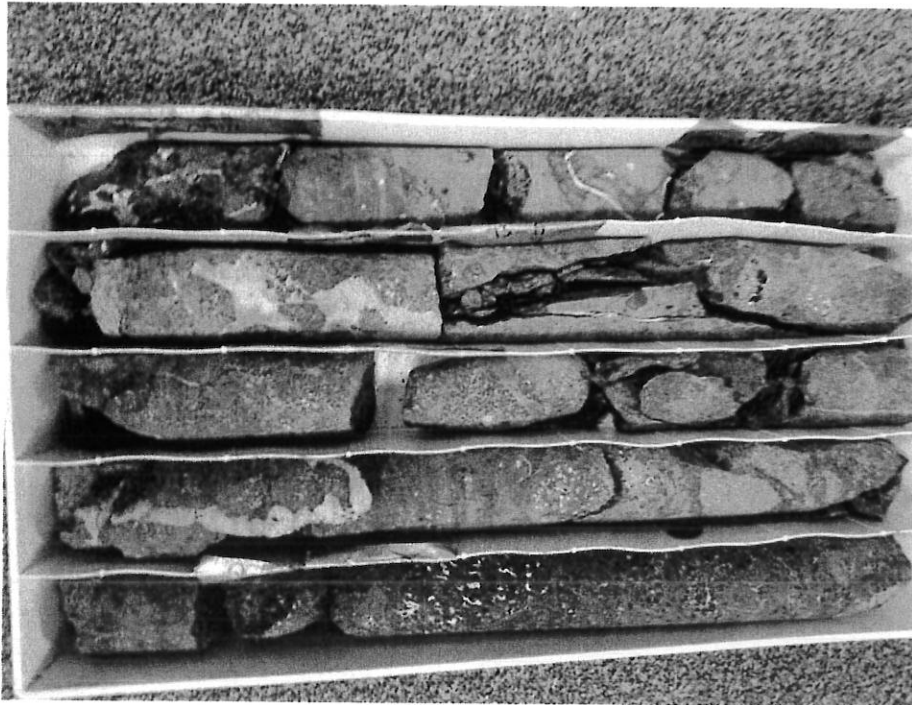
Photo 7 - Close-up view of rock core samples from boring B-2 recovered from approximately 10 to 19.5 feet below ground surface.
