Neskowin Coastal Hazard Area Permit #851-21-000393-PLNG: Rusina

NOTICE OF ADMINISTRATIVE REVIEW Date of Notice: January 31, 2022

**Geologic Hazards and Geotechnical Investigation
Tax Lot 1900, Map 5S-11W-24BD
45740 Kinnikinnick Drive
Neskowin, Tillamook County, Oregon**

Project #Y214556

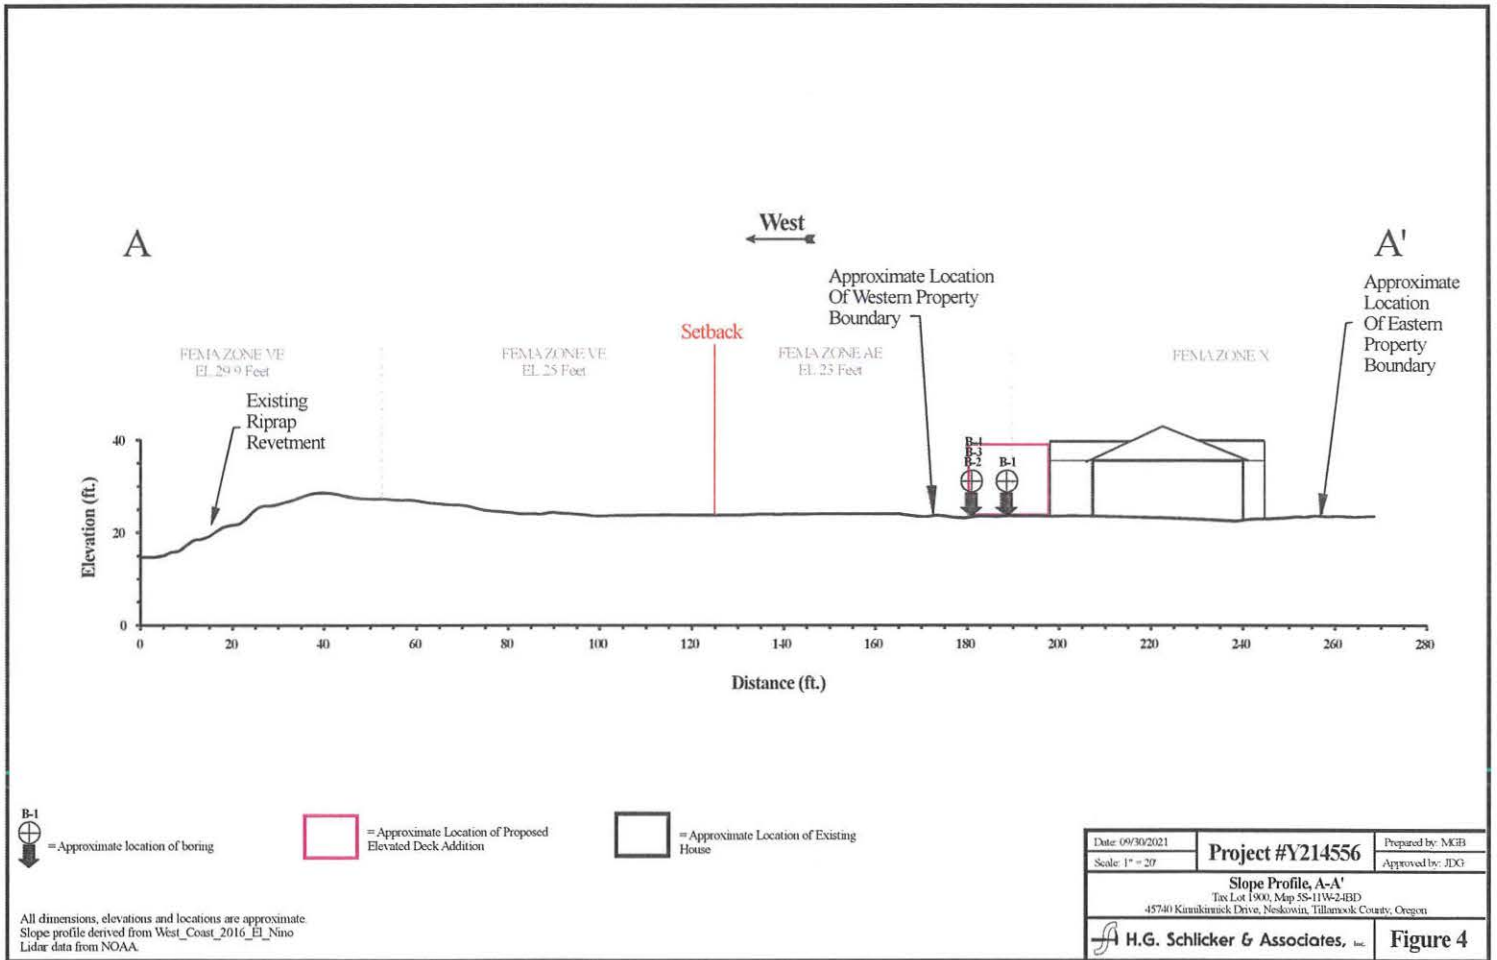
Figure 3

Based on the 2018 Flood Insurance Rate Map (FIRM, Panel #41057C1005F), the western portion of the site lies in an area mapped as a Special Flood Hazard Area (SFHA) Zone AE with Base Flood Elevations determined at 23 feet. The eastern approximately 65 feet of the site lies within Zone X, determined to be an area of minimal flood hazard (Figures 3 and 4).

Based on our site observations, the existing riprap revetment west of the site will prevent significant dune erosion at the site with proper maintenance. However, during severe storm events, the revetment may be overtopped by severe wave swash. Areas west of the site are mapped as FEMA VE Zones. We recommend that all foundation elements for the new addition be set back a minimum of 100 feet from the top of the revetment and outside of the FEMA VE zones, whichever is greater. It is our understanding that the addition is proposed to be approximately 150 feet from the top of the revetment, well east of this minimum setback (Figures 3 and 4).

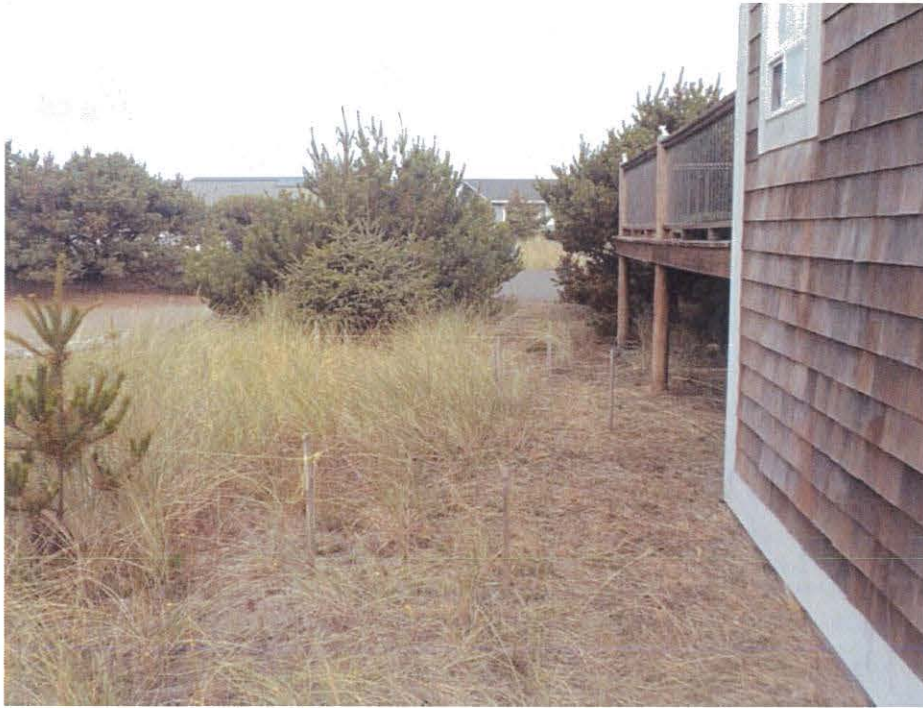
Photo 3 – View of the existing deck at the northwest corner of the house and the location of the proposed new elevated deck.

It is our understanding that the proposed deck will be attached to the existing attached deck. We recommend that the lowest horizontal member of the deck's frame be elevated a minimum of one foot above the BFE of 23 feet. If modifications to the existing structure contribute substantially greater loads to the existing foundations, additional geotechnical investigation, analysis, foundation design and construction recommendations may be required.

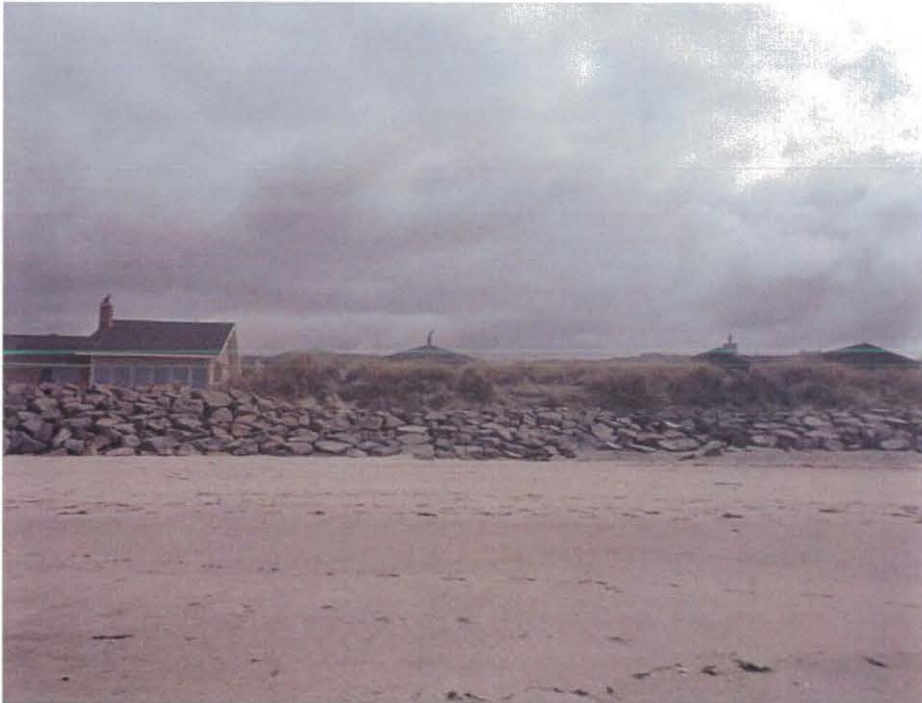
The seaward front of the oceanfront property west of the subject site is densely vegetated with European beachgrass and a few small shorepines. The riprap revetment appeared to be in generally good condition. The quality of the single armor stone layer used for the construction of the revetment was variable and consisted of a mixture of highly fractured basalt breccia, occasional sandstone, and relatively unfractured basalt (Appendix A). Additional observations are addressed in Section 3.0 and Appendix A.

The existing revetment located on the west of the subject site slopes down to the beach at approximately 20 to 30 degrees and consists of angular basalt boulders approximately 4 to 6 feet diameter on its lower portion and approximately 3 to 5 feet diameter on the upper portion (Figure 3; Appendix A). Severe storms in the winter of 2007–2008 partly undermined the revetments in areas located along Neskowin Beach. The riprap revetment west of the site greatly reduces the potential for erosion when maintained and repaired as necessary.

Photo 6 – Easterly view of the existing rip rap revetment exposed west of the site.

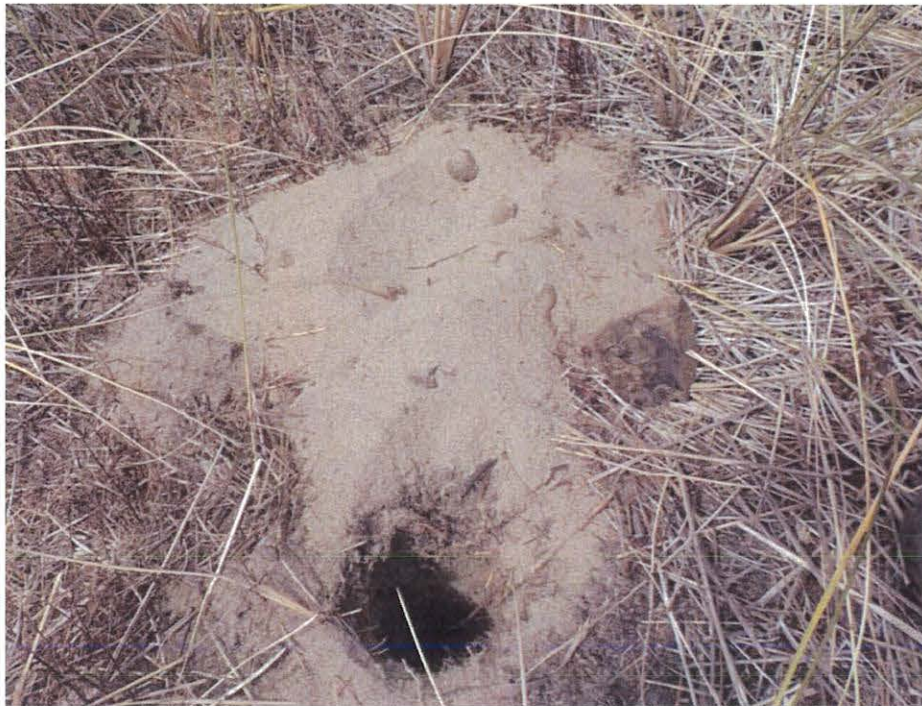
The borings generally encountered approximately 2 feet of tan, loose, dune sand and gravel fill underlain by loose dry native sands.

2. Loose unconsolidated soils and fill at least 2 feet deep are present. This material is unsuitable for supporting new foundations.
3. A portion of the site lies within a mapped FEMA flood zone and is subject to potential flooding.

Photo 7 – View of the sand typical of the materials encountered in the borings.

All existing loose disturbed soil, fills, and debris should be stripped and removed from footing areas prior to construction so that new foundations and structural fill materials can rest on native sand soils, recompacted non-organic fill sands, or imported granular fills.

The thickness of fill and loose soils at the site is variable, and the depth to suitable non-organic, native firm sandy soils is unknown. We recommend that footing areas be over-excavated and replaced with structural fill per the recommendations provided in section 5.3.2 below. Structural fill underlying footings should extend to depths of 2 times the footing width below the bottom of the footing or a minimum of 3 feet, whichever is greater, and have a width of 2 times the footing width.
