Neskowin Coastal Hazard Area Permit #851-22-000380-PLNG: LEAHY

NOTICE OF ADMINISTRATIVE REVIEW Date of Notice: April 5, 2023

**Geologic Hazards and
Geotechnical Investigation
Tax Lot 5400, Map 5S-11W-25CB
Breakers Boulevard
Neskowin, Oregon**

Project #Y214521

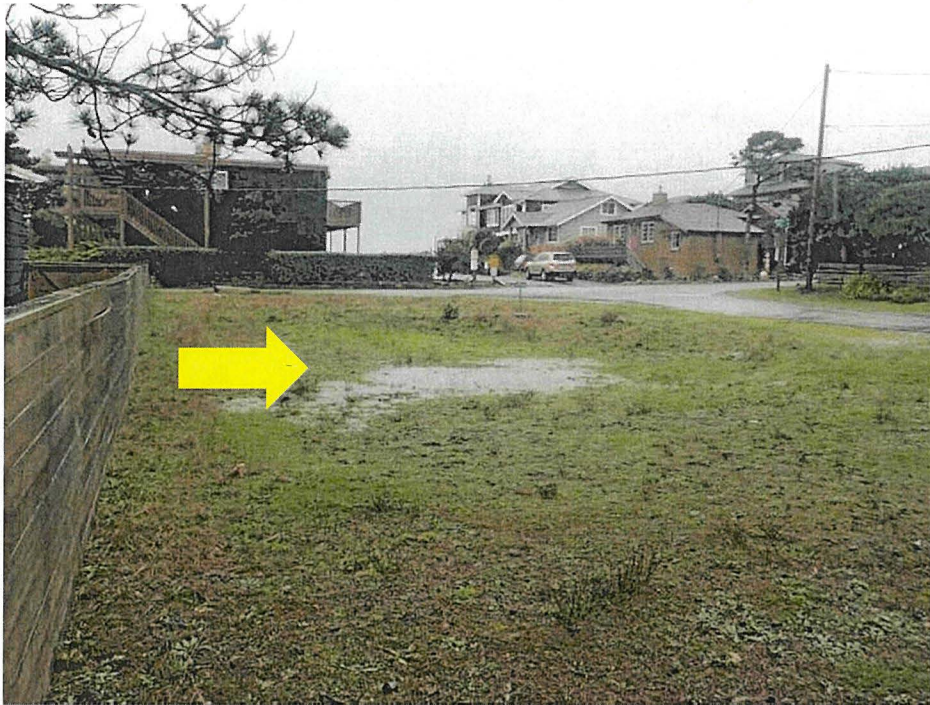
Stormwater at the site generally flows towards the center of the site. At the time of our site visit, we observed no streams at the site. The nearest stream is Kiwanda Creek, located approximately 680 feet east of the site. Kiwanda Creek joins Neskowin creek and discharges onto the beach approximately 0.5 miles south of the site.

Photo 3 – Westerly view along the southern boundary of the site. Note the standing water in the shallow depression in the center of the site (indicated with yellow arrow).

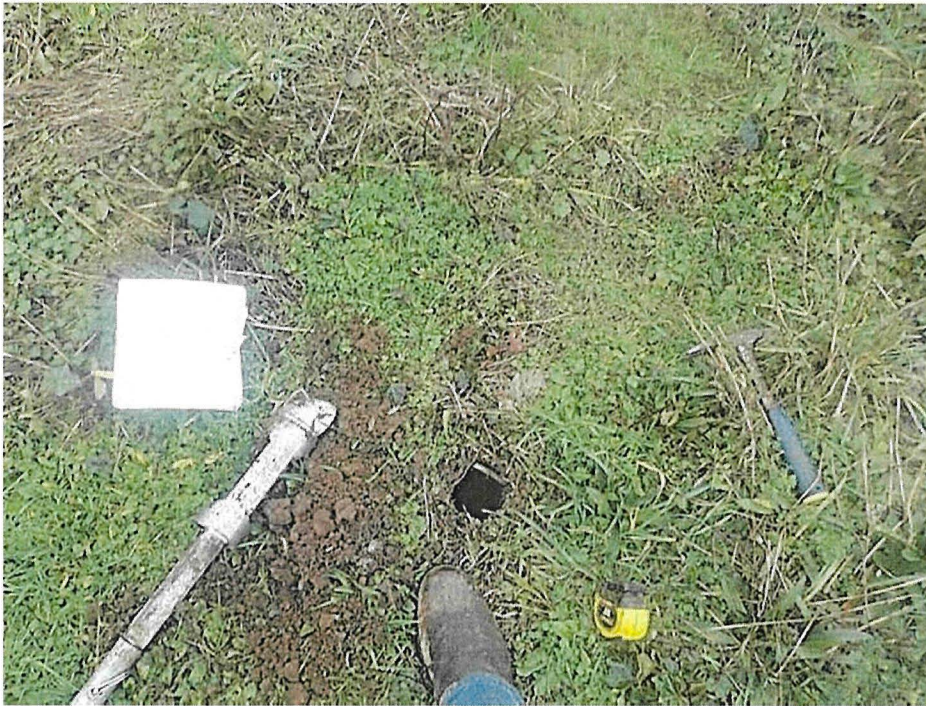
Boring B-1 generally encountered approximately 2 feet of brown, very loose to loose, organic-rich silt and silty sand overlying tan, loose to slightly dense moist dune sand. Borings B-2 and B-3, on the west side of the lot, both met refusal at shallow depths due to rock fragments. We anticipate that undocumented fill at least two feet thick will be encountered throughout the western portion of the site. Probing of the center of the site encountered moderate resistance at depths of approximately 2 feet.

Photo 4 – Close-up view of the silty fill soils encountered in borings B-2 and B-3 on the western portion of the site.

All existing fills and debris should be stripped and removed from building, slab and driveway areas prior to construction so that new foundations and structural fill materials can rest on dense native sand soils, recompact fill sands at the site or imported granular fills. Fills need to be properly moisture conditioned when compacting.

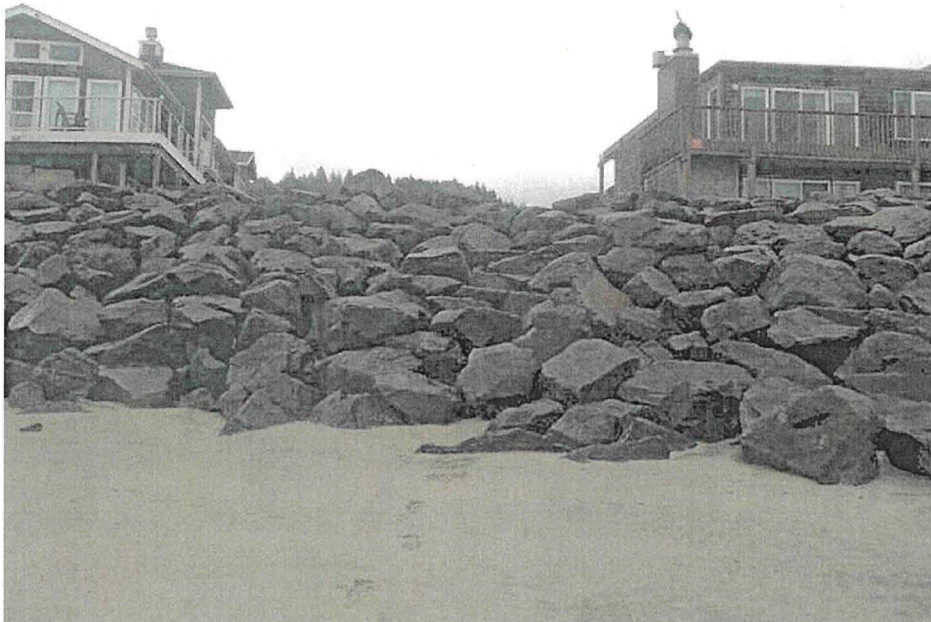
The existing revetments located west of the subject site consist of angular basalt boulders. (Appendix A). Severe storms in the winter of 2007–2008 partly undermined the revetments in areas located along Neskowin Beach. The riprap revetment greatly reduces the potential for erosion when maintained and repaired as necessary.

Photo 5 – Easterly view of the riprap revetment at the end of Amity Avenue near the site.
