**ADMINISTRATIVE REVIEW 851-16-000149-PLNG:  
PASTEGA OCEANFRONT SETBACK LINE DETERMINATION  
Decision Date: January 5, 2017**

**Update To A  
Geologic Hazards Study and Geotechnical Report  
Tax Lots 2200 and 2400, Map 1S-11-25AA  
1816 Maxwell Mountain Road  
Oceanside, Tillamook County, Oregon**

**November 21, 2016  
Project #Y163980**

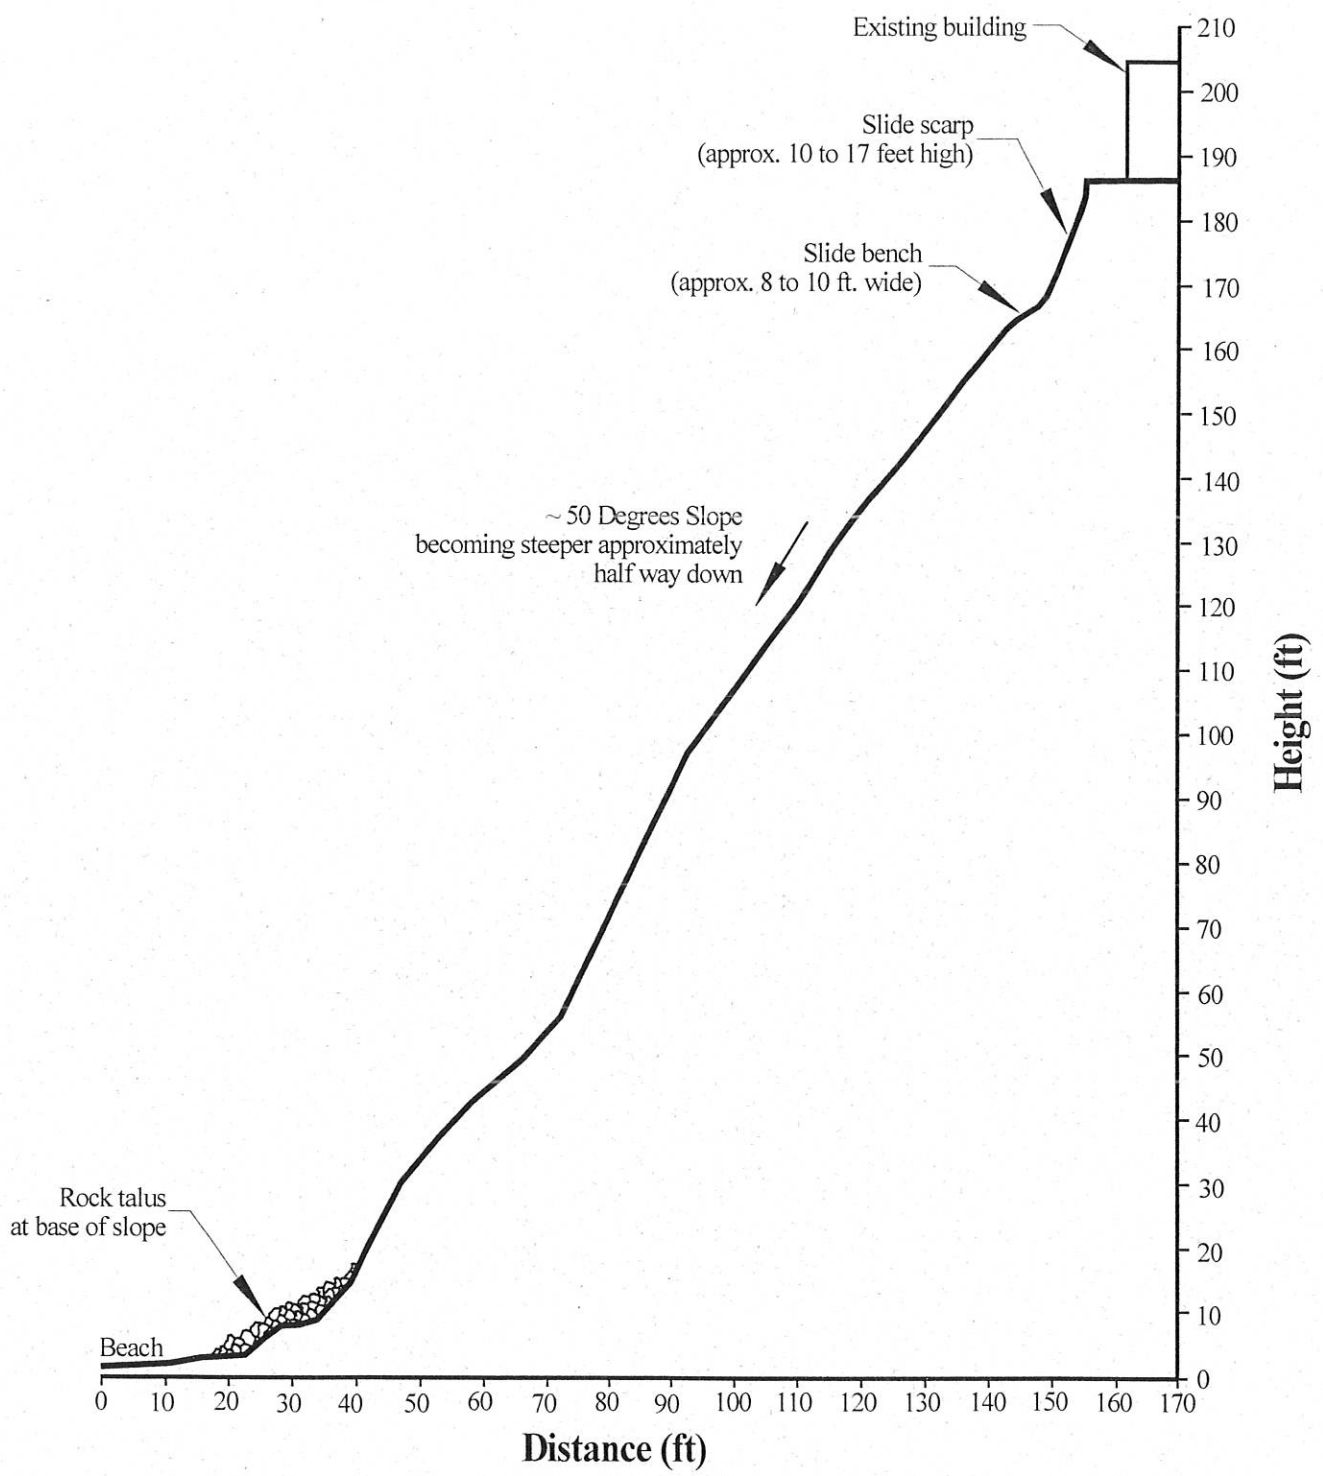
Date: 11/21/2016	Prepared by: CJH	<b>Project #Y163980</b>
Scale: 1" = 30'	Approved by: JDG	
<b>H.G. Schlicker &amp; Associates, Inc.</b> Tax Lots 2200 and 2400, Map 1S-11-25AA 1816 Maxell Mountain Road, Oceanside, Oregon		<b>Figure 5</b>

Upper slope profile based on site measurements in 2013, 2014 and 2016.  
 Lower slope profile from prior work.  
 All dimensions and locations are approximate.

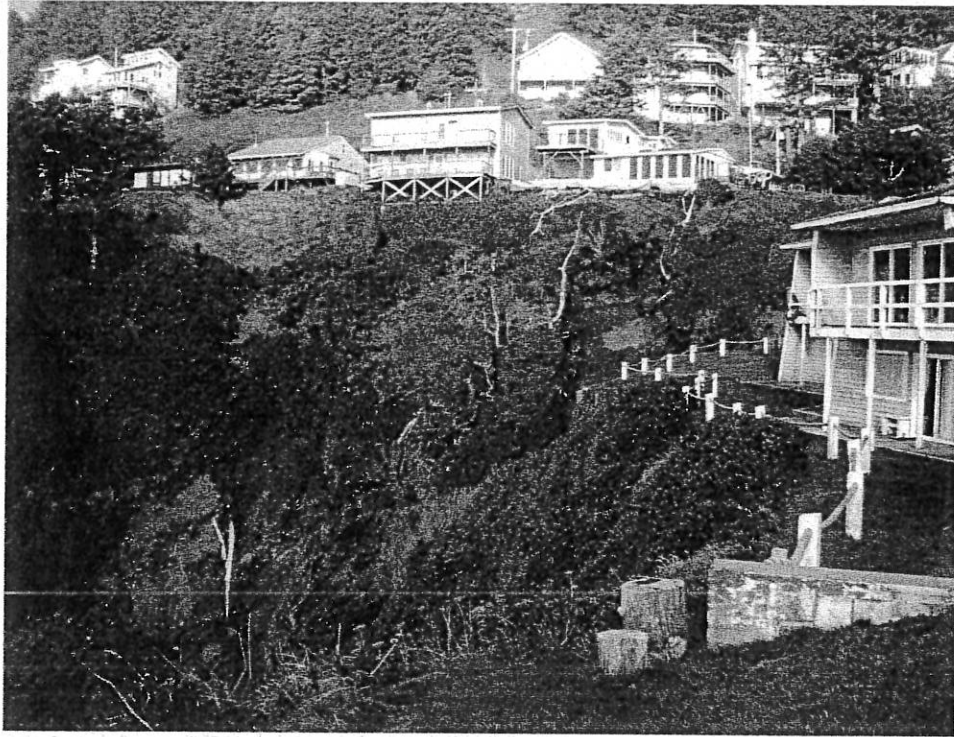
Photo 1 - Easterly view along the northern slope of Maxwell Point.

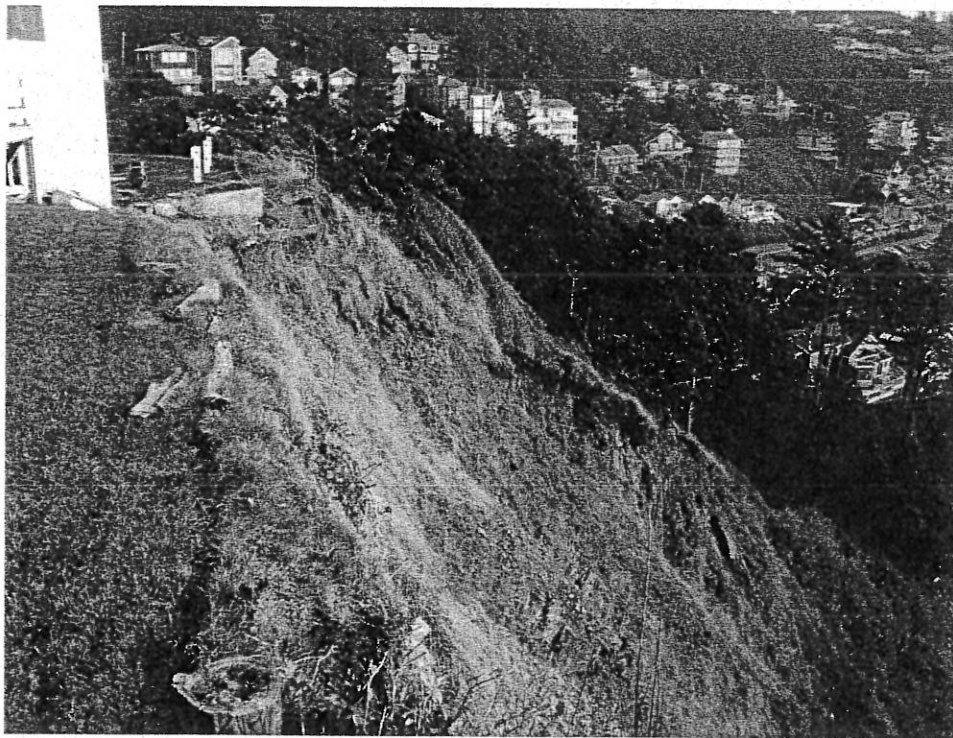
Photo 2 - Southeasterly view along the southern bluff slope.

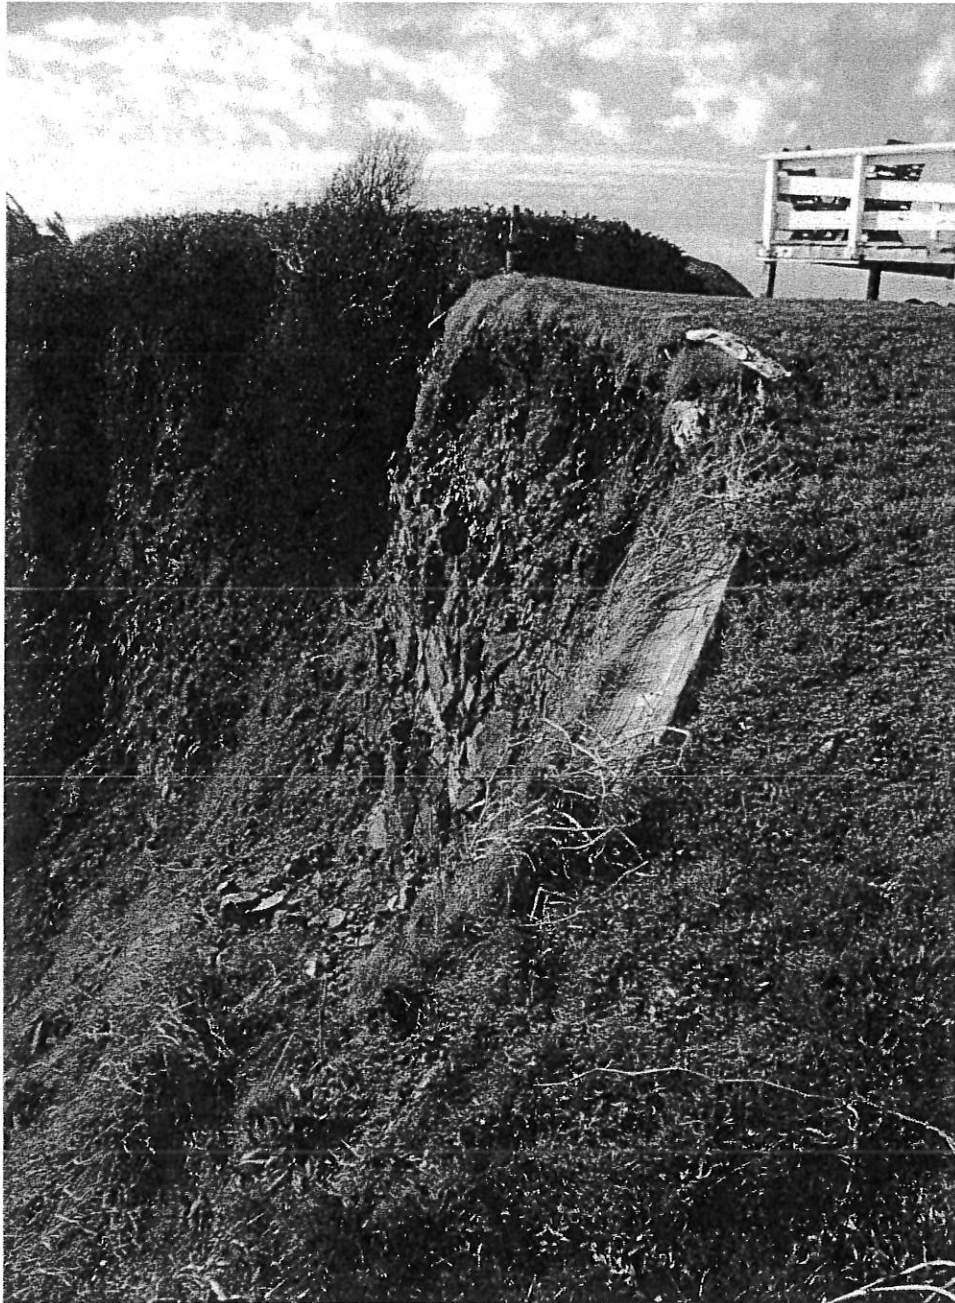
2. There is a relatively small distance from some of the existing structures to the upper edge of the bluff slope, particularly the southwest corner of the western building where the foundation lies 6½ feet from the failing bluff edge.

Photo 3 - Looking northwest along the failing upper edge of the southern bluff slope.

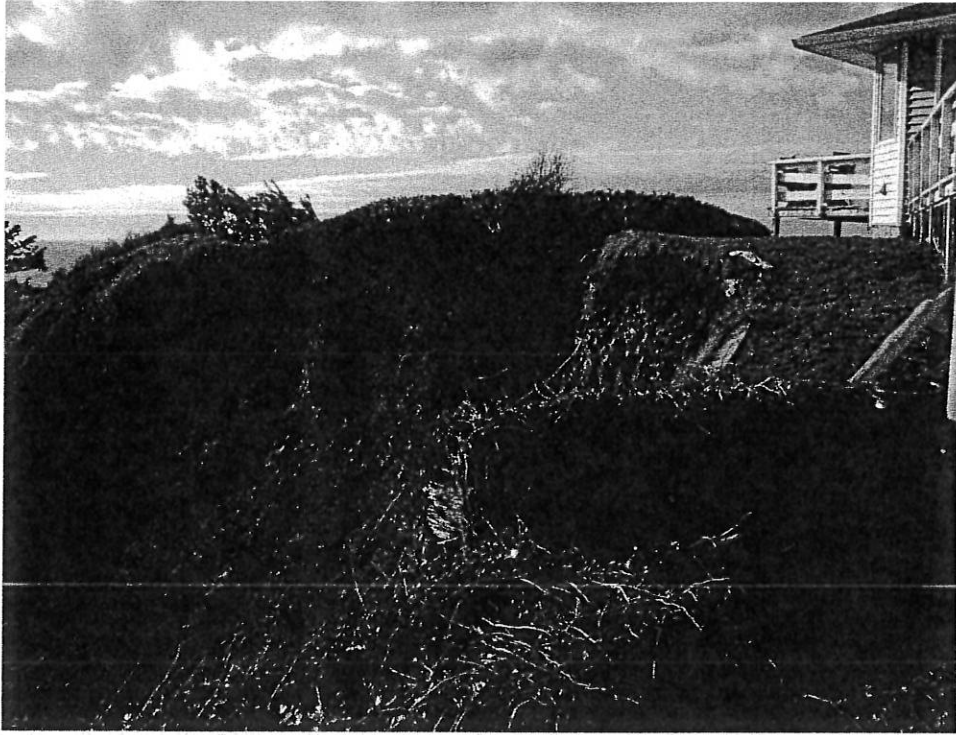
Photo 4 - Northwesterly view along the southern bluff. Southwest corner of existing building is at far lower right of photo.

Foundations along the southwest corner of the western building should be placed on pile for additional protection when ground movement occurs. Pile should consist of a steel reinforced, bored and grouted micropile.

The final design should consider structural needs and constructability. For long term monitoring of any slope movement, we recommend that an inclinometer be installed at the southwest corner of the western building.
