**OREGON PUBLIC LAND CORNER REPORT / RESTORATION REPORT**  
Tillamook County Surveyor's Office

<b>SECTION: SE COR 33</b>	<b>TOWNSHIP 2 North</b>	<b>RANGE 10 West</b>
<b>COUNTY: Tillamook</b>		<b>DATE: 5-13-10</b>
<b>CORNER DESIGNATION:</b> The Section Corner common to Sections 33,34 T. 2 N. R. 10 W. and Sections 3, 4 T. 1N. R. 10 W.		<b>(Please check one)</b>
		<input type="checkbox"/> Condition Report Only <input type="checkbox"/> Restoration <input checked="" type="checkbox"/> Rewitness <input type="checkbox"/> Unrecorded <input type="checkbox"/> Reset at surface <input type="checkbox"/> Referenced Out
<b>Previous Rewitnesses, Restorations and Surveys, etc:</b> BLM Field Notes Volume: OR-R0122 Page 57, (GLO Book 1N10 Page 32) (1873), Map B-437 (1959), Rewitness Book 2 Page 489 (1961), Tillamook County Survey Records.		
<b>Found Monument(s) and Accessories (Condition &amp; Source):</b> Found a 3" diameter O.S.B.F. Brass Cap under the root system of a 12" dia. Hemlock, down 0.5'. No original evidence was found and the monument was proportioned on Map B-437 (1959). Rewitness Book 2 Page 489 was the corner report reflecting the work done on Map B-437. The intent of this rewitness is

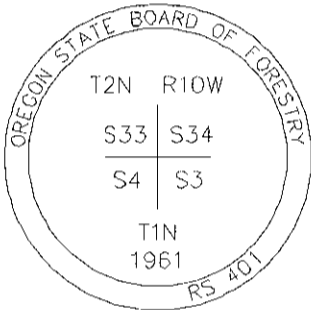
<b>Monument Found (Procedures and Description):</b> After felling the Hemlock and cutting out the root system to expose the monument, we ran a control traverse to the monument from GPS established control. The Oregon North Zone State Plane in NAD 83/91 grid coordinate for the position is N = 726075.430, E = 7330887.101 U.S. Survey Feet. Convergence = -2°24'52.59333", Grid Scale = 0.99992388.		<b>Sketch of Found Monument:</b>

<b>New accessories set:</b> Set 120 lbs. of concrete in a 12" dia. cylinder around the monument. Set 72" hat section post with a yellow metal location tag East 3.0' from the monument.		
<b>New Bearing Trees set:</b> *18" dia. Spruce bears N 4° W 17.6' scribed, "T2N R10W S33 BT", tagged and painted. *19" dia. Spruce bears N 73° E 26.7' scribed, "T2N R10W S34 BT", tagged and painted. *19" dia. Spruce bears S 33° E 17.0' scribed, "T1N R10W S3 BT", tagged and painted. *15" dia. D. Fir bears S 87° W 26.9' scribed, "T1N R10W S4 BT", tagged and painted. * Indicates an aluminum nail with a washer marked, "Till. Co. Surveyor" in the face of the blaze between the scribed "B" and "T" and a yellow metal location tag affixed.
