NESKOWIN COASTAL HAZARDS AREA PERMIT

#851-21-000393-PLNG: RUSINA

NESKOWIN COASTAL HAZARD AREA PERMIT REQUEST
#851-21-000393-PLNG: RUSINA
ADMINISTRATIVE DECISION & STAFF REPORT

**Geologic Hazards and Geotechnical Investigation
Tax Lot 1900, Map 5S-11W-24BD
45740 Kinnikinnick Drive
Neskowin, Tillamook County, Oregon**

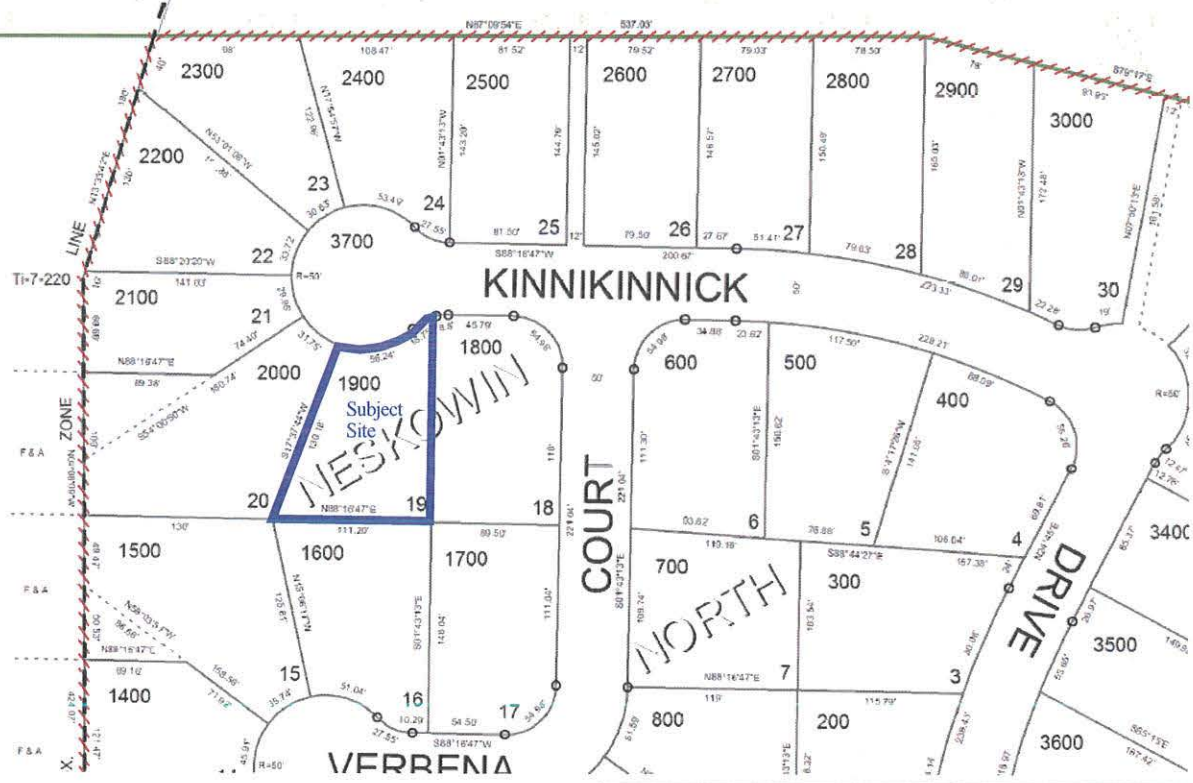
Date: 09/30/2021	Project #Y214556	Prepared by: MGB
Scale: 1" = 100'		Approved by: JDG
Plat Map Tax Lot 1900, Map 5S-11W-24BD 45740 Kinnikinnick Drive, Neskowin, Tillamook County, Oregon		
H.G. Schlicker & Associates, Inc.		Figure 2

Modified from the Tillamook County assessor's plat
5S-11W-24BD
All locations and dimensions are approximate.

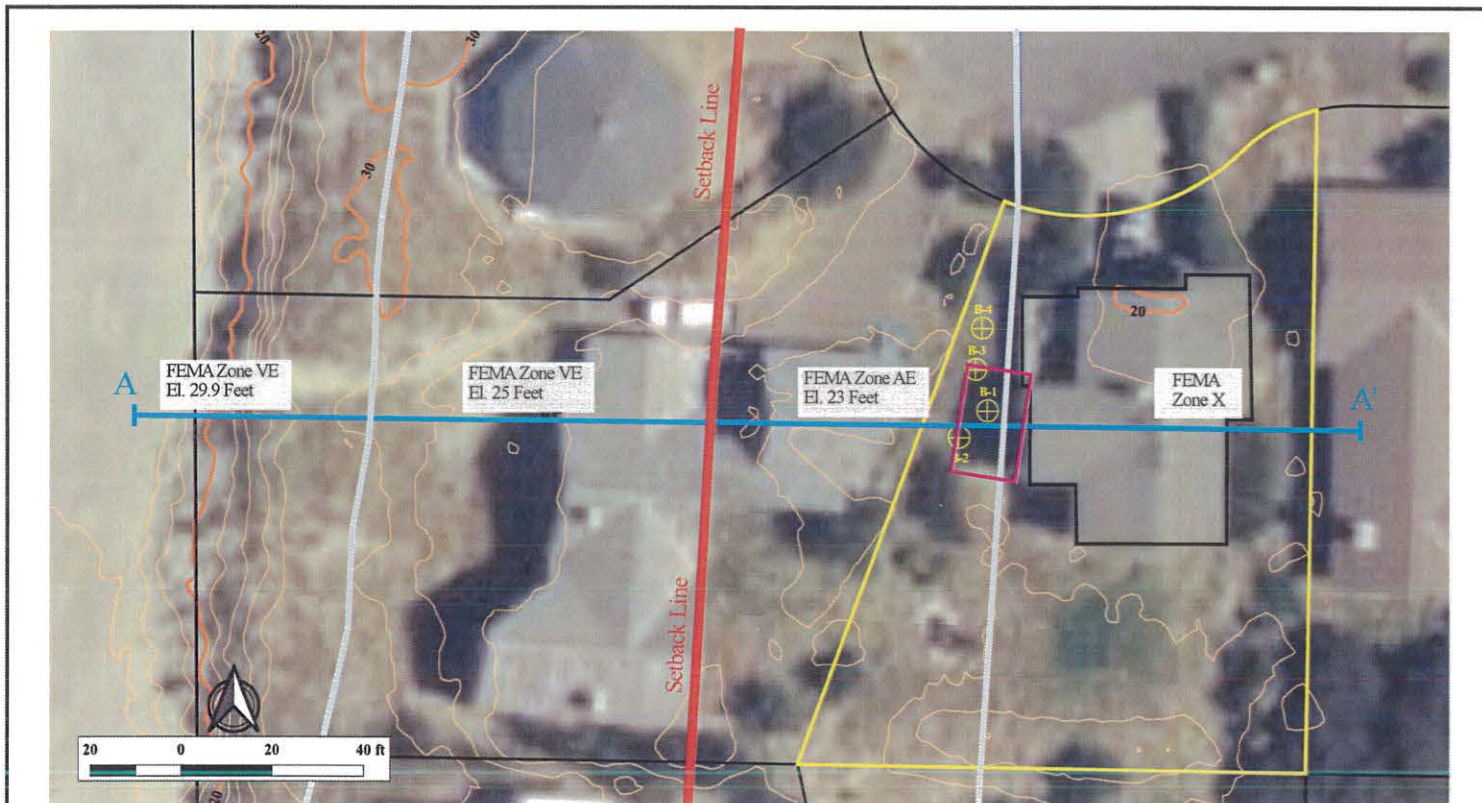
H.G. Schlicker & Associates, Inc. **Figure 3**

A — A' = Approximate trend of profile line

[Pink rectangle symbol] = Approximate Location of Proposed Elevated Deck Addition

Site Topographic Map
 Tax Lot 1900, Map 58-11W-245D
 45740 Kurokinnick Drive, Neskowin, Tillamook County, Oregon

Lidar data from 2016 shows the junction between the beach and the revetment was at an elevation of approximately 16 feet (NAVD 88) (Figures 3 and 4). Allan and Hart (2005) surveyed the elevation of the beach/dune junction in 1997, 1998, and 2002 at approximately 25 feet, 19 feet, and 16 feet, respectively. Winter elevations primarily depend on beach profiles formed by storm conditions.

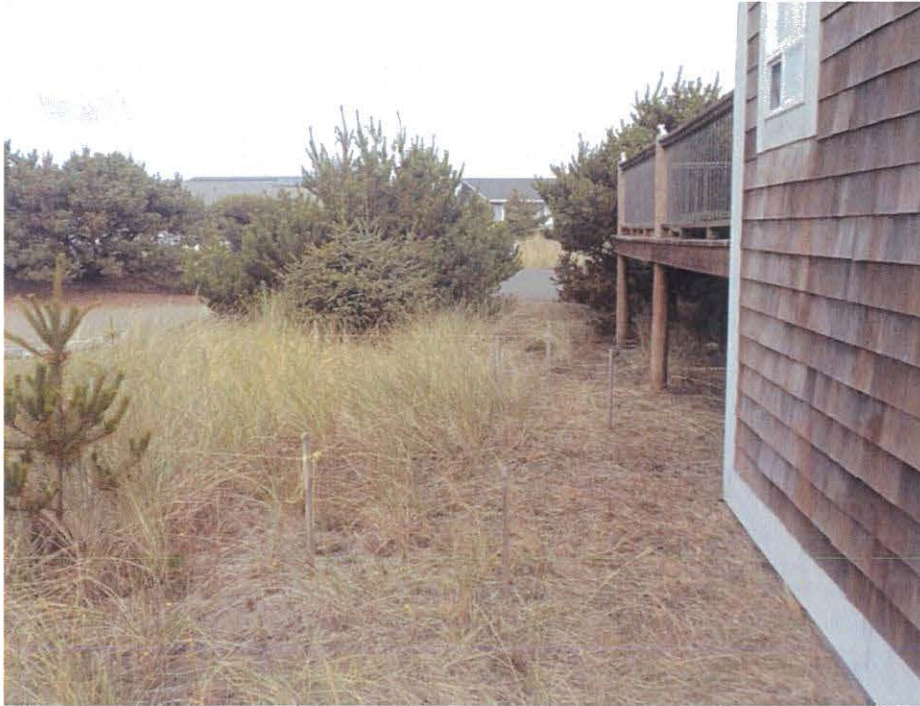
Photo 3 – View of the existing deck at the northwest corner of the house and the location of the proposed new elevated deck.

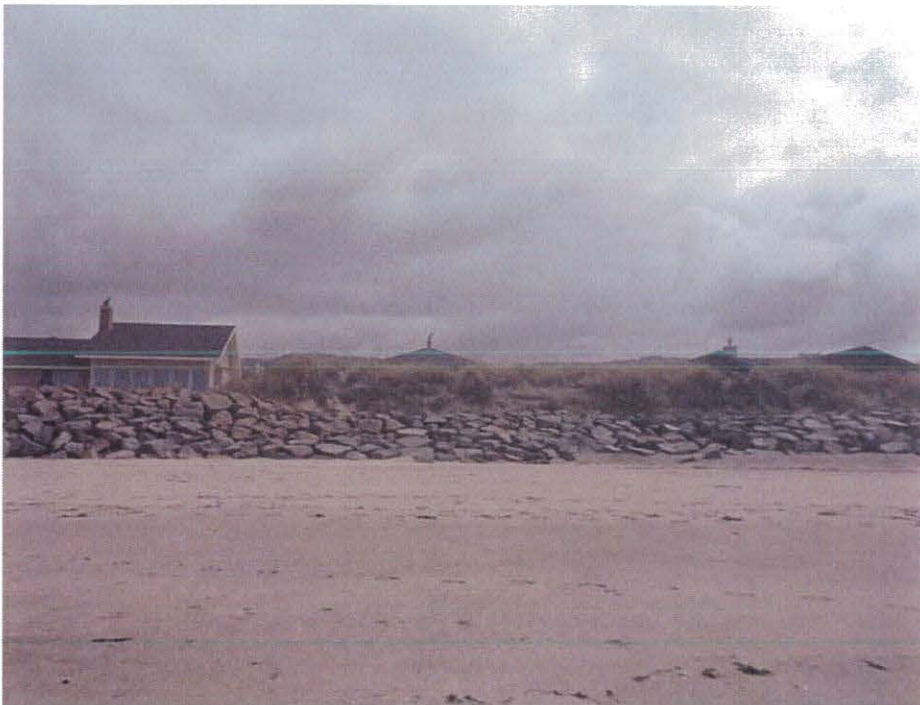
Photo 6 – Easterly view of the existing rip rap revetment exposed west of the site.

The seaward front of the oceanfront property west of the subject site is densely vegetated with European beachgrass and a few small shorepines. The riprap revetment appeared to be in generally good condition. The quality of the single armor stone layer used for the construction of the revetment was variable and consisted of a mixture of highly fractured basalt breccia, occasional sandstone, and relatively unfractured basalt (Appendix A). Additional observations are addressed in Section 3.0 and Appendix A.

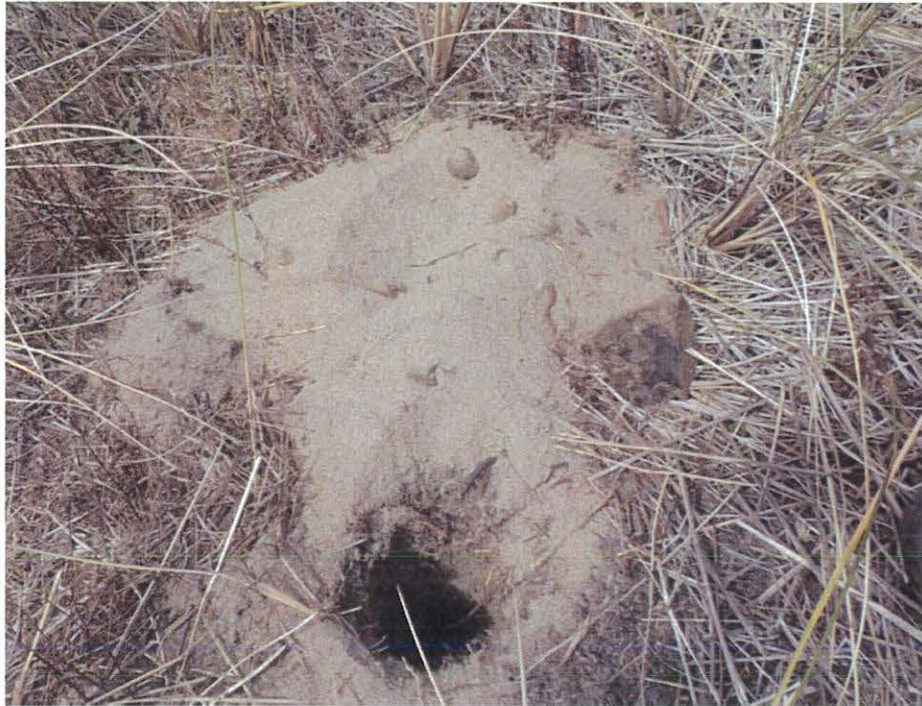
Photo 7 – View of the sand typical of the materials encountered in the borings.

The borings generally encountered approximately 2 feet of tan, loose, dune sand and gravel fill underlain by loose dry native sands.

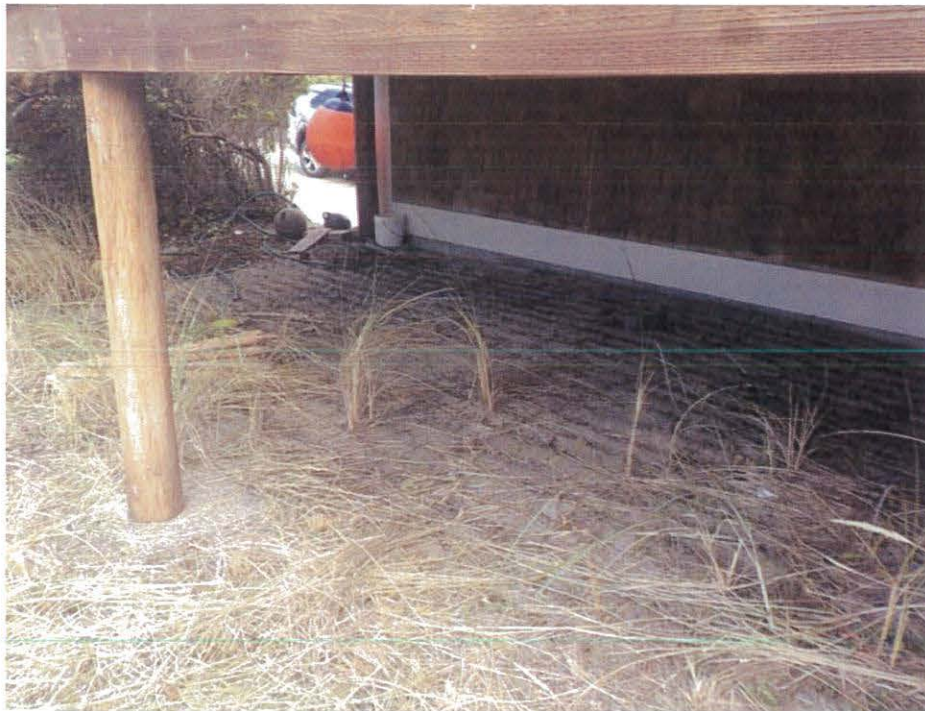
Photo 8 – Close-up view of the existing deck.
