Feasibility Analysis and Conceptual Restoration Plan

Revised  
November 2017

# Technical Memorandum

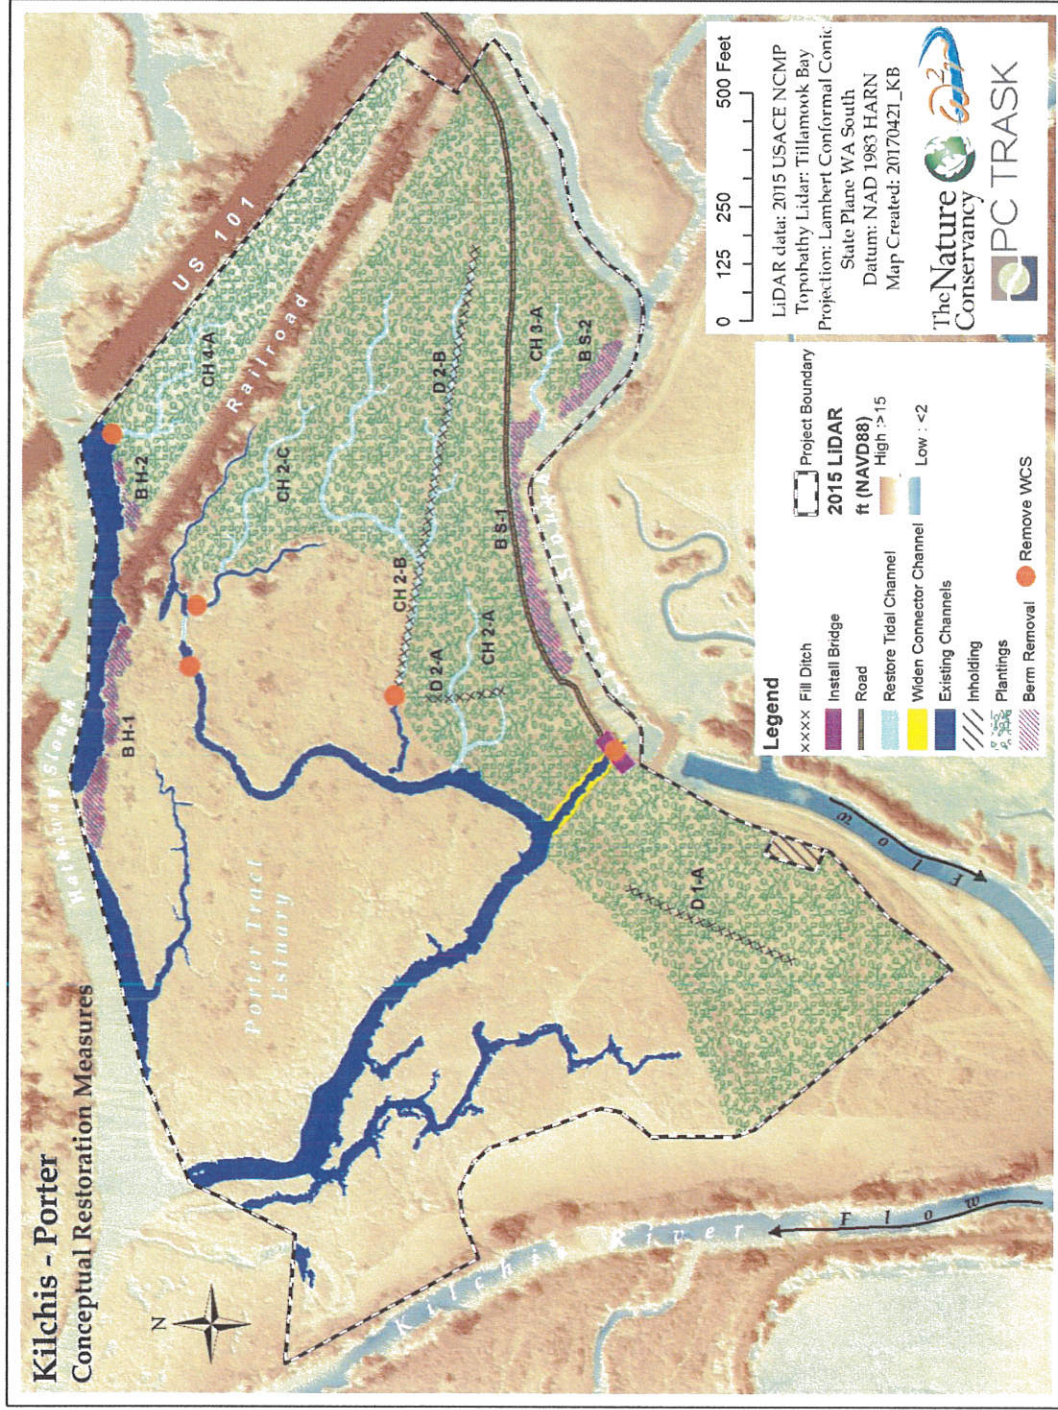
Figure 5. Porter Tract Conceptual Restoration Design.

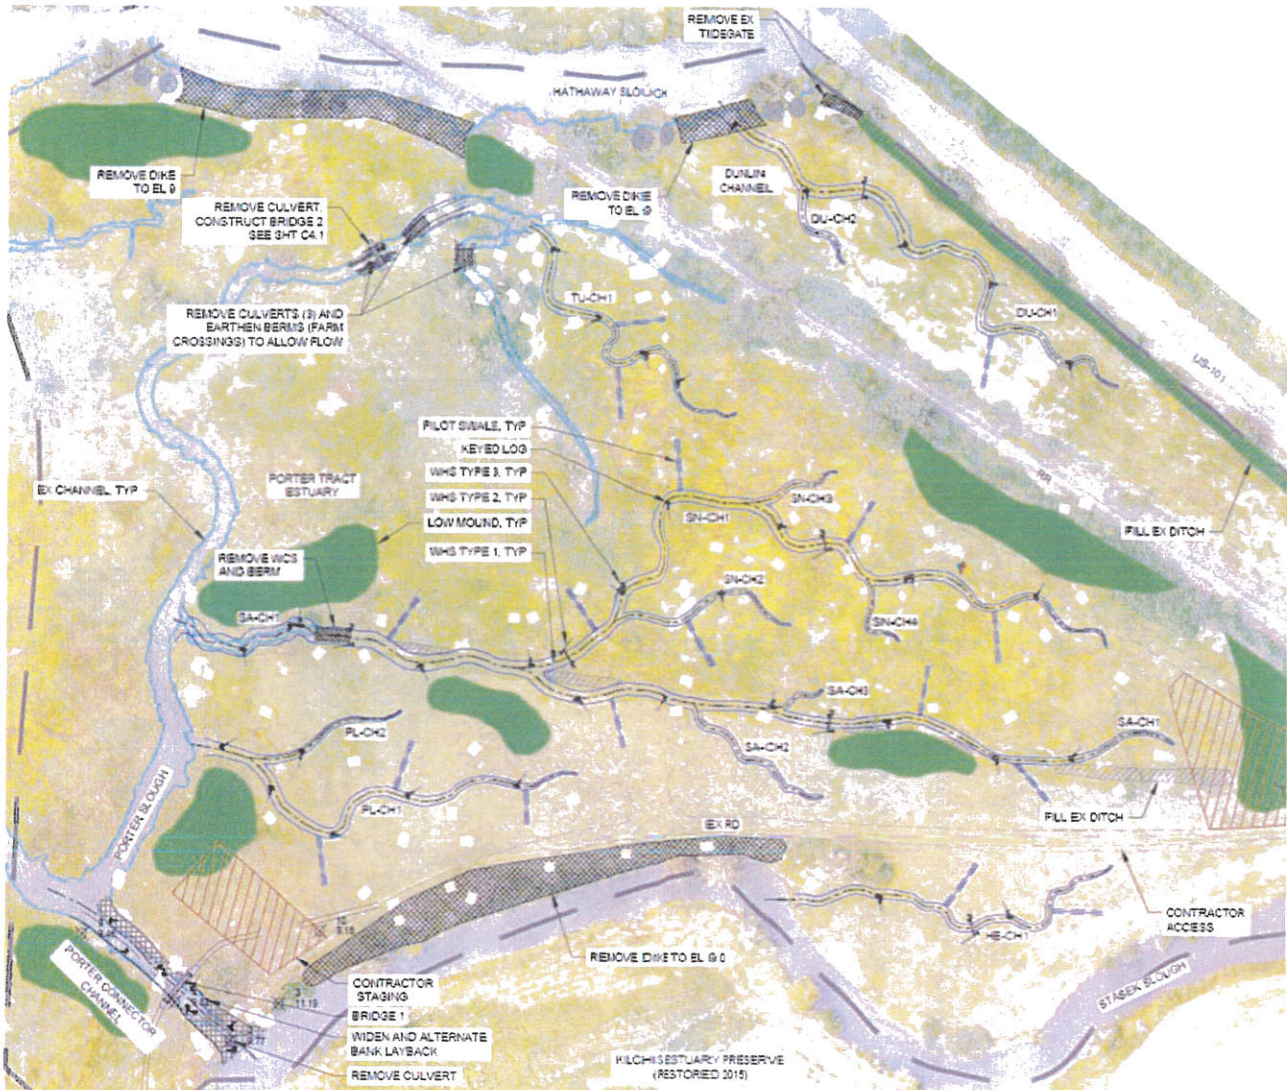
Figure 1 Porter Tract restoration site overview indicating restored channels, filled ditches, dike removals, new bridges, and low mounds.

The Phase 1 model was updated to reflect Porter Tract Concept Restoration Designs (W2r 2017), and then it was updated for minor revisions associated with the final engineering designs (W2r 2019). The most recent changes to the model to reflect final restoration design are described in the letter report by Northwest Hydraulic Consultants (NHC 2019), which is included in Attachment A. The final restoration design overview and associated changes to the hydrodynamic model geometry are included in Figure 1 and Figure 2, respectively.

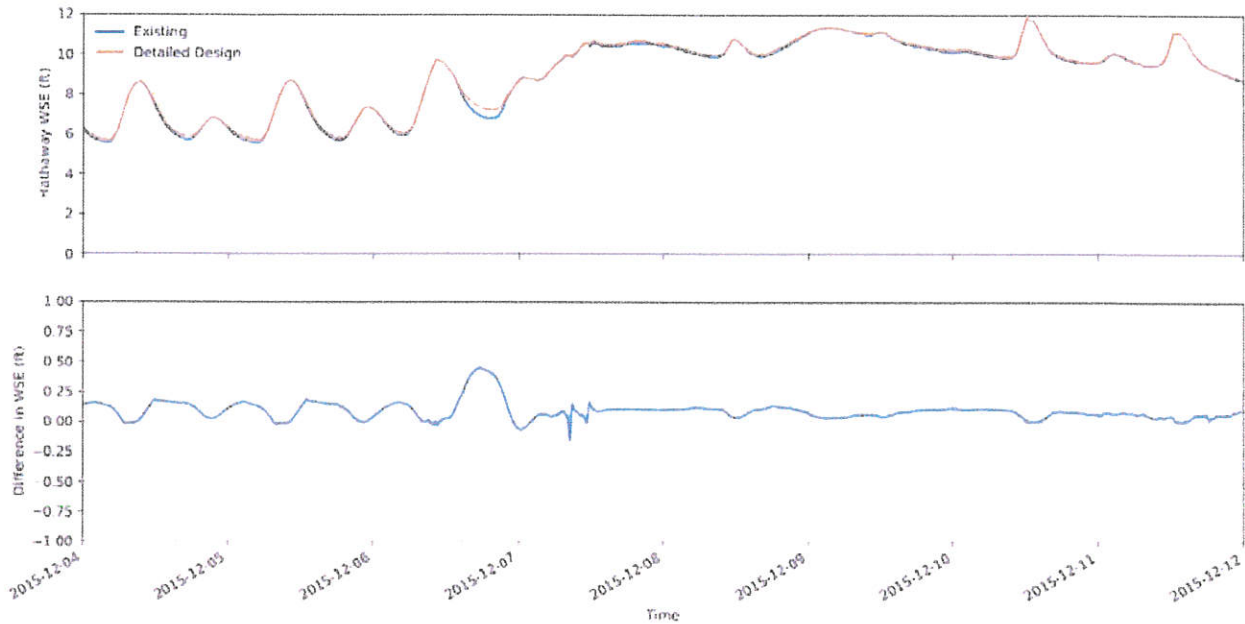
Figure 4 Comparison of water levels in Hathaway Slough under existing and proposed conditions for the December 2015 peak flood event.

At **Hathaway Slough** during non-peak / high tide conditions, there is a corresponding minor increase in water levels (0 to 0.5 feet) on the same order of magnitude as the decreases in Stasek Slough. The short term increases also occur during the falling limb of the tide. The minor increase appears to be due to additional / faster drainage from Stasek Slough into the Hathaway Slough tributary.

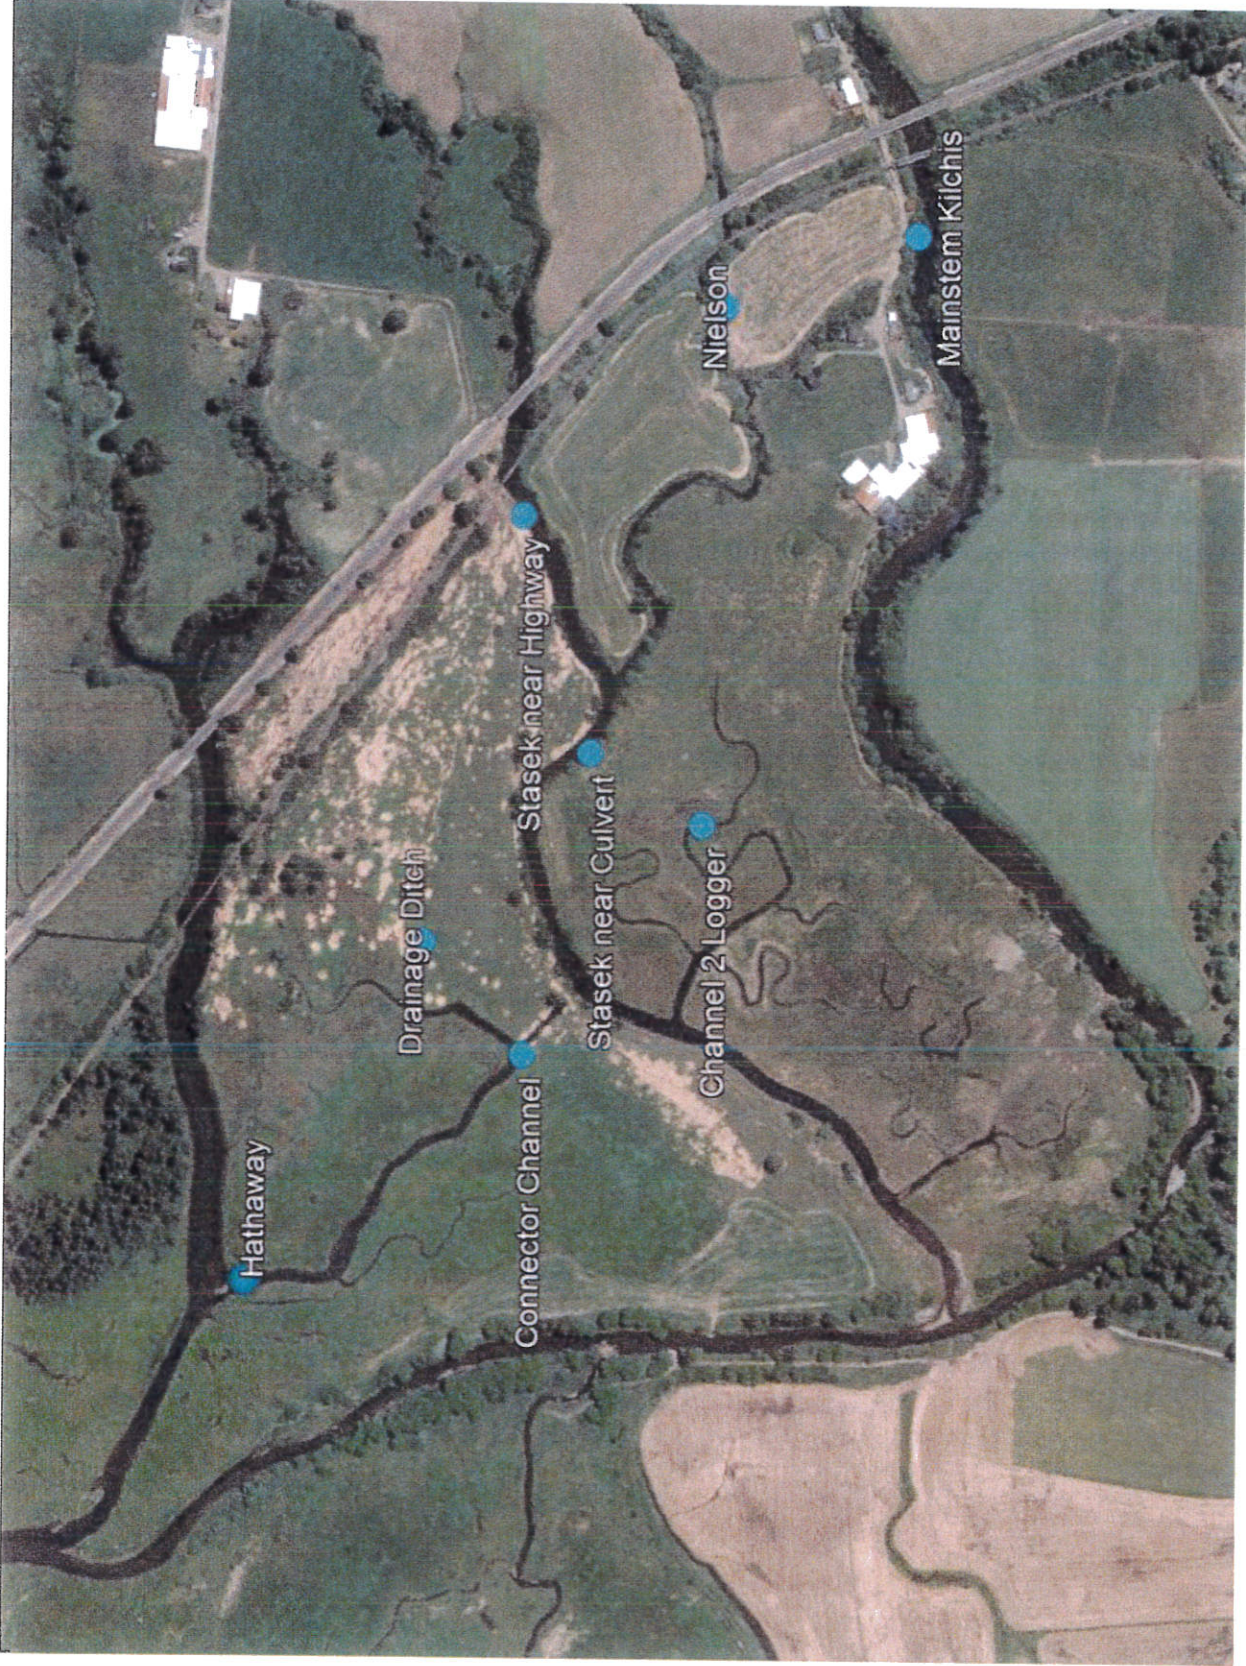
Figure 17. Locations of Water Level Loggers at Kilchis Preserve for Hydrologic Monitoring
