Technical Memorandum

Date:	07/16/2022
To:	Dick Vander Schaaf, Project Manager Associate Coast and Marine Conservation Director The Nature Conservancy of Oregon
From:	Curtis Loeb, PE, Principal Engineer Rowyn Cooper-Caroselli, PE, Lead Modeler Wolf Water Resources Portland, OR
Project:	Porter Tract Restoration - Kilchis Estuary Preserve
Subject:	Hydrodynamic Model Refinements in Response to Hydraulic Review

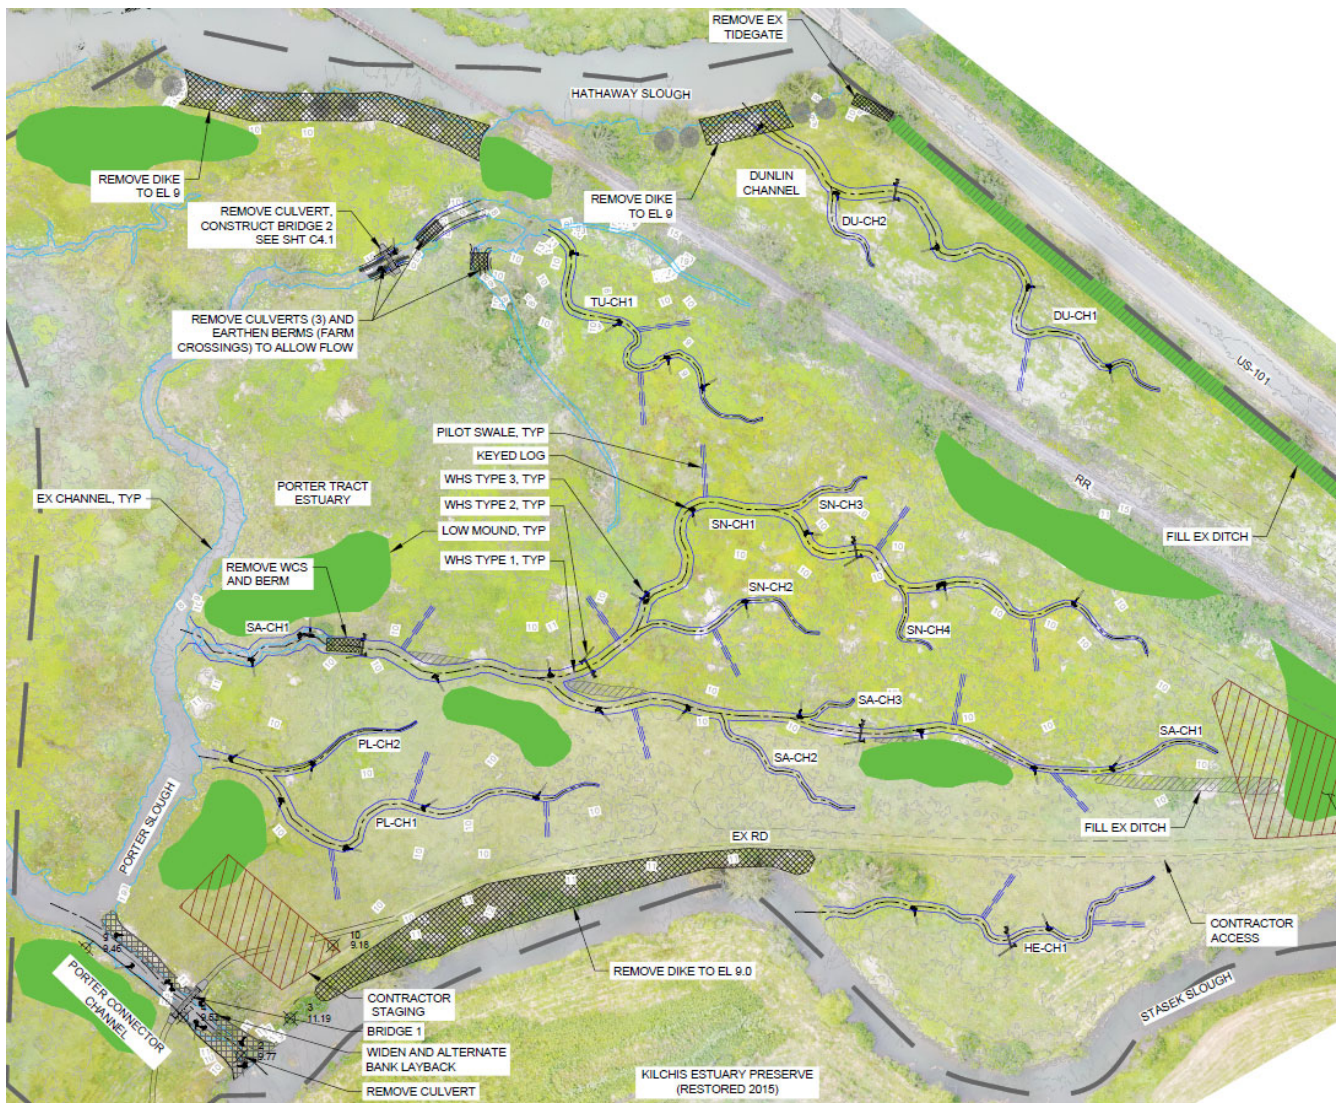
Figure 1 Porter Tract restoration site overview indicating restored channels, filled ditches, dike removals, new bridges, and low mounds.

A two-dimensional hydrodynamic model was originally developed for the Doohar Property (Kilchis River Estuary Restoration Phase1; ESA 2014). Model geometry or topographic extents along the Kilchis River and Tillamook Bay tidelands are described in the Phase 1 report. This report also describes model calibration to observed water levels, and hydrologic (tidal water level and riverine flow) boundary condition scenario development to examine typical tidal conditions as well as extreme storm events. The Phase 1 model was later updated to reflect Porter Tract Concept Restoration Designs (W2r 2017), and then it was updated for minor revisions associated with the final engineering designs (W2r 2019a and W2r 2019b). An overview of the Porter Tract elements is shown in Figure 1.

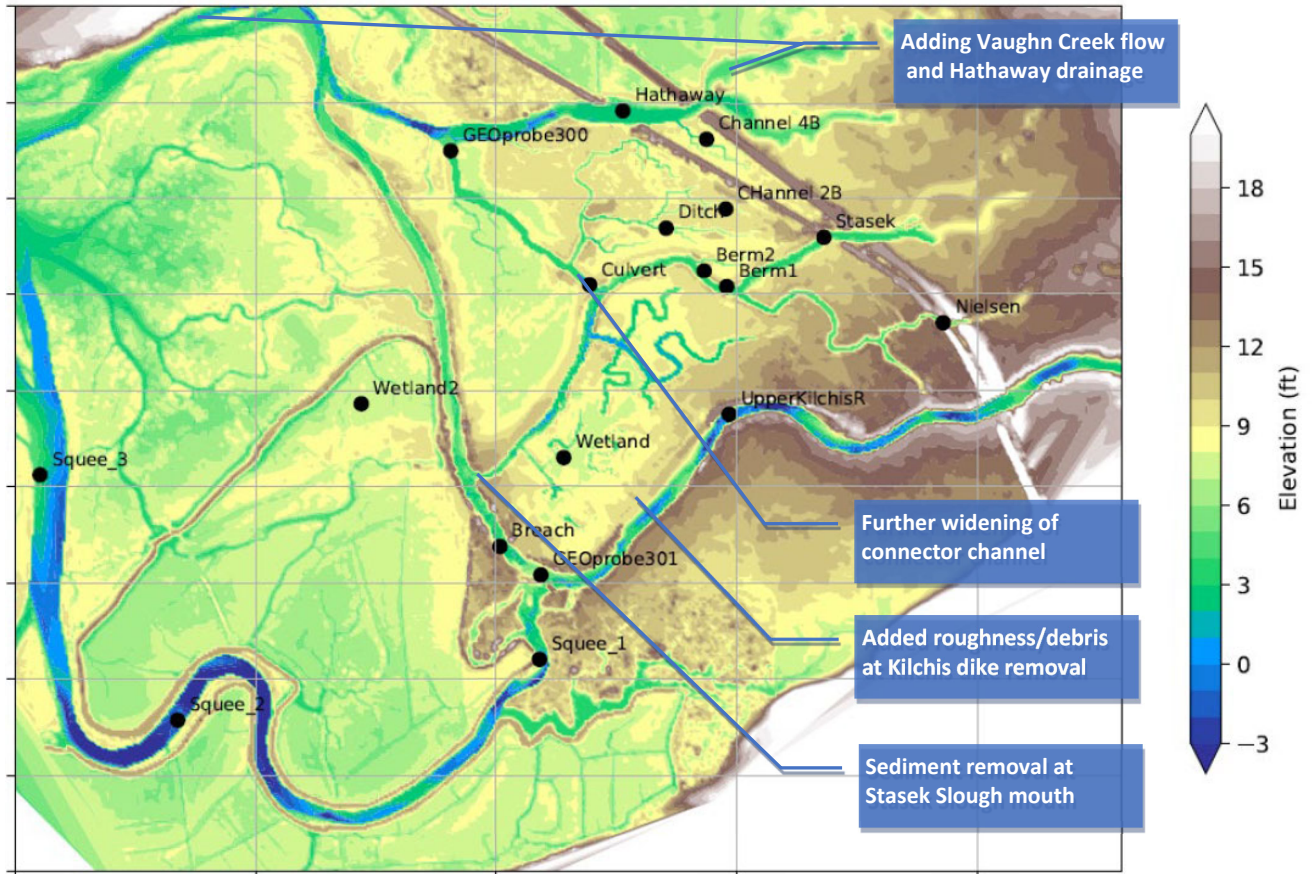
Figure 2 Summary of actions/ model scenarios developed to refine and improve the Porter Tract Restoration; model output locations are also shown for reference.

Model scenarios were developed to address items 1, 2, 3, 6, and 7. Item 4, Stasek Berm, was not evaluated further because it is clear through inspection of prior model results that these low, discontinuous berms do not impede overland or in-channel flows from tidal events or Kilchis River overflows. Item 5, Highway 101 drainage, was also not considered explicitly as the current Porter Tract Restoration (base case) already includes a new drainage channel and removal of drainage impairments (old tide gate and earthen berm), and it was unsure how to improve drainage further from this region. Item 7 includes evaluation of bank treatments along the Kilchis River where the levee was removed as part of the Kilchis Restoration (Phase 1, or Dooher Tract Restoration) – see Model Refinements Section of this memo. A summary map showing model changes and/or elements considered is shown in Figure 2.

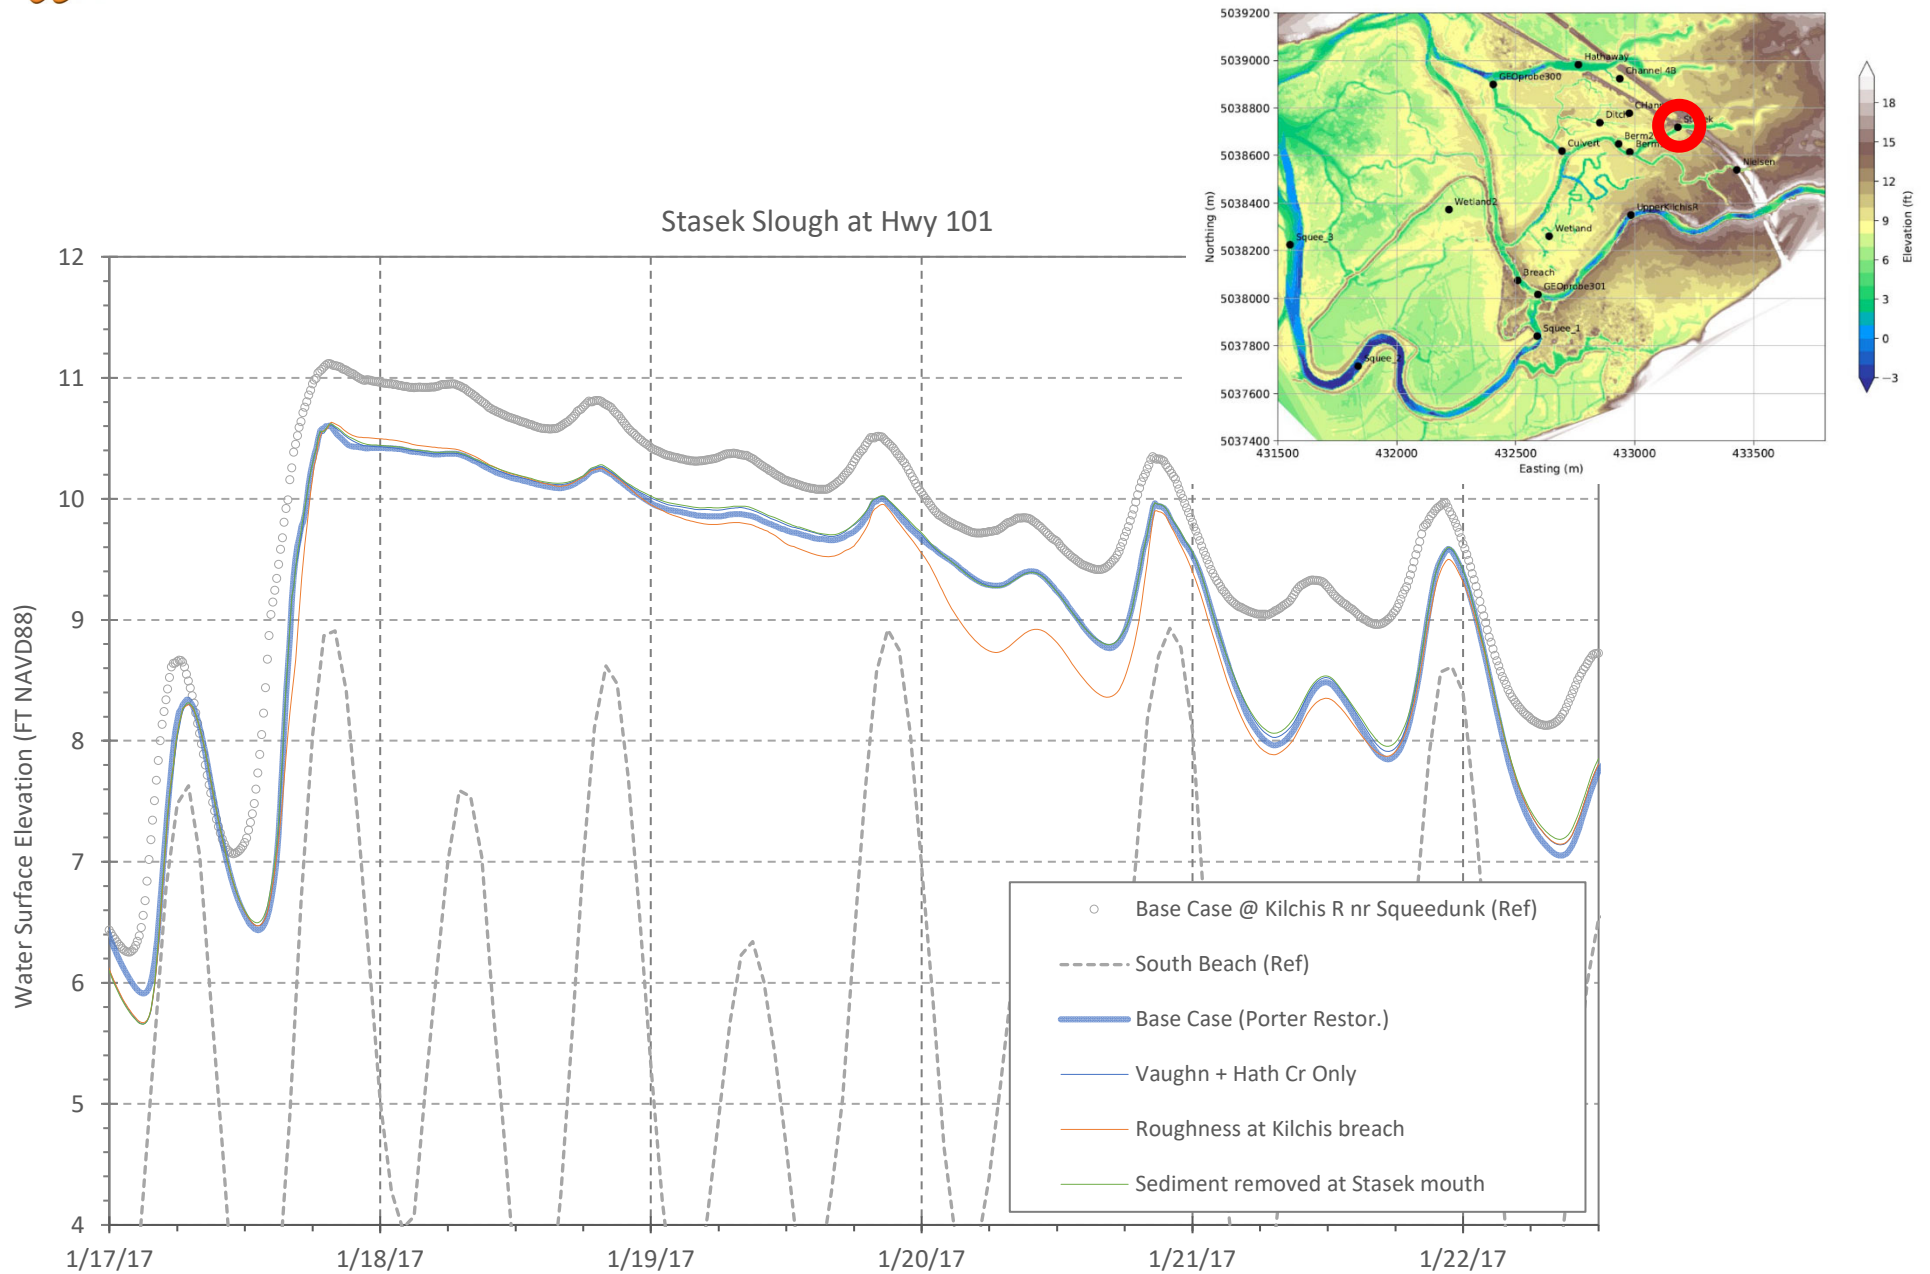
Figure 4 Comparison of simulated water surface elevations between the base case and the test scenarios in Stasek Slough at Highway 101.

Results of these scenarios were compared to the base case scenario, which is the Porter Tract Restoration scenario (W2r 2017) at two locations: Figure 4 at Stasek Slough and Figure 5 at Hathaway Slough. Results are also shown alongside observed tidal water levels at the NOAA South Beach Station (nearest observed tidal station in Yaquina Bay) for reference. Both figures also show water levels in the Kilchis River at Squeedunk Slough to understand the river stages relative to general land surface elevations and elevations of the Kilchis River bank where the levee was removed (and roughness elements were added in Scenario 2). To note, Kilchis bank elevations are in the range of 10 to 12 feet NAVD88 where the levee was removed (i.e., river stages above 10 to 12 feet NAVD88 will flow into the Preserve and towards Stasek Slough and the other tidal channels).

1. **Vaughn Creek:** the addition of flow inputs at Vaughn Creek (and Hathaway Slough drainage) does not appear to have appreciable effects on water levels. At both Stasek and Hathaway locations, the thin blue line (Vaughn + Hathaway) is slightly higher than the base case (bold blue line) for a brief period of time when water levels are just below 10 feet NAVD88 which occurs for a day after 1/19/2017. There are also a few other brief periods during low tides when water levels are also very slightly elevated above the base case towards the end of the simulation.

2. **Kilchis Riverbank roughness:** of the test evaluations considered, adding roughness to the river bank at the location of the prior levee removal has the strongest effect on reducing water levels at Stasek and Hathaway Sloughs compared to the based case and the preceding Scenario 1 Vaughn and Hathaway flows inputs. The red curves at Stasek and Hathaway show significant declines of up to 0.5 feet at Stasek and slightly less at Hathaway relative to the base case and Vaughn/Hathaway scenarios. The reduction in water levels is due to less conveyance of overbank flows when river stages are above and just below 10 feet NAVD88.

3. **Stasek sediment removal:** this scenario had minor effects on water levels relative to the preceding Scenario 2 (Kilchis bank roughness). At both locations, the green curves representing the sediment removal scenario is essentially the same as results from Vaughn + Hathaway (which show slightly higher water levels than the base case due to the additional flow inputs which are also a part of this scenario).
4. **Connector channel widening:** although it is not shown here, initial review of base case simulation results at the connector channel between Stasek and Hathaway Sloughs shows no

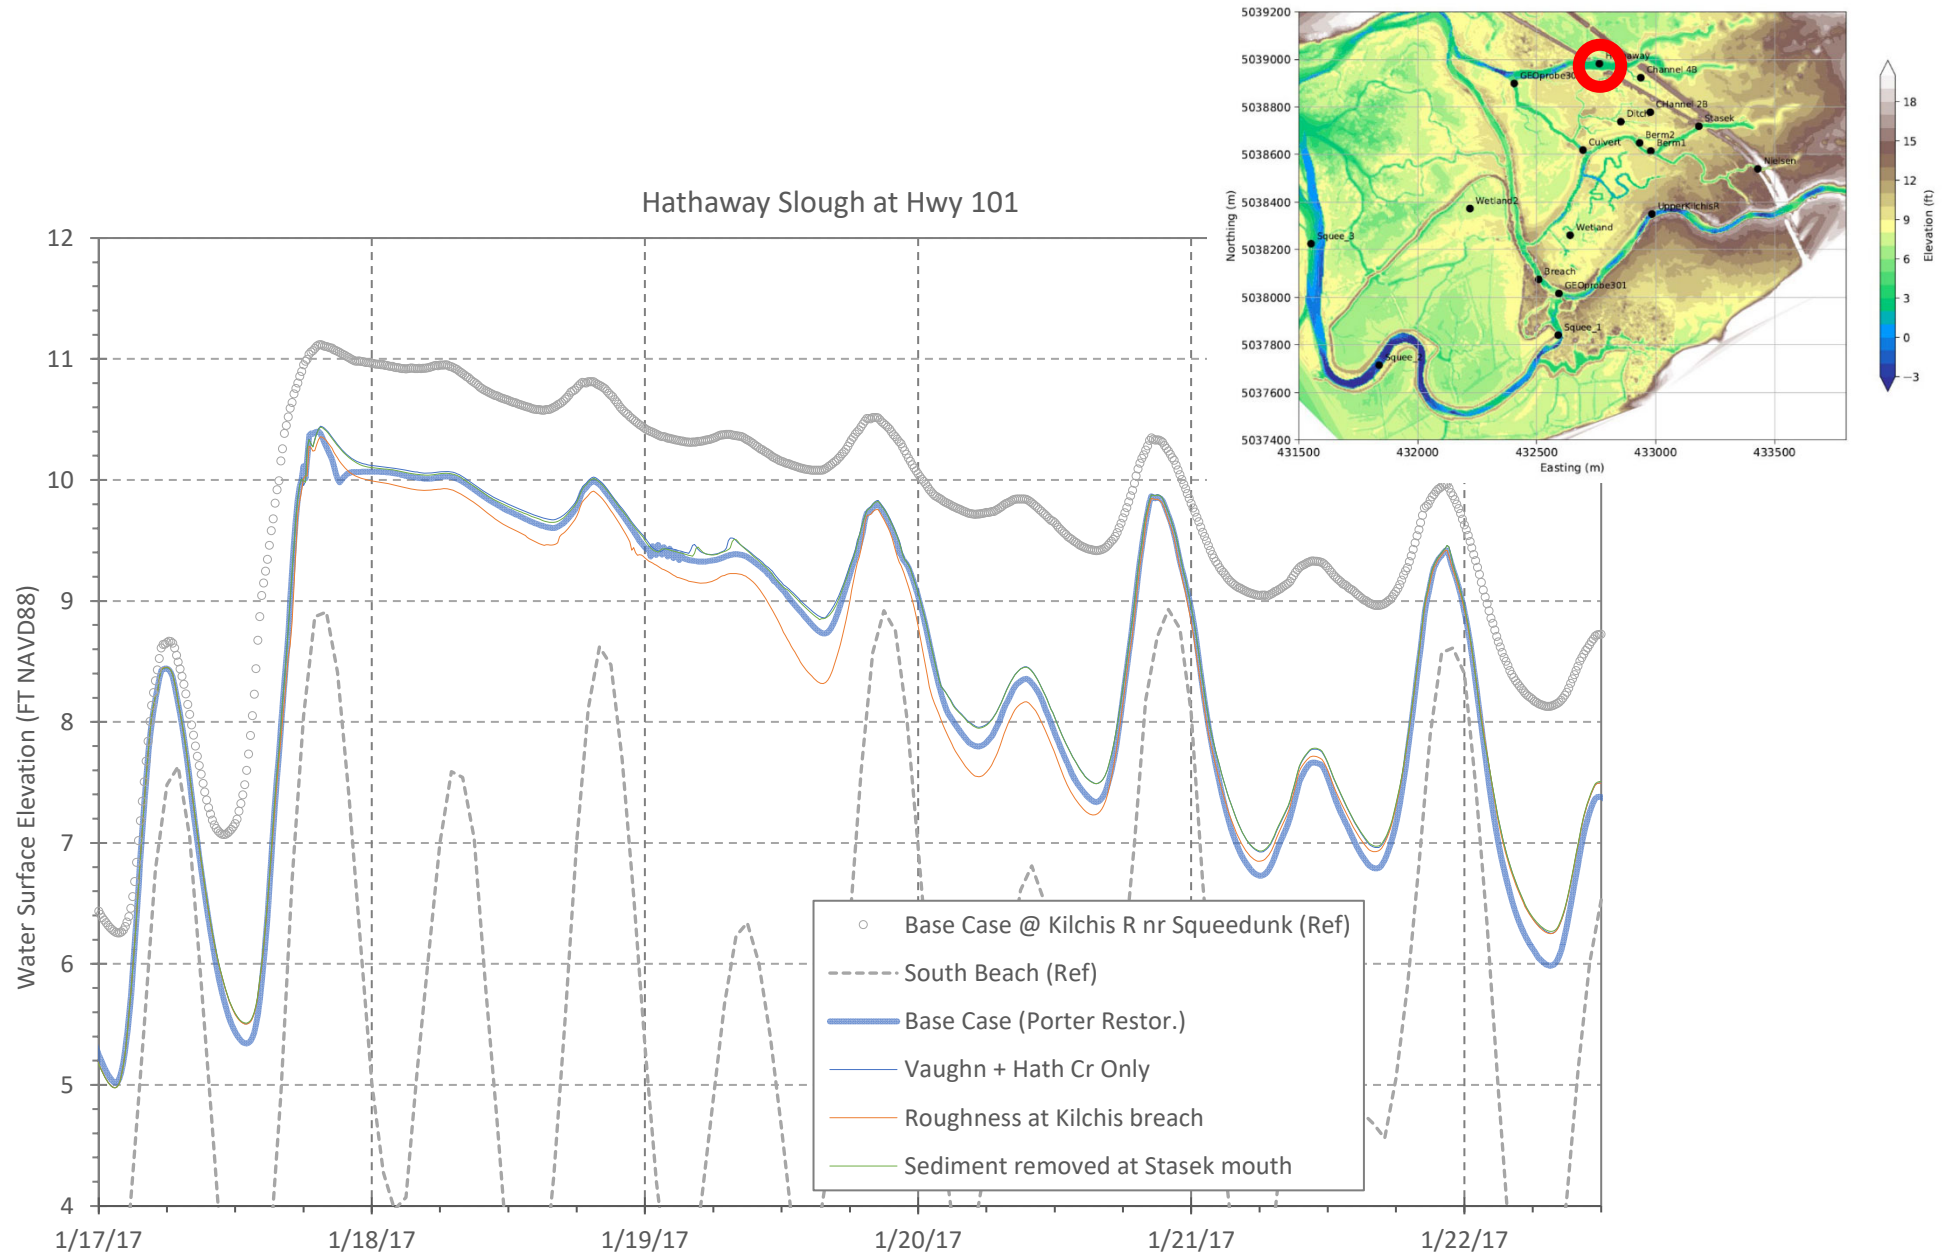
Figure 5 Comparison of simulated water surface elevations between the base case and the test scenarios in Hathaway Slough at Highway 101.

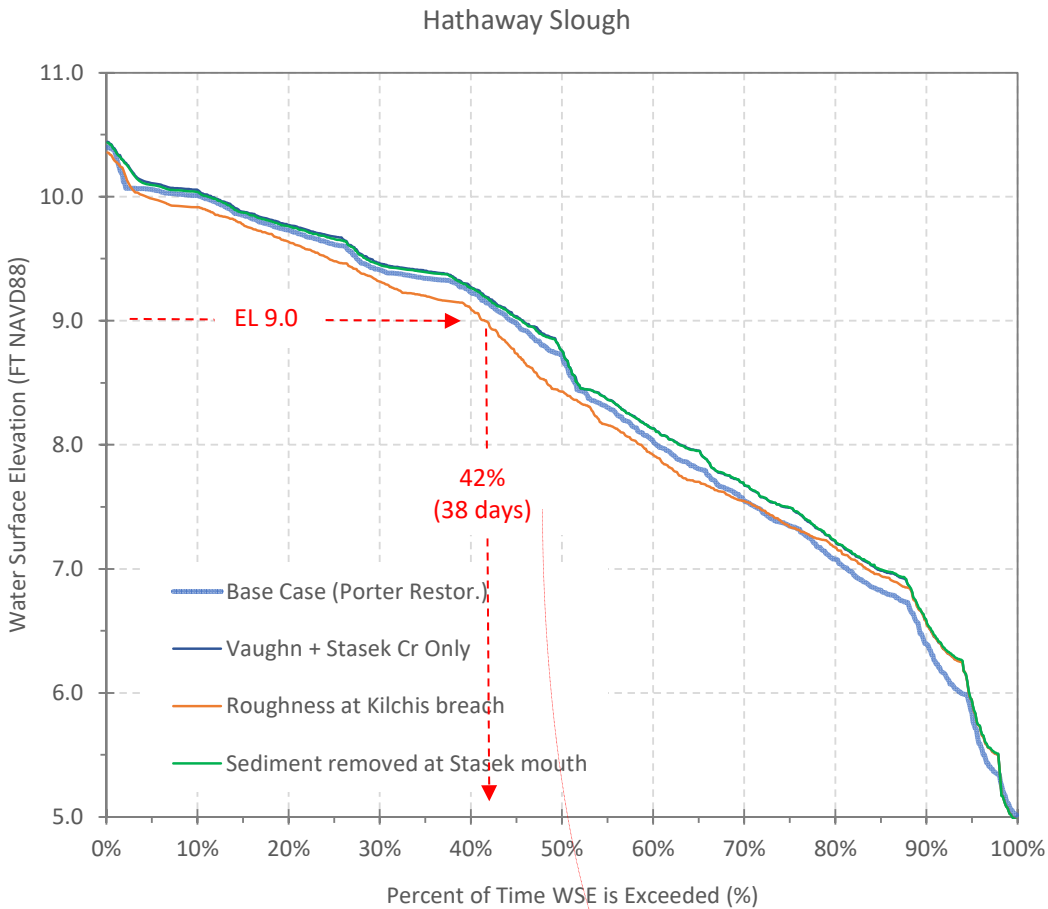
Figure 6 Cumulative water surface elevation (WSE) frequency exceedance curves at Hathaway Slough for the various scenarios.

To highlight the subtle differences in water level results shown in Figure 4 and Figure 5, cumulative water level frequency curves were developed for the Hathaway Slough results (see Figure 6 below). This figure shows the percentage of time that water levels are exceeded over the simulation periods for each scenario. For example, higher water levels on the left of the figure correspond to low frequencies of exceedance, and lower water levels on the right of the figure are exceeded a higher percent of the time; the curves thus slope down and to the right.

Results shown from Figure 6 correspond to those from the preceding figures, with the Kilchis bank roughness scenario showing lower frequencies (lower percentage of time) that water levels are at a given stage (i.e., the red curve is generally below the others except when water levels are below about 7.5 feet NAVD88).

Another benefit of the cumulative frequency curves described above is that frequencies can be converted into number of days in a particular period for a more familiar comparison of results. Exceedence frequencies shown in Figure 6 were converted to “number of days exceeded” by assuming the simulation was representative or could reoccur over a 90-day winter period. This assumption may be true in some years, but it may not be true in others (when winter water levels might be either higher or lower than the January 2017 sequence). It is believed to be mostly representative, but if the 2017 event were to be higher in stage for example than the true typical winter, this analysis would show a higher number of days at a particular threshold. However, the relative differences between number of days between scenarios will be accurate regardless of the 2017 period being higher or lower than an average winter.

To illustrate the conversion from frequency to number of days, red text and arrows indicate that the Kilchis bank roughness scenario (red line in Figure 6) is above elevation 9.0 feet NAVD88 for approximately 42% of the time. And, 42% of 90 days is equal to 37.5 days, as shown in the orange column and middle row of Table 1.
