**NESKOWIN COASTAL HAZARDS AREA PERMIT**

**#851-22-000380-PLNG: LEAHY**

**Geologic Hazards and  
Geotechnical Investigation  
Tax Lot 5400, Map 5S-11W-25CB  
Breakers Boulevard  
Neskowin, Oregon**

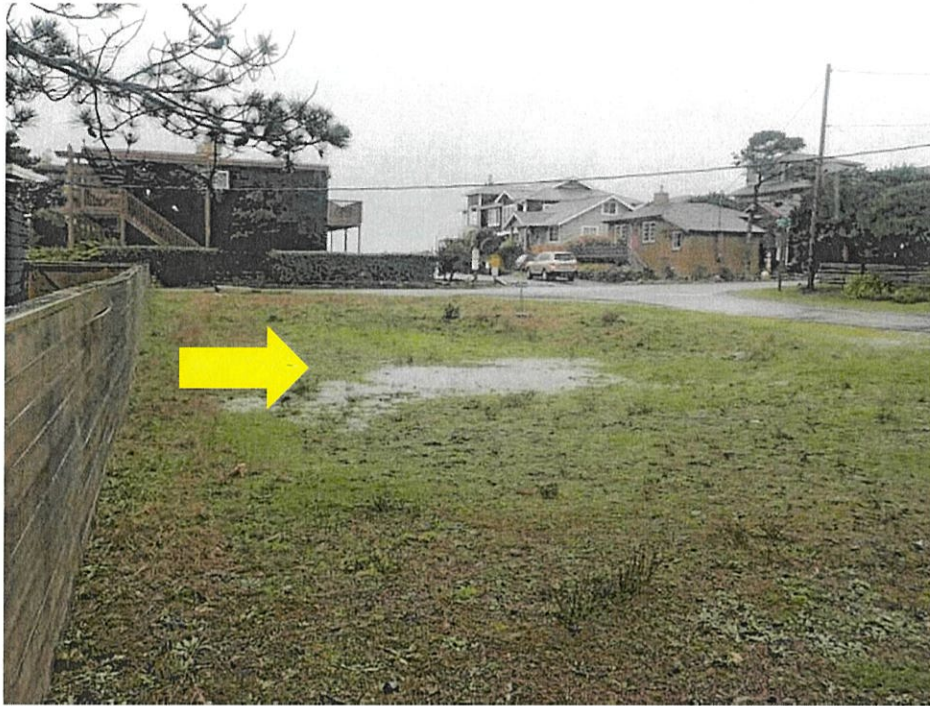
Photo 3 – Westerly view along the southern boundary of the site. Note the standing water in the shallow depression in the center of the site (indicated with yellow arrow).

Stormwater at the site generally flows towards the center of the site. At the time of our site visit, we observed no streams at the site. The nearest stream is Kiwanda Creek, located approximately 680 feet east of the site. Kiwanda Creek joins Neskowin creek and discharges onto the beach approximately 0.5 miles south of the site.

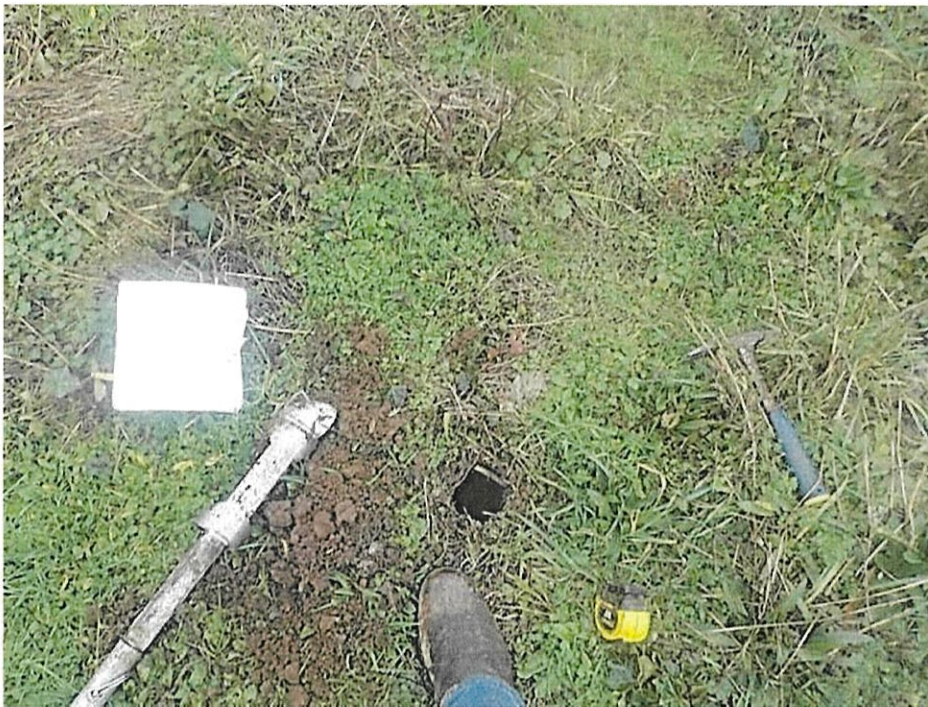
Photo 4 – Close-up view of the silty fill soils encountered in borings B-2 and B-3 on the western portion of the site.

Boring B-1 generally encountered approximately 2 feet of brown, very loose to loose, organic-rich silt and silty sand overlying tan, loose to slightly dense moist dune sand. Borings B-2 and B-3, on the west side of the lot, both met refusal at shallow depths due to rock fragments. We anticipate that undocumented fill at least two feet thick will be encountered throughout the western portion of the site. Probing of the center of the site encountered moderate resistance at depths of approximately 2 feet.

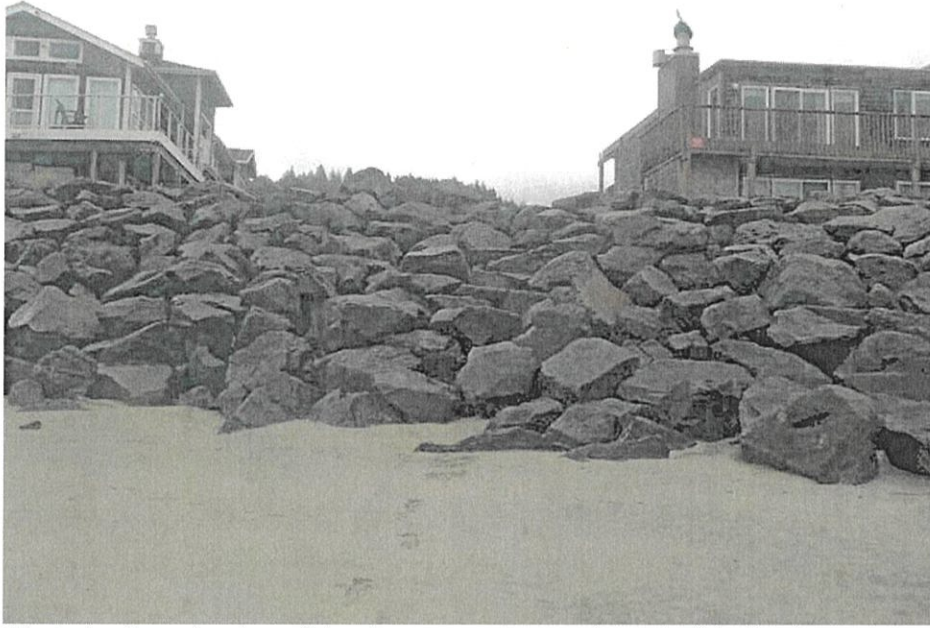
Photo 5 – Easterly view of the riprap revetment at the end of Amity Avenue near the site.

The existing revetments located west of the subject site consist of angular basalt boulders. (Appendix A). Severe storms in the winter of 2007–2008 partly undermined the revetments in areas located along Neskowin Beach. The riprap revetment greatly reduces the potential for erosion when maintained and repaired as necessary.
