MEMO

Date: March 9, 2023 MJ
To: Tillamook County Board of Commissioners
From: Melissa Jenck, CFM, Senior Planner
Subject: March 16, 2023, LUBA Remand Hearing Re: #851-22-000107-PLNG: Conditional Use approval for a 19-site recreational campground on an approximately 18-acre portion of a 58.51-acre parcel.

**ON REMAND FROM THE OREGON LAND USE BOARD OF APPEALS
FINAL OPINION AND ORDER: 2022-065**

Request: Reconsideration of a request for Conditional Use approval for a 19-site recreational campground on an approximately 18-acre portion of a 58.51-acre parcel. The proposed campground is located within the Rural Residential 2-Acre (RR-2) zoned portion of the property.

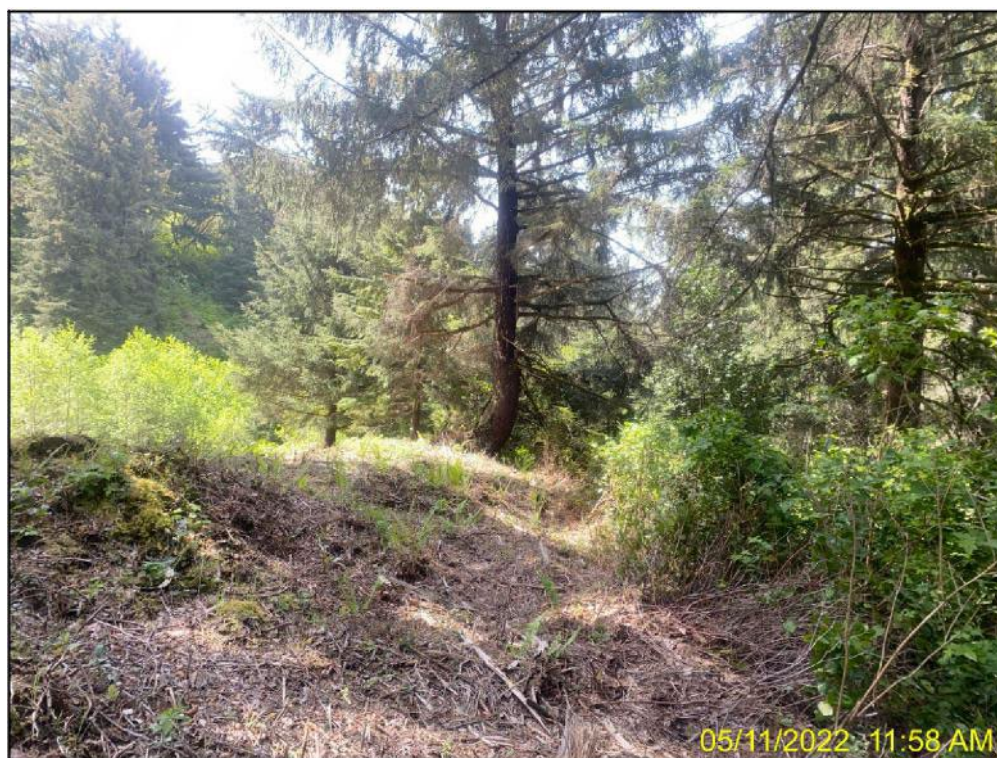
Photo 1: A tree with a curved trunk, as observed along the access road (photo center).

The vegetation at the site generally includes understory consisting of deciduous trees, blackberries, grasses and ferns. The canopy generally consists of large Sitka spruce and fir trees. A few curved tree trunks were observed, indicating local soil creep or shallow landsliding.

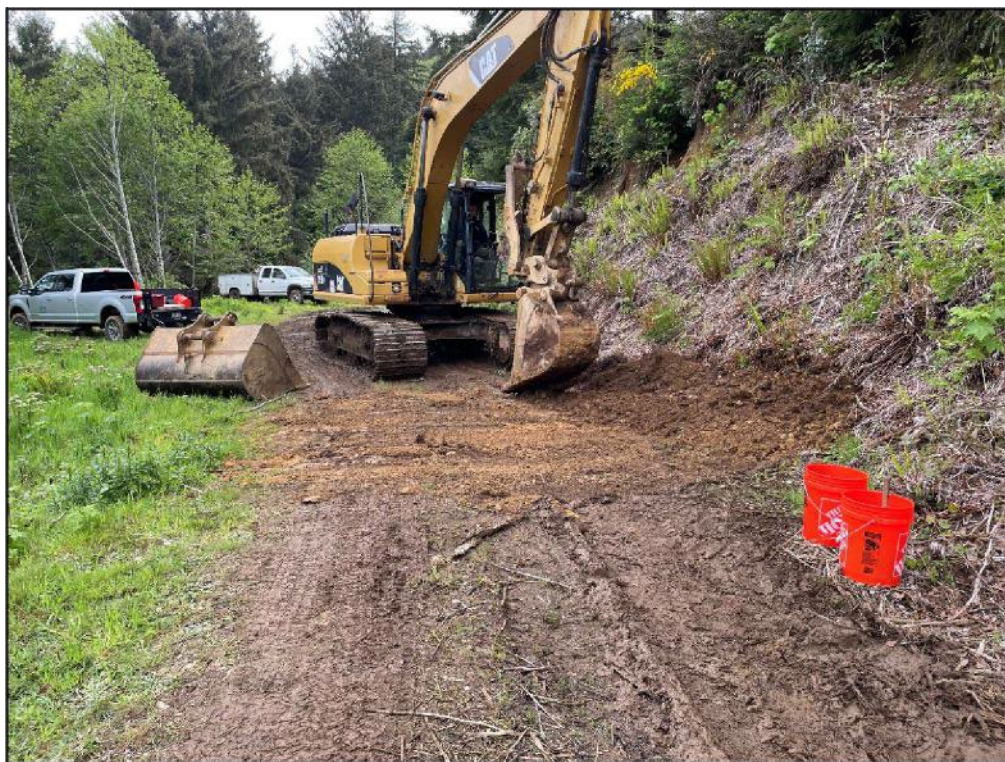
Photo 2: Photo looking northeast along the existing road before the creek. Note that the existing road cut has an oversteepened slope.

Broadly, the subject property slopes downward to the west at an average slope of approximately 2H:1V (Horizontal:Vertical). Excluding the site's west facing slopes, the site's topographic relief is largely dominated by an unnamed creek that roughly bisects the site from east to west. There is also an old rock quarry where the existing access road crosses the creek. Locally, slopes are generally steeper than 2H:1V where the road is cut into the hillside, on the downhill side of the road, and in the old rock quarry area. We generally consider slopes steeper than 2H:1V to be oversteepened.

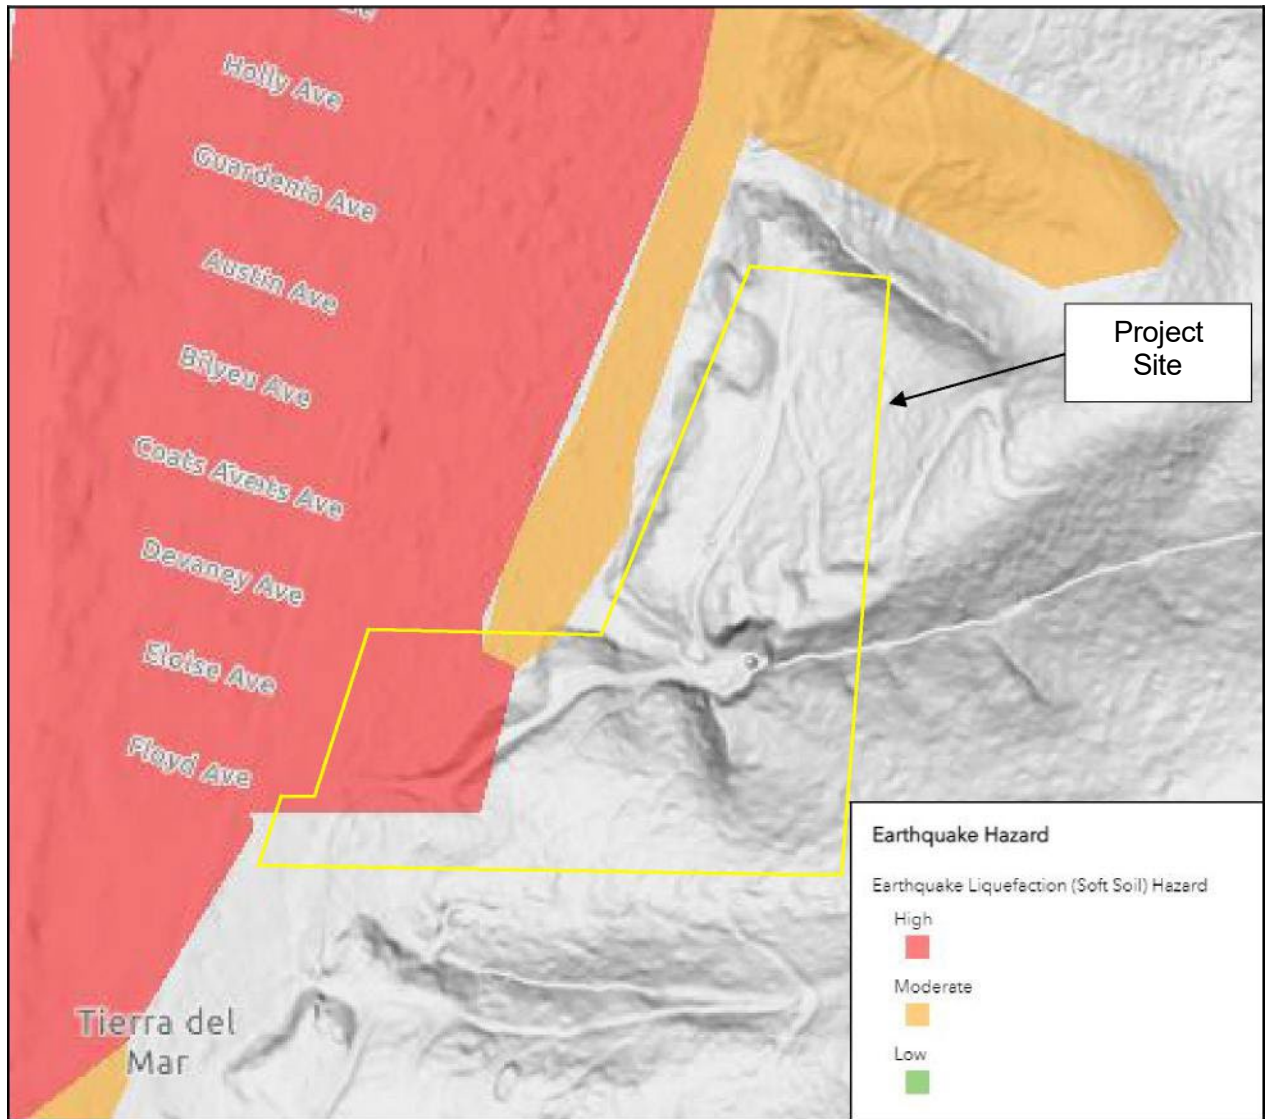
Figure 8: HazVu map showing extent and degree of liquefaction hazards.

It should be noted that liquefaction was not a mapped hazard on or near the property. Figures 5 through 8 below show mapping of the geologic hazards presented by Oregon's HazVu, Figure 9 shows the mapped landslide inventory presented by Oregon's SLIDO, and Figure 10 shows modeled tsunami inundation predictions from the website <http://nvs.nanoos.org/TsunamiEvac>.

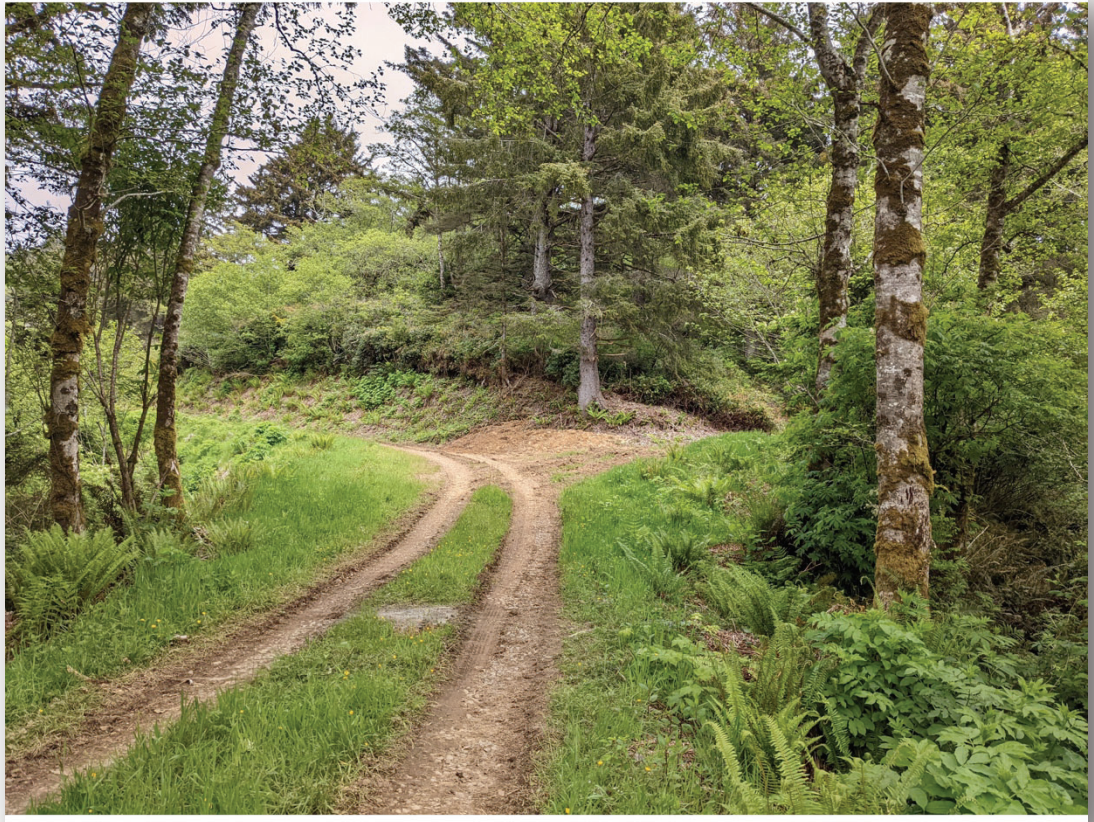
Figure 1. At culvert crossing on Floyd Avenue looking east (P-1)

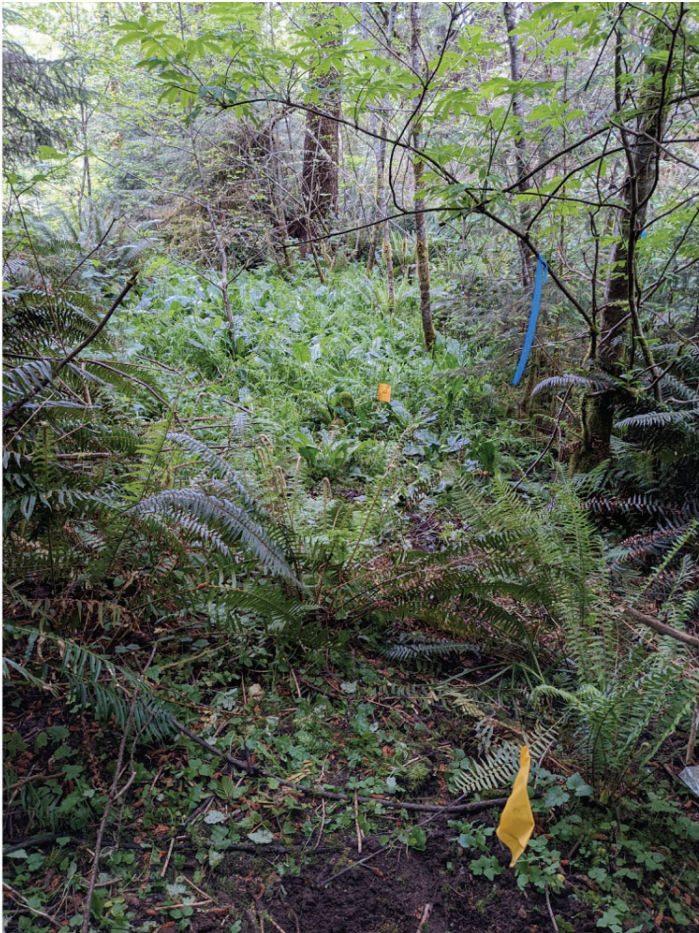
Figure 5. Blue flag is at Wetland C boundary. Yellow flag in the background at SP-10 and SP-11 in non-wetland in the foreground. View is to the northwest (P-5).

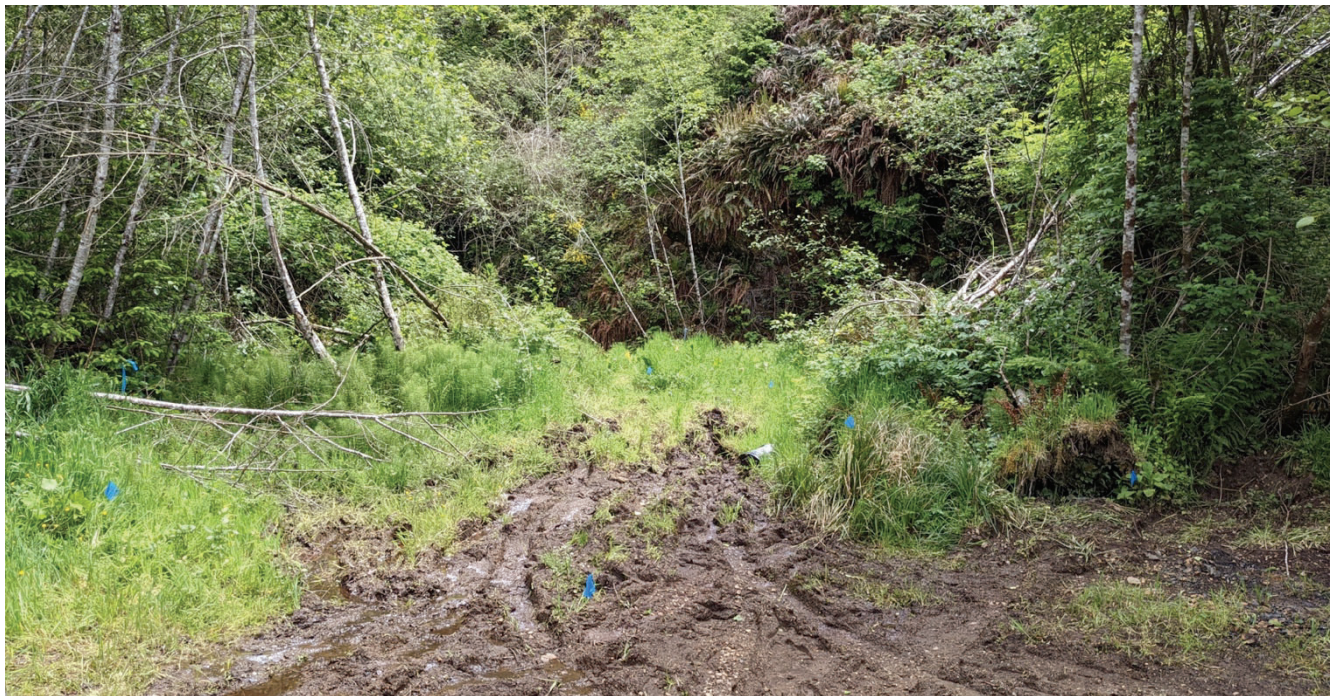
Figure 6. Wetland D at Quarry looking east from forest road (P-6).

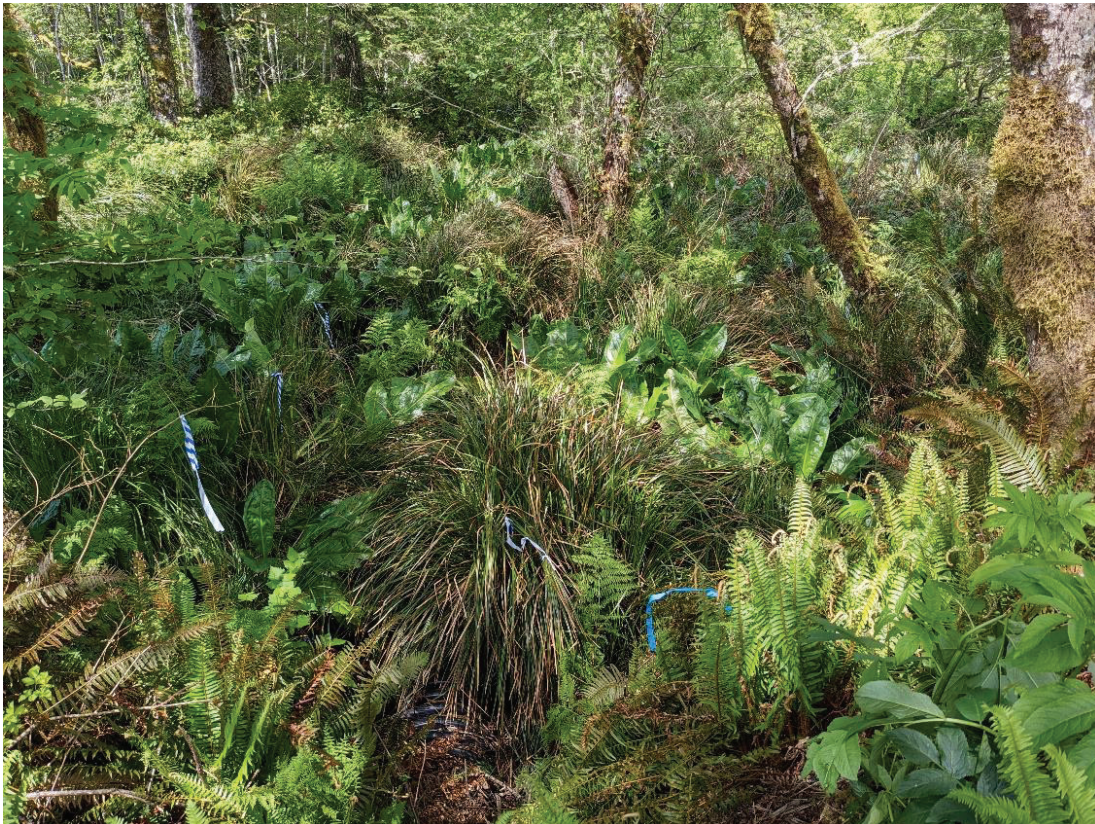
Figure 11. Blue and White flagging is edge of Beltz Creek Channel. The blue flagging is wetland boundary. Looking d/s to the north into wetland B (P-11).

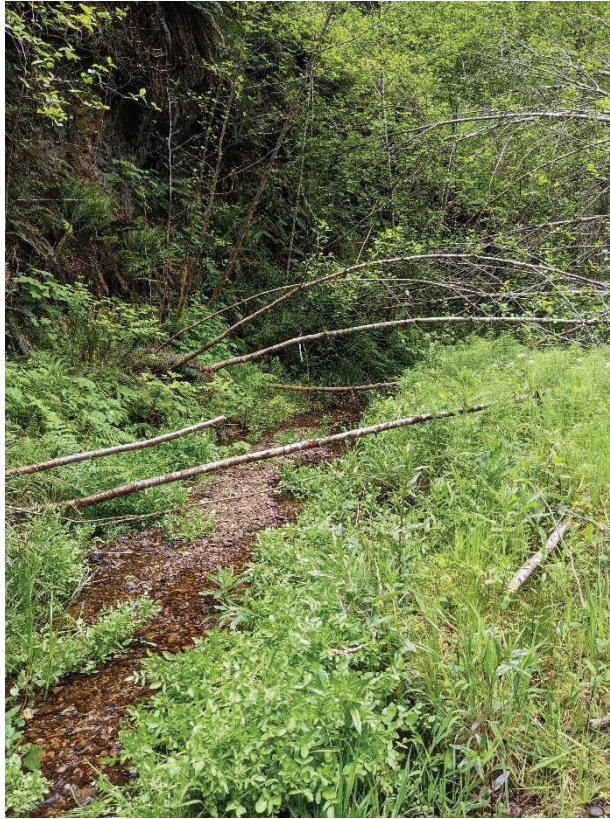
Figure 12. S1 stream at Quarry looking d/s (P-12).
