Neskowin Coastal Hazard Area Permit #851-21-000130-PLNG: Kircher

NOTICE OF ADMINISTRATIVE REVIEW Date of Notice: October 22, 2021

**Geologic Hazards and Geotechnical Investigation Report
Tax Lot 4400, Map 5S-11-35DA
Tillamook County, Oregon**

Project #Y174044

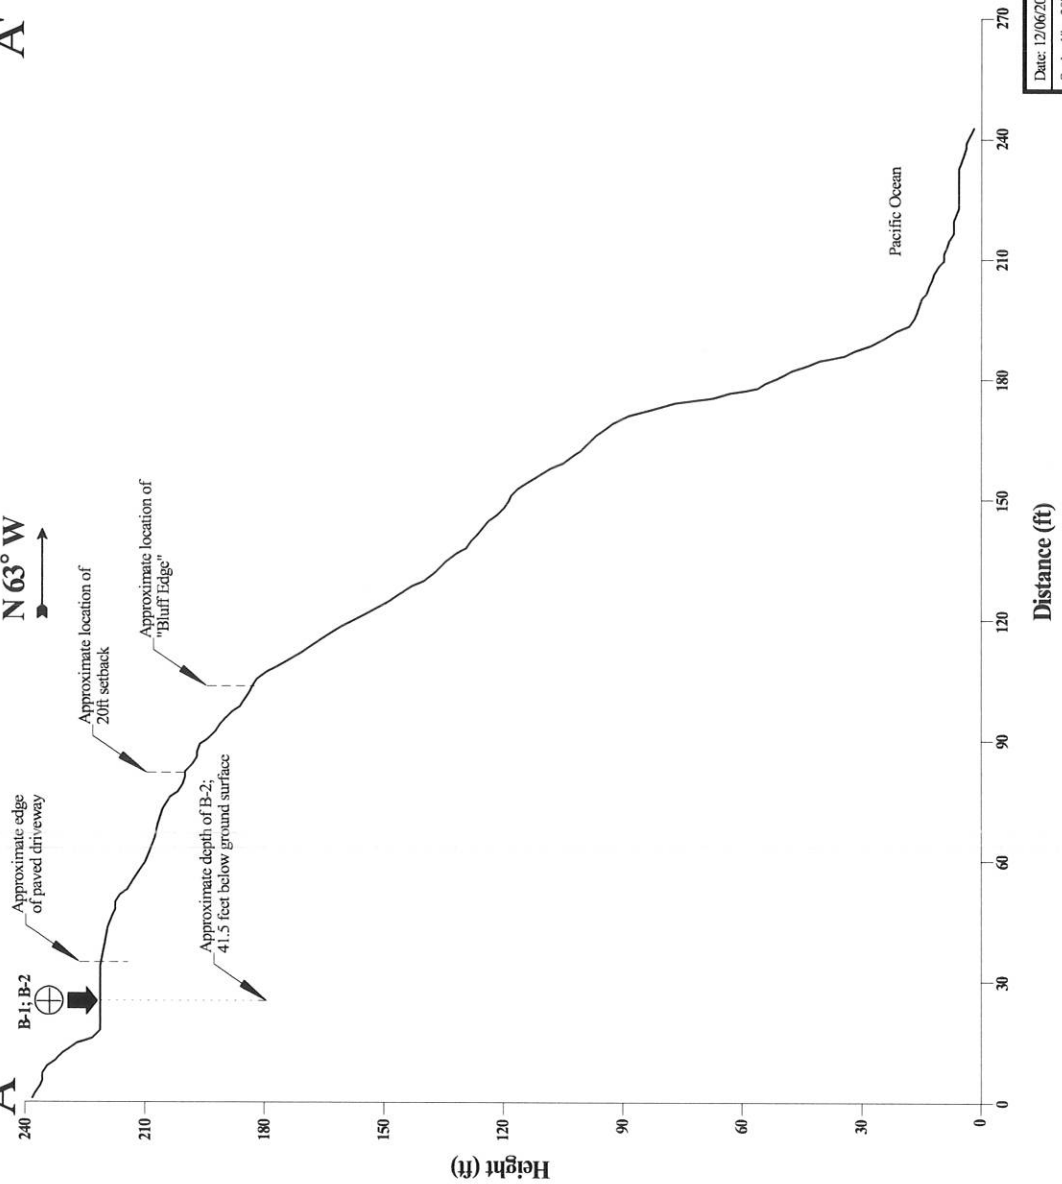
H.G. Schlicker & Associates, Inc.		Figure 4

The site is located at the top of a basalt bluff that is part of the Cascade Head headlands. A topographic survey completed on August 9, 2017 determined the elevation at top of the cliff to be at approximately 190 feet MSL and approximately 220 feet MSL (NAVD 88) at the lower end of the driveway (Figures 4 and 5). The site slopes approximately 30 degrees to the west for approximately 50 to 60 feet from the driveway to the bluff edge at which point the slope increases to 60 to 75 degrees to the west. Additional observations are addressed and illustrated in Section 3.3, Figures 3, 4, 5, and Appendix A of this report.

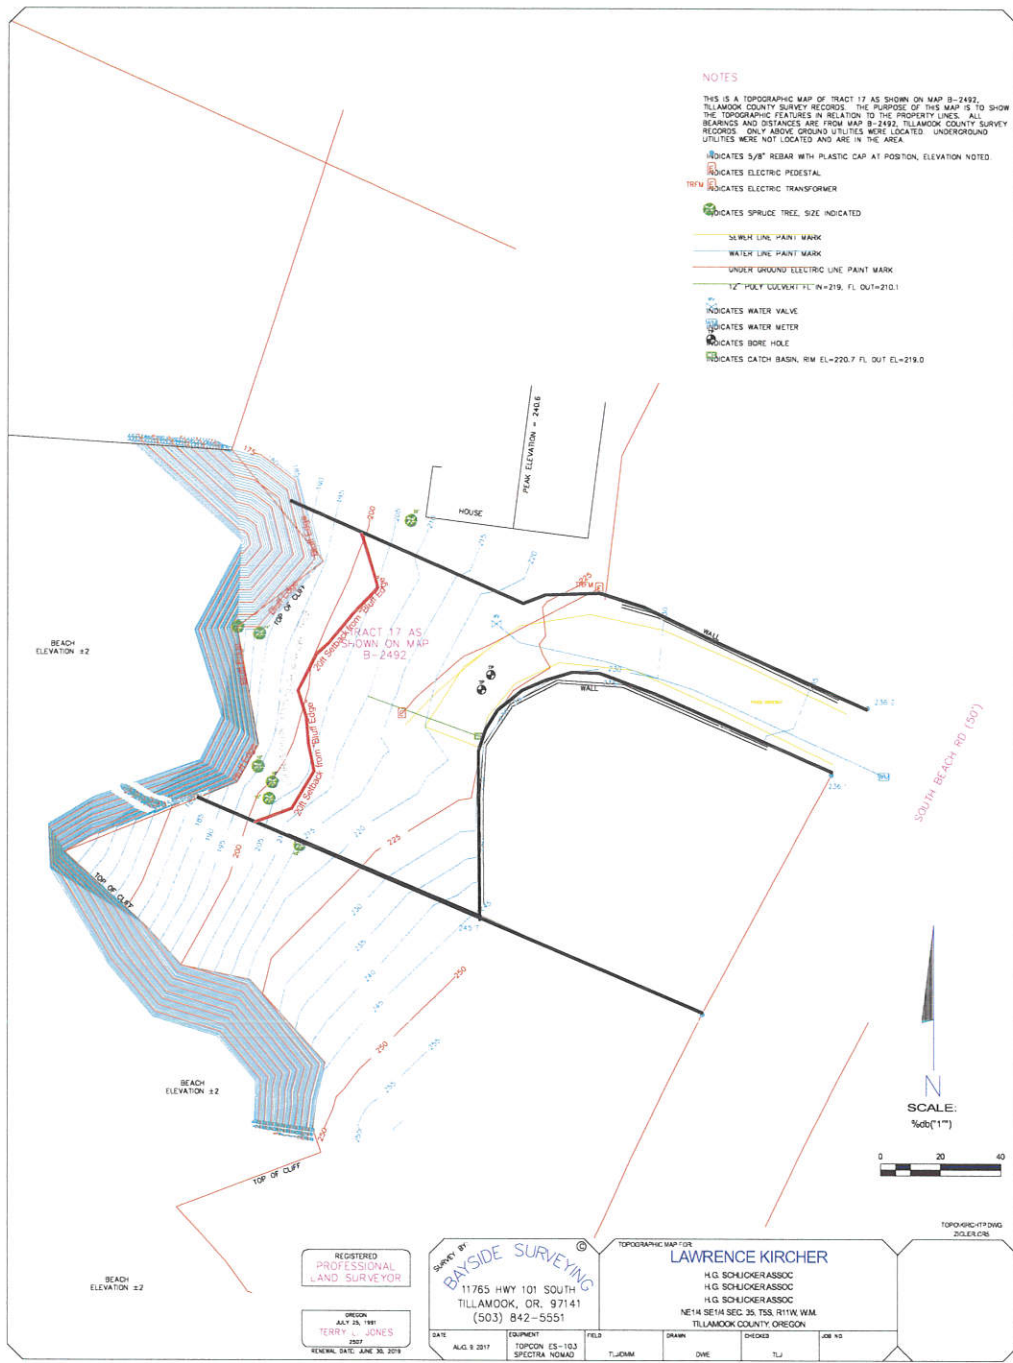
Date: 12/06/2017	Project #Y174044	Prepared by: AML
Scale: 1" = 40'		Approved by: JDG
Site Topographic Survey Tax Lot 440, Map 5S-11-35DA Tillamook County, Oregon		
H.G. Schlicker & Associates, Inc.		Figure 5

The site is densely vegetated with brush and at least 5 spruce trees along the slope (Figure 5 and Appendix A).

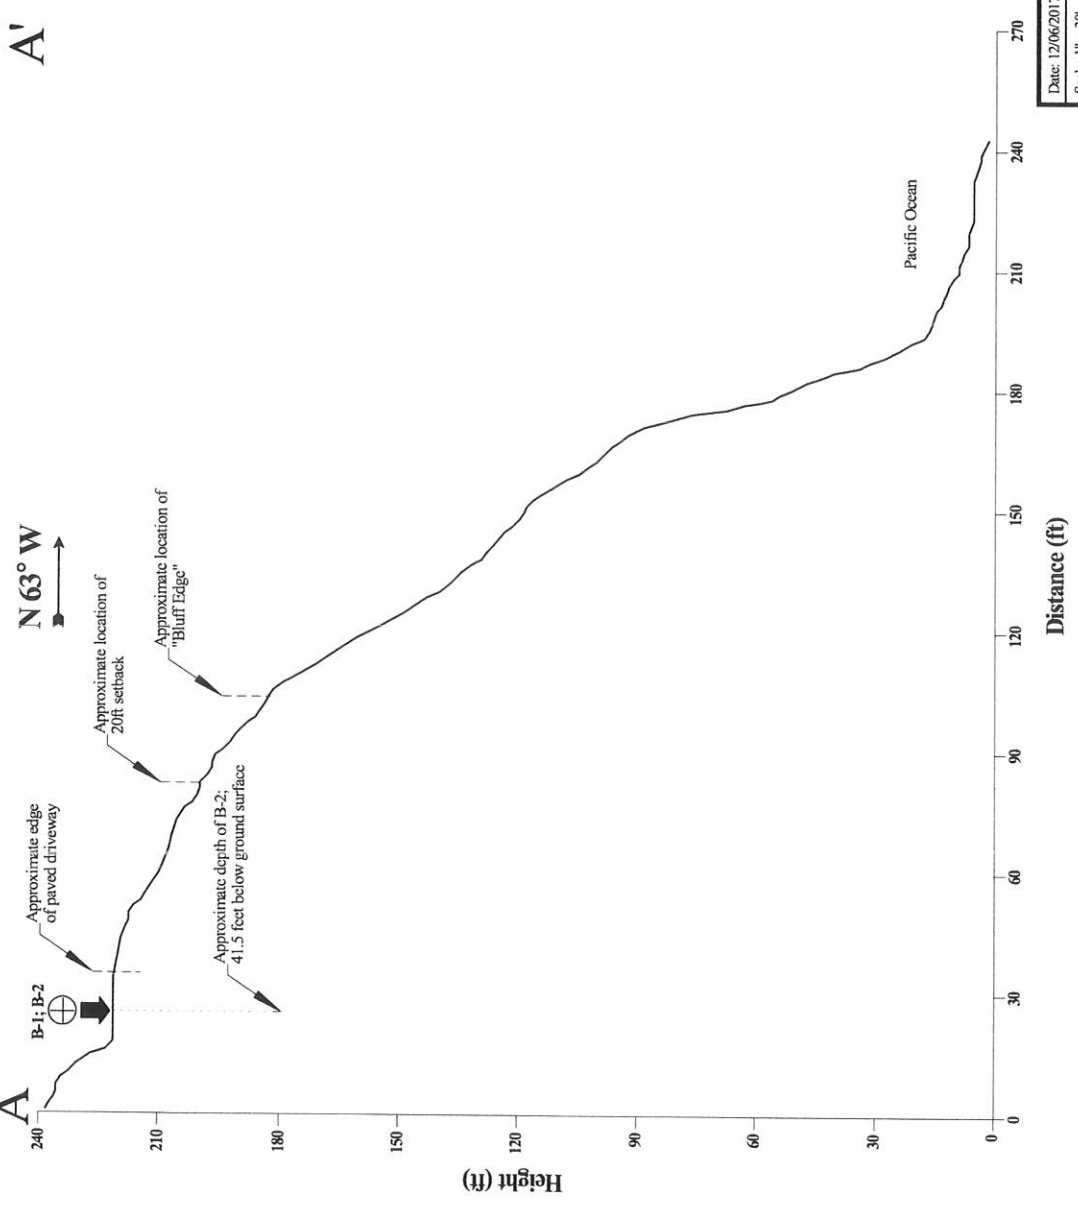
H.G. Schlicker & Associates, Inc.
Figure 4

The site is located at the top of a basalt bluff that is part of the Cascade Head headlands. A topographic survey completed on August 9, 2017 determined the elevation at top of the cliff to be at approximately 190 feet MSL and approximately 220 feet MSL (NAVD 88) at the lower end of the driveway (Figures 4 and 5). The site slopes approximately 30 degrees to the west for approximately 50 to 60 feet from the driveway to the bluff edge at which point the slope increases to 60 to 75 degrees to the west. Additional observations are addressed and illustrated in Section 3.3, Figures 3, 4, 5, and Appendix A of this report.
