<b>SECTION: 19, 20</b>	<b>TOWNSHIP: 1 South</b>	<b>RANGE: 9 West</b>
<b>COUNTY: Tillamook</b>		<b>DATE: 4/25/2023</b>
<b>CORNER DESIGNATION:</b> The Quarter corner common to sections 19 and 20 Township 1 South, Range 9 West, Willamette Meridian.		<b>(Please check one)</b>
		<input type="checkbox"/> Condition Report Only
		<input type="checkbox"/> Restoration
		<input checked="" type="checkbox"/> Rewitness
		<input type="checkbox"/> Unrecorded
		<input type="checkbox"/> Reset at surface
		<input checked="" type="checkbox"/> Referenced Out

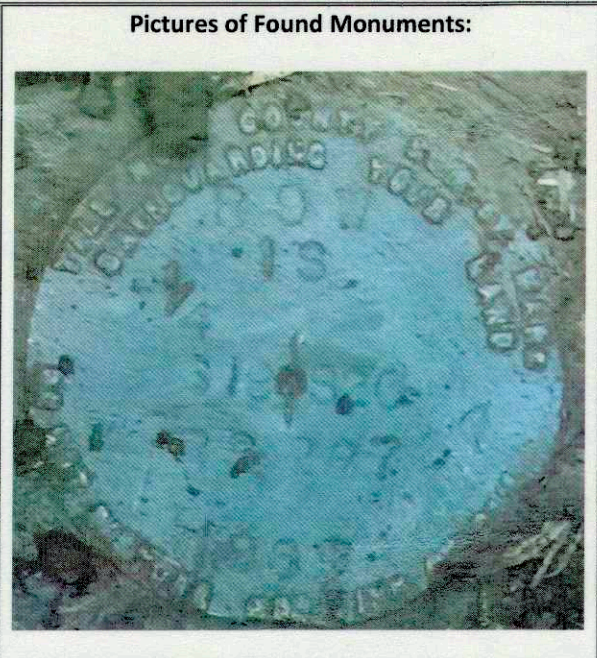
- Found: (Rewitness card #212) Bonneville power pole with scribing and nail with badly rusted location tag (S 09° 00' 30" W 65.64')
- Found: (Rewitness card #212) Bonneville power pole with scribing and nail with badly rusted location tag (S 15° W 59')
- Not Found: (Rewitness card #212) 84" hat section post with yellow metal location tag (North 1.5') now gone
- Found: Unknown origin P.U.D. power pole #198400 with yellow metal location tag (S 5° E 51.2')

**Found:** PUD power pole # 198400 not of record has yellow metal location tag dated 2003 verified bearings & distance on tag (S 05° E 51.2').

**Set:** Hat section post with yellow metal location tag West 19.3'

The Monument was tied directly using G.P.S. established control. The coordinates have been converted and are provided here in WGS 84, Latitude and Longitude.

Latitude: 45° 28' 14.03"  
Longitude: - 123° 49' 25.83"

**Location:** South on Blum Rd. for ±1300' then East on a private drive for ±1200' to bridge across slough. Corner is on the East side of slough and North ±60' from edge of as built road.
