## Neskowin Coastal Hazard Area Permit #851-24-000313-PLNG: Ready2Market/Wells Fargo Bank

**#851-24-000313-PLNG:** A request for approval of a Neskowin Coastal Hazard Area Permit for the construction of a single-family dwelling, to rebuild after a fire, on a property located within the Unincorporated Community Boundary of Neskowin, zoned Neskowin Low Density Residential (NeskR-1) and within the Neskowin Coastal Hazards Overlay (Nesk-CH) Zone. The subject property is accessed via Breakers Blvd and designated as Tax Lot 92411 of Section 25CB in Township 5 South, Range 11 West of the Willamette Meridian, Tillamook County, Oregon. The applicant is Ready2Market and the property owner is Wells Fargo Bank.

At your request and authorization, we visited the subject site on November 2, December 13, 2023, and February 15, 2024, to complete a geotechnical investigation. Previously, we completed a Geologic Hazards Investigation (Phase 1) (dated May 23, 2023) at Tax Lot 92411, Map 5S-11W-25CB Supp. Map No. 2, Lot-Unit 11, 48060 Breakers Boulevard, Neskowin, Tillamook County, Oregon. In our earlier report, we recommended that a second-phase investigation be completed to explore and characterize

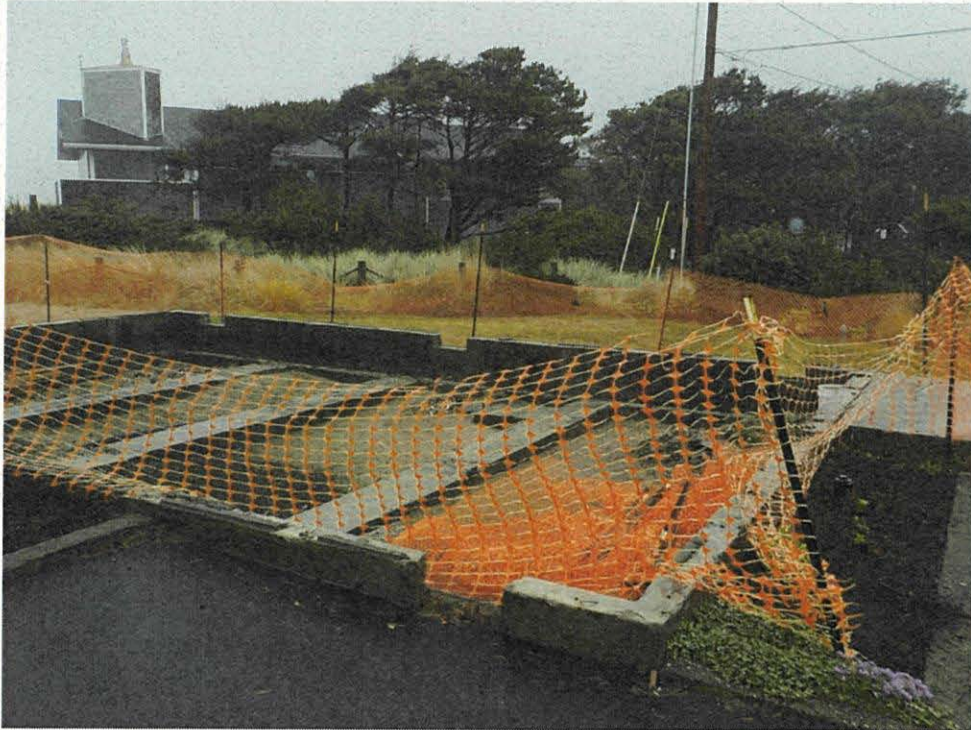
Photo 1 – View of the foundation of the previous house at the site after demolition.

During our previous Geologic Hazards Investigation the site was occupied by a fire-damaged residential structure and attached deck. Since the time of our previous work, the damaged house was demolished, the foundation was removed for equipment access, and a drilling pad was graded using sand (Appendix A). Based on our review of the document provided to us, a surveyor completed an elevation certificate before the demolition of the previous structure.

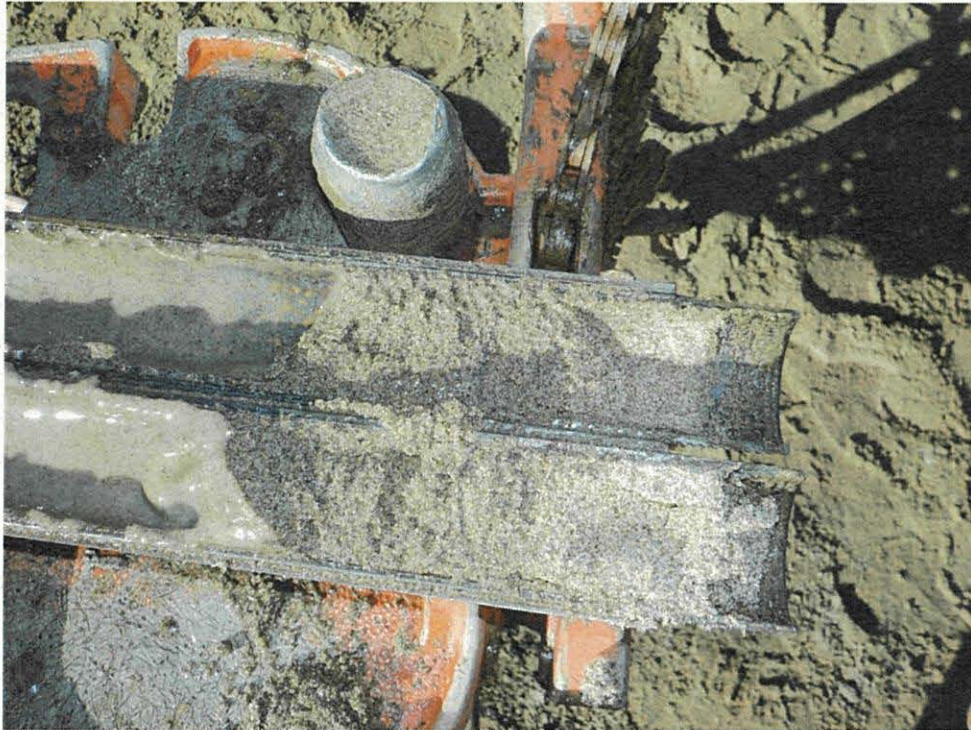
Photo 3 – View of the loose to medium dense, fine-grained sand recovered between 10 to 11.5 feet depth in Boring B-1.

The boring generally encountered approximately 15 feet of loose to medium dense sand overlying approximately 20 feet of wet to saturated, dense sand from approximately 15 to 35 feet, underlain by organic-rich soft silty sand and peat from approximately 35 to 45 feet. From approximately 45 to 60 feet, dense to very dense, wet to saturated sand was encountered. Groundwater was encountered at approximately 12.5 feet.

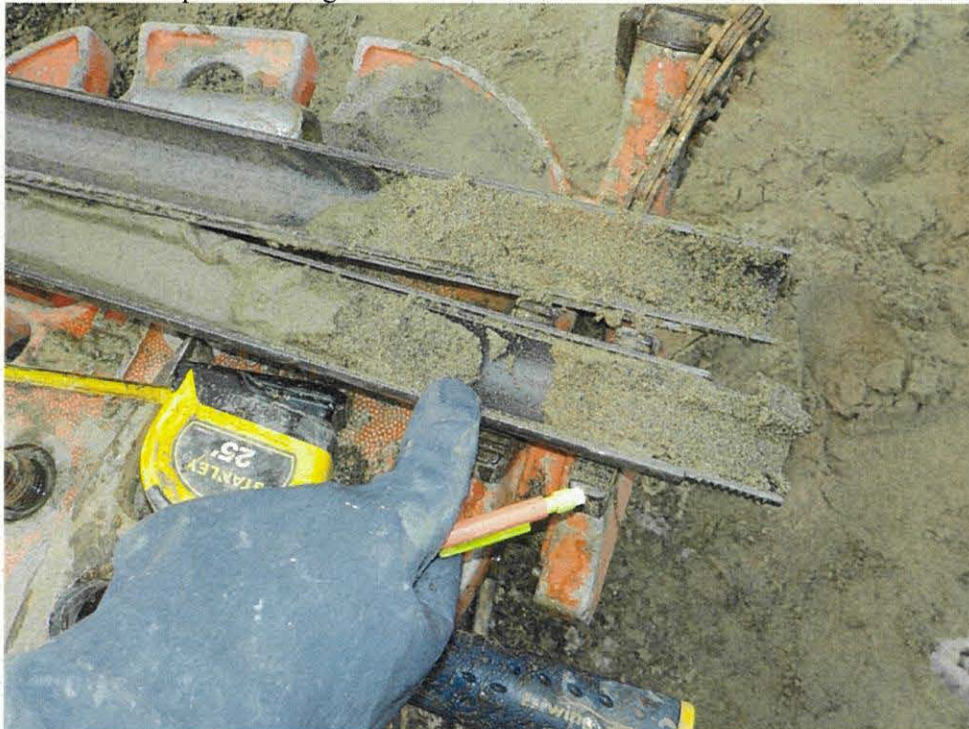
Photo 4 – View of the dense, silty sand recovered between 25 to 26.5 feet depth in Boring B-1.

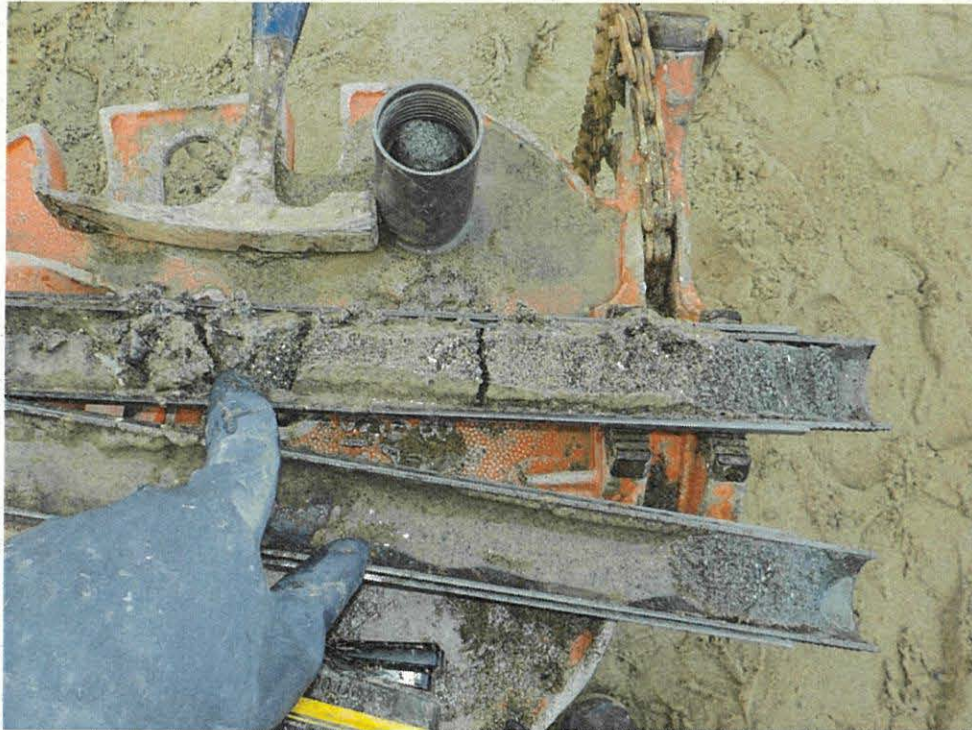
Photo 5 – View of the dense, medium to coarse-grained sand with shell fragments recovered between 30 to 31.5 feet depth in Boring B-1.

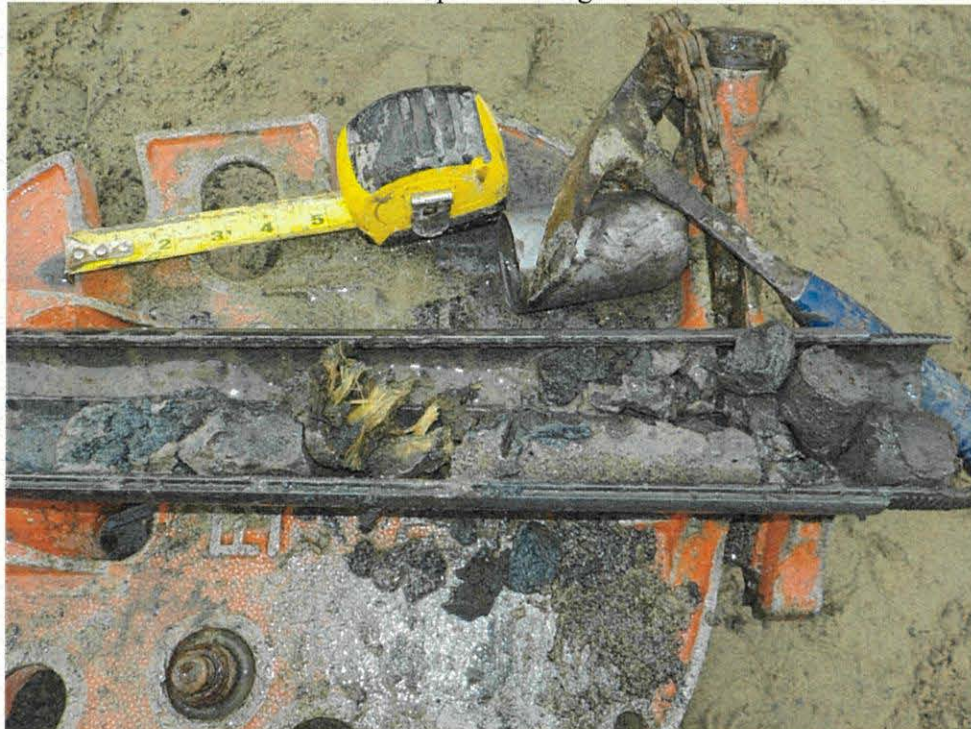
Photo 6 – View of the soft/loose, clayey, silty sand with decaying wood fragments recovered between 37 to 38.5 feet depth in Boring B-1.

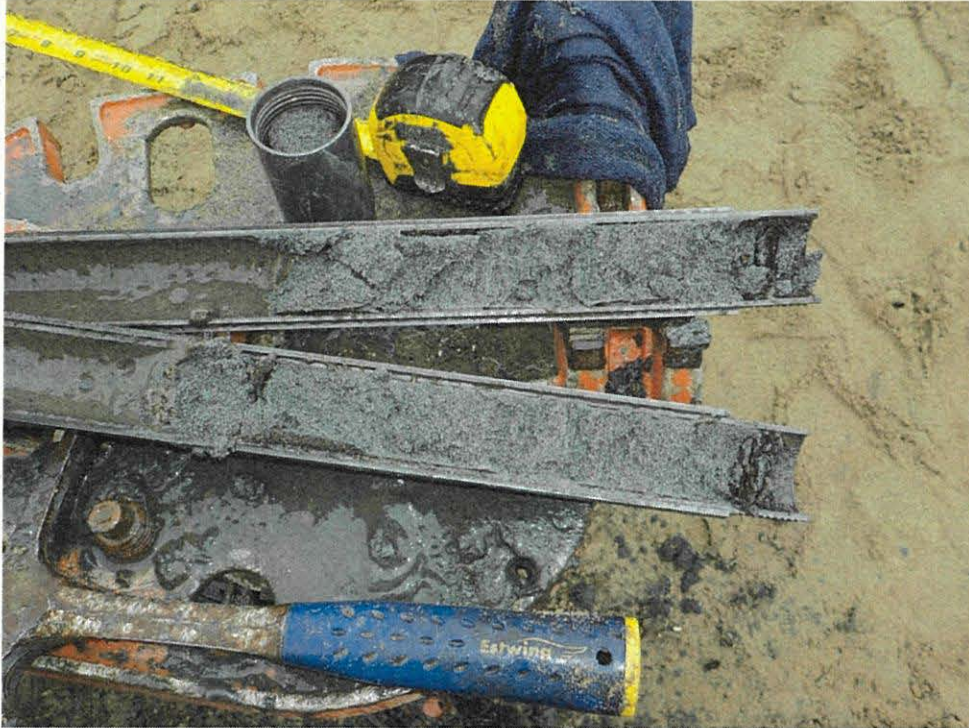
Photo 7 – View of the very dense silty sand with decaying wood fragments recovered between 50 to 51.5 feet depth in Boring B-1.

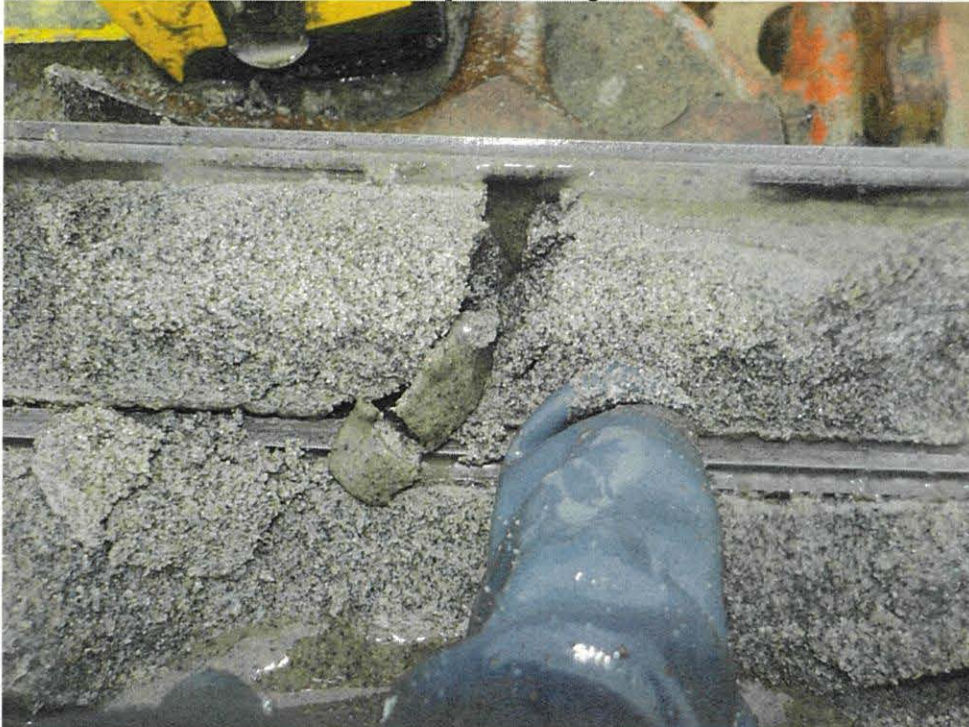
Photo 8 – Close-up view of the very dense, fine-grained, clean sand recovered between 60 to 61.5 feet depth in Boring B-1.

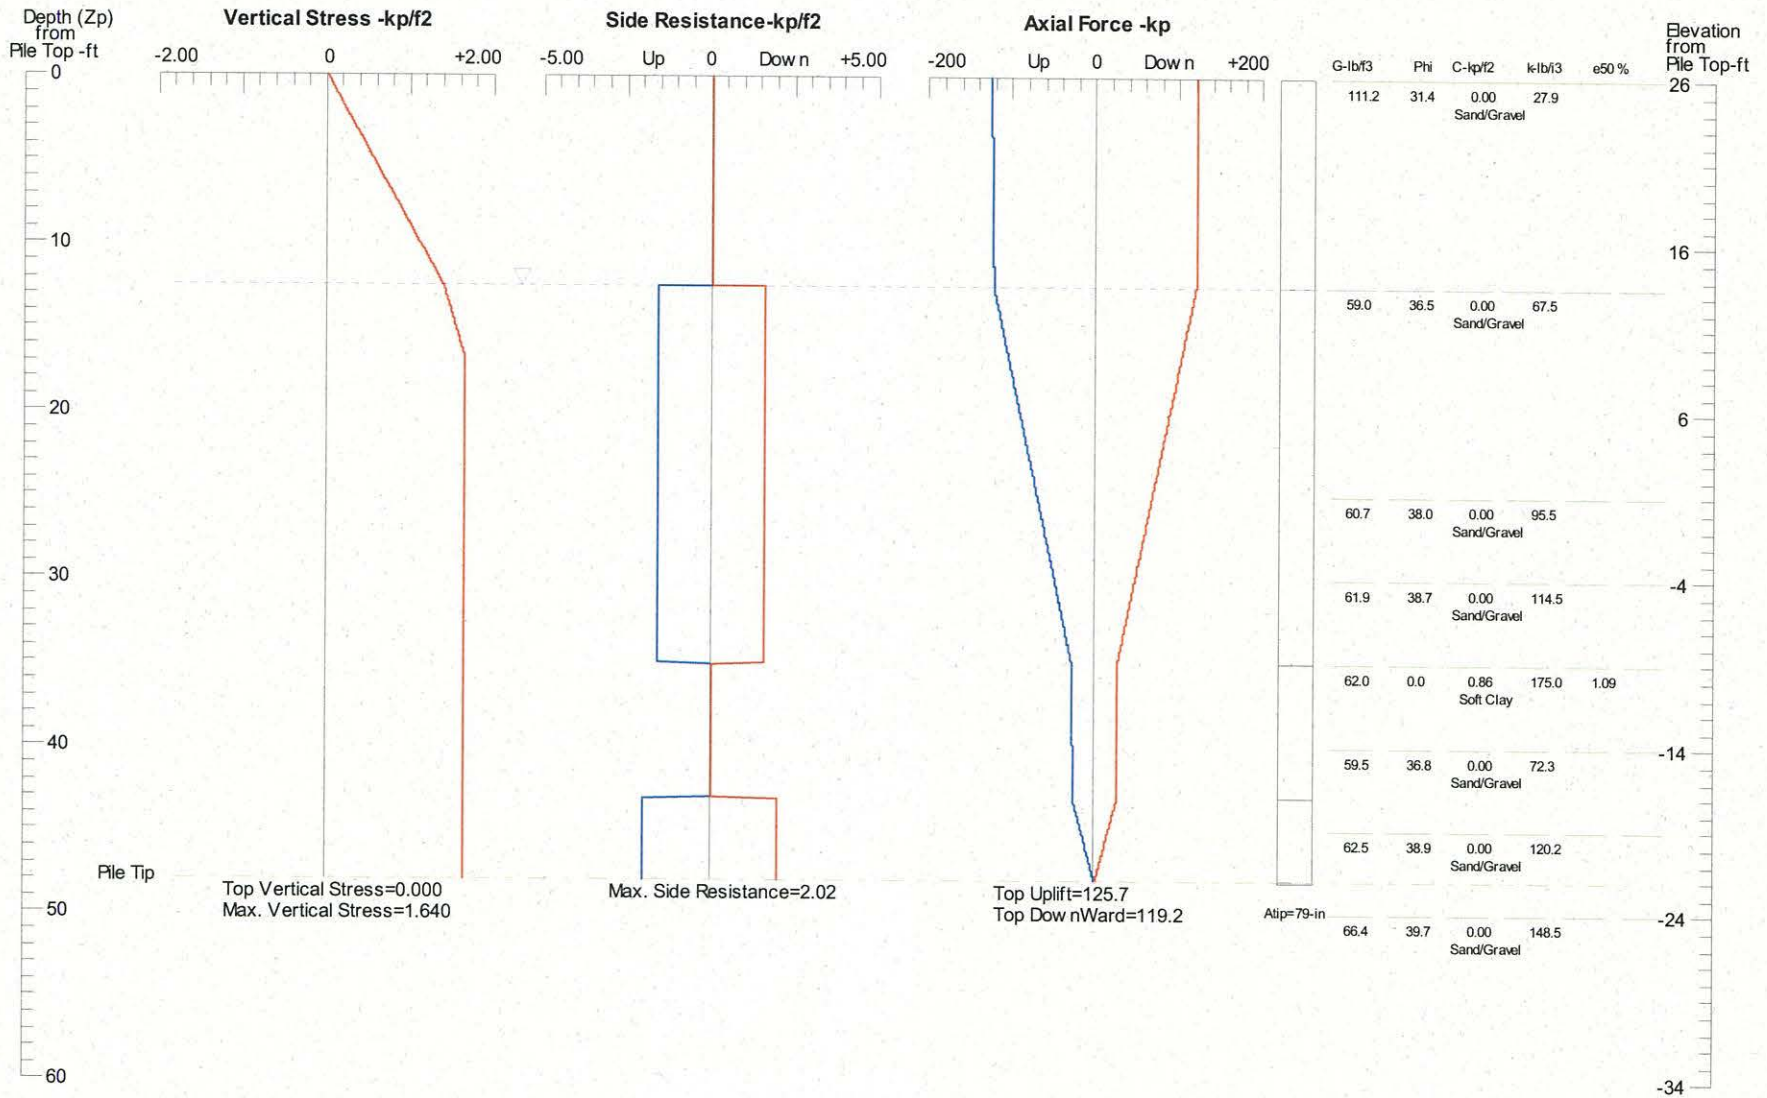
### SOIL STRESS, SIDE RESISTANCE, & AXIAL FORCE vs DEPTH Based on Ultimate Load Condition

Y234676B  
Breakers 10inch

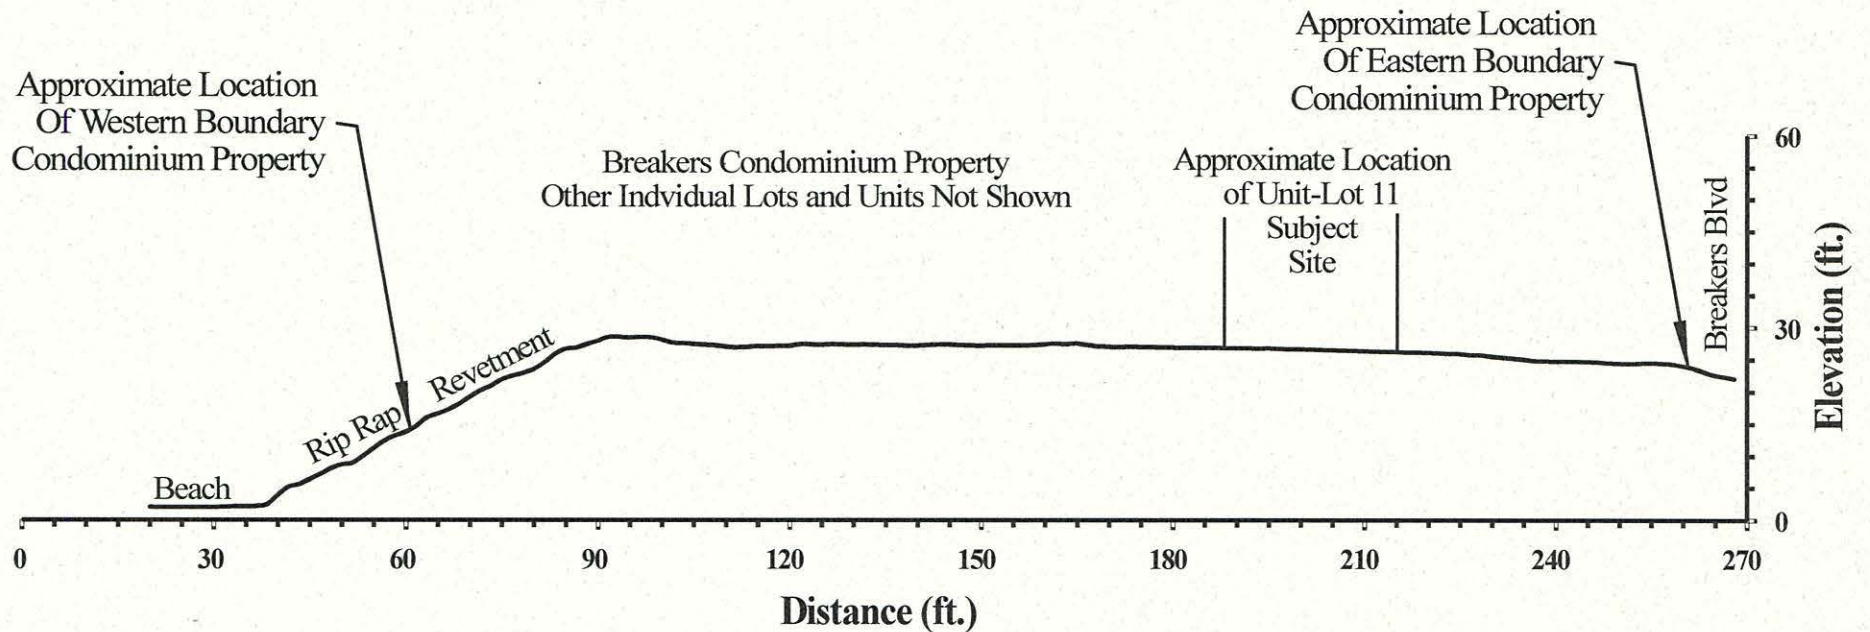
<b>H.G. Schlicker &amp; Associates, Inc.</b>		<b>Figure 4</b>

North 83° West  
←————→

Date: 05/23/2023	<b>Project #Y234676</b>	Prepared by: MGB
Scale: 1" = 30'		Approved by: AML
<b>Slope Profile, A-A'</b> Tax Lot 92411, Map 5S-11W-25CB Supp. No. 2 Lot-Unit 11, 48060 Breakers Blvd., Neskowin, Tillamook County, Oregon

The site is located on the western portion of a younger stabilized dune. Elevation at the site is approximately 26 feet (NAVD 88). The area of the site is generally flat but appears to have been subject to prior grading activities (Figures 3 and 4; Appendix A).

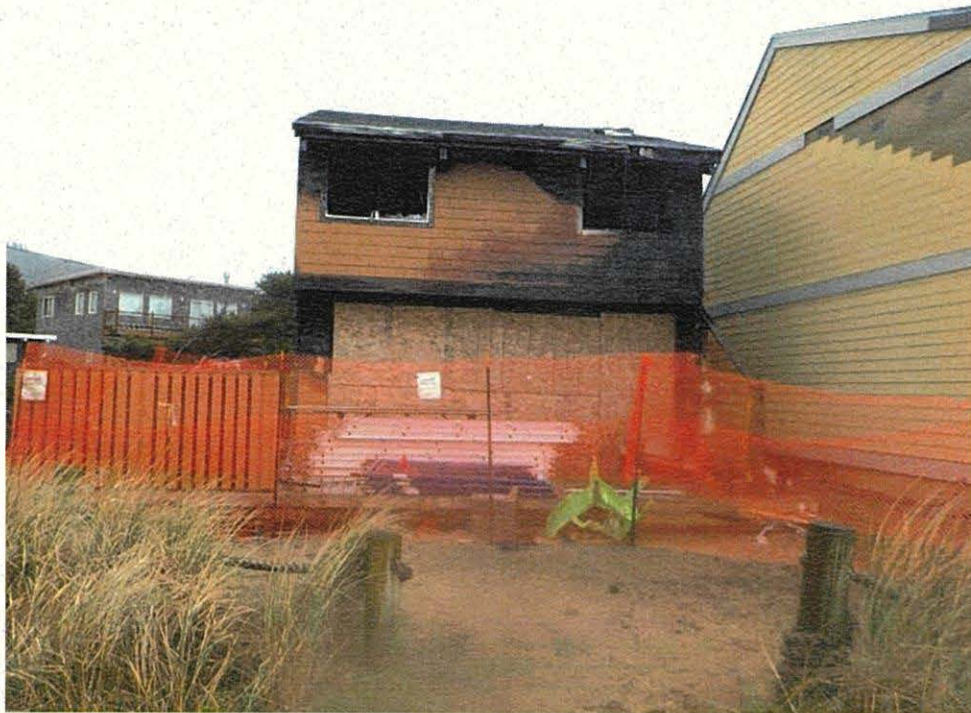
Photo 2 – Southeasterly view of the subject site occupied by the existing fire-damaged residential building.

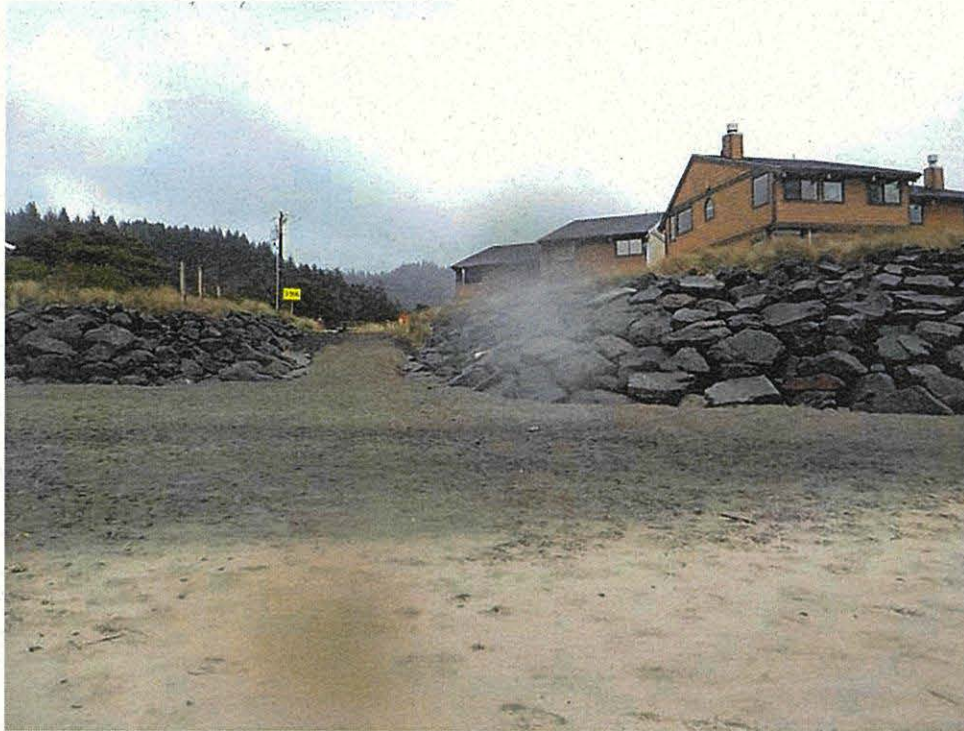
Photo 5 – Easterly view of the oceanfront area west of the site from the beach.

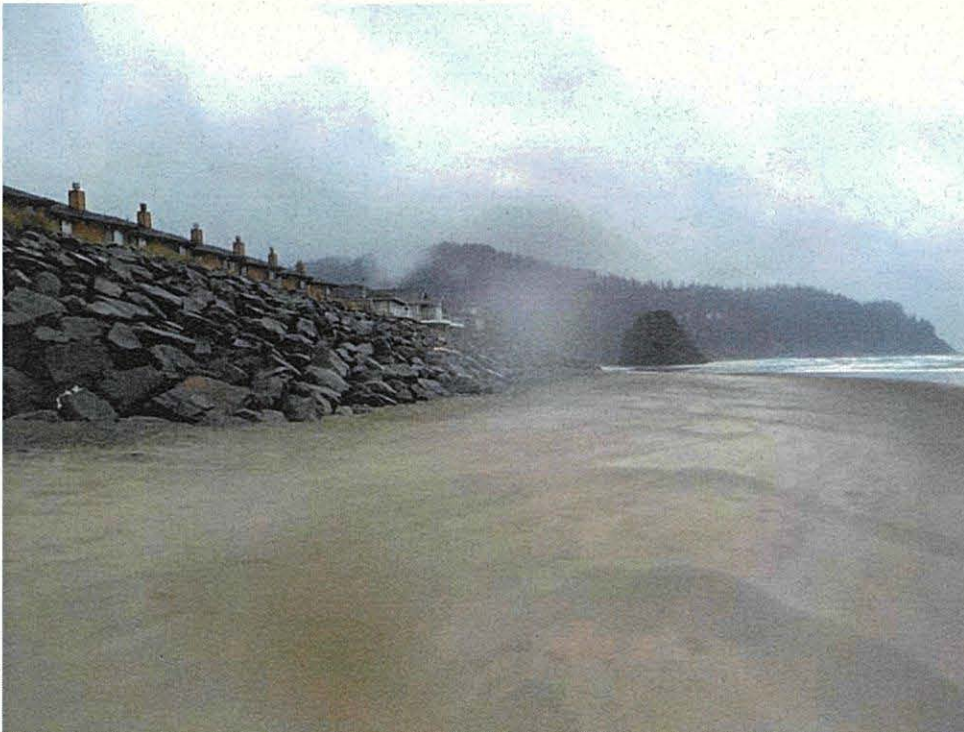
Photo 6 – Southerly view of the beach and rip rap revetment west of the site.

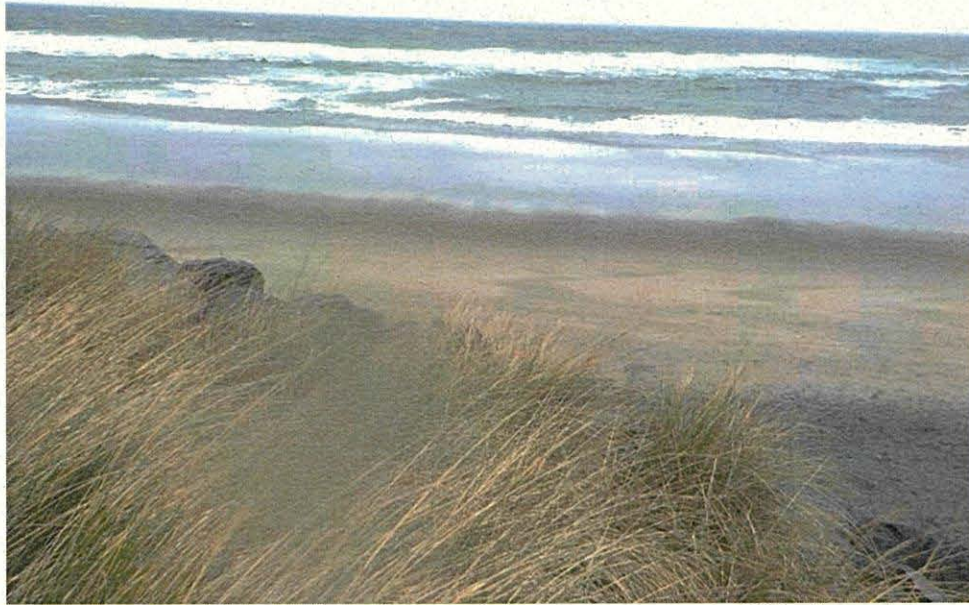
Photo 7 – Westerly view from the top of the revetment, west of the site.

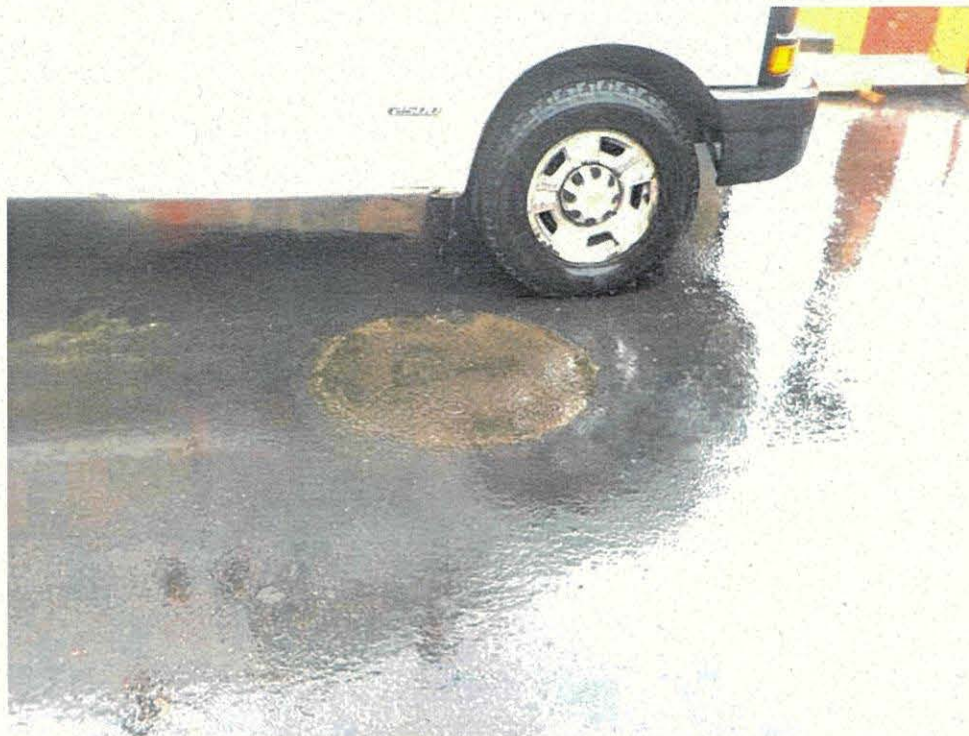
Photo 8 – Close-up view of a manhole near the site indicating the potential presence of buried private utilities and installations.
