OREGON PUBLIC LAND CORNER REPORT / RESTORATION REPORT
Tillamook County Surveyor's Office

SECTION: 6 and 7	TOWNSHIP: 3 South	RANGE: 10 West
COUNTY: Tillamook		DATE: 11/1/2023
CORNER DESIGNATION: The Quarter corner common to sections 6 & 7, Township 3 South, Range 10 West, Willamette Meridian, Tillamook County, Oregon.		(Please check one)
		<input type="checkbox"/> Condition Report Only
		<input type="checkbox"/> Restoration
		<input checked="" type="checkbox"/> Rewitness
		<input type="checkbox"/> Unrecorded
		<input type="checkbox"/> Reset at surface
		<input type="checkbox"/> Referenced Out

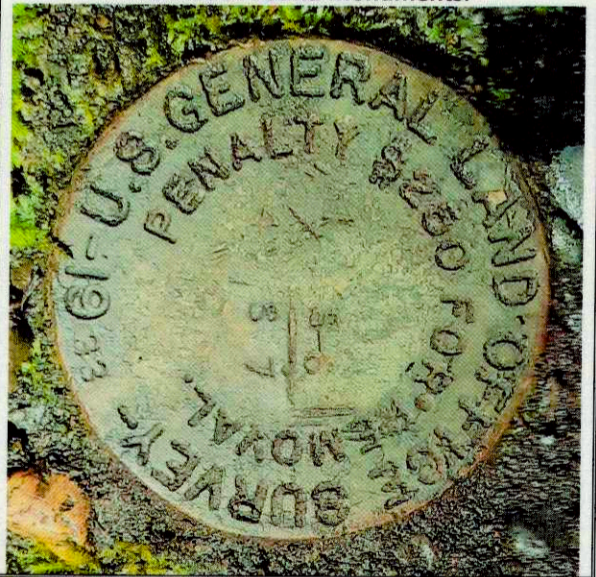
Pictures of Found Monuments:

History, condition, and sources: In 1890 (G.L.O. 3S10 pg. 62) under G.L.O. contract number 552 Albert P. Wilson set a 4"x 4" post for corner and established two bearing trees. In 1933 (Rewitness Bk. 3 pg. 206 and 207) Ernest P. Rands district cadastral engineer set a 1" diameter iron post with a Brass Cap for corner using original bearing trees for reference. In 1969 (Rewitness Bk. 3 pg. 319) Tom O. McCullough set a steel post with a Forest Service boundary sign facing south, a steel post 5' north facing to the west and established one new bearing tree. He found a 25" Hemlock stump with two Forest Service tags and a downed 30" Spruce with Forest Service tag visible. In 1979 (Rewitness Card #578) Tillamook County Surveyor's Office set a 10" tile with concrete around the found Brass Cap and established one new bearing tree. In 1990 (B-1458) Ronald H. Schulson set an orange fiber glass post alongside the corner. In 2023 Tillamook County Surveyor's Office visited the corner and found a 2 1/2" U.S. General Land Office Brass Cap marked "1/4 S6 S7 1933" in concrete and tile in good condition as shown hereon.
