**OREGON PUBLIC LAND CORNER REPORT / RESTORATION REPORT**  
Tillamook County Surveyor's Office

<b>SECTION: 7</b>	<b>TOWNSHIP: 1 South</b>	<b>RANGE: 9 West</b>
<b>COUNTY: Tillamook</b>		<b>DATE: 4/18/2024</b>
<b>CORNER DESIGNATION:</b> The 1/4 corner common to sections 7 and 18, Township 1 South, Range 9 West; Willamette Meridian		<b>(Please check one)</b>
		<input type="checkbox"/> Condition Report Only
		<input type="checkbox"/> Restoration
		<input checked="" type="checkbox"/> Rewitness
		<input type="checkbox"/> Unrecorded
		<input type="checkbox"/> Reset at surface
		<input type="checkbox"/> Referenced Out

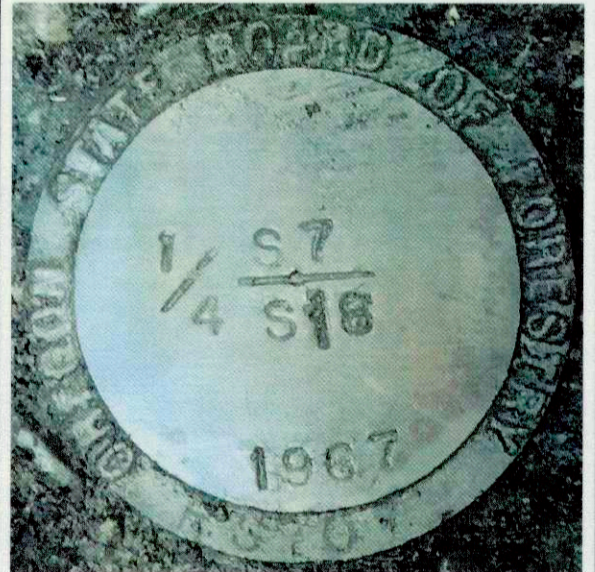
**Pictures of Found Monuments:**

**History, condition, and sources:** The Corner was first established by Henry Meldrum DS in 1857 he set a post for the corner and established 2 bearing trees. In 1887 (Rewitness bk. 10 pg. 11) Tillamook County Surveyor Hayes reset a post for the corner and established 2 bearing trees. In 1967 (Bk. 3 pg. 226) Harold Russell restored the missing corner with a 1.5" x 36" galvanized iron pipe and 3" bronze cap and established 3 new bearing trees and a 4"x4" white painted cedar post. In 1985 (Rewitness card # 190) the Tillamook County Survey office found the monument in good condition and encased the monument in an 8" cylinder of concrete with a hat section post and a yellow metal location tag. In 2024 (field book MR 16 pg. 27-28) the Tillamook County Survey office found a 3" Oregon State Board of Forestry brass cap in concrete marked "1/4 S7 S18 1967 RS 707" as shown hereon. The record accessories are listed below.

- Not Found: (Rewitness card #190) 16" hemlock stump with scribing visible S 85.5° W 18.4'
- Not Found: (Rewitness card #190) 18" hemlock stump bottom part of face overgrown N 29° E 47.3'
- Found: (Rewitness card #190) 14" fir stump S 68° E 6.4' NOW badly decayed stump
- Found: (Rewitness card #190) 4" x 4" white cedar post burnt NW 1.0' Now badly decayed remains lying next to monument
- Found: (Rewitness card #190) 60" hat section post with yellow metal location tag N 50° E 1.5'

- 20" Hemlock S 03° W 16.9' scribed "T1SR9S18BT" with nail and washer between the B & T, with a yellow metal location tag
- 21" Hemlock S 59°E 27.4' scribed "T1SR9WS18BT" with nail and washer between the B & T, with a yellow metal location tag
- 19" Hemlock S 61° E 33.4' scribed "T1SR9WS7BT" with nail and washer between the B & T, with a yellow metal location tag
- 19" Hemlock N 17° W 34.6' scribed "T1SR9WS7BT" with a nail and washer between the B & T, with yellow metal location tag
