TILLAMOOK COUNTY REWITNESS # 194
 SEC. 10
 COR. 15 T 15 R 9 W., WM.

HISTORICAL: PROPORTION CORNER G.L.O. Pg. 140 159

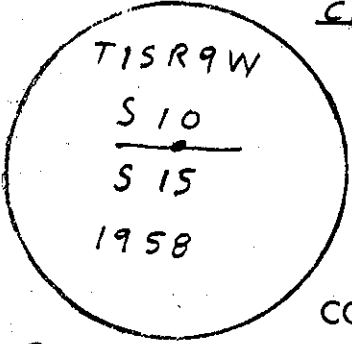
FD. CONDITION	FOUND	FOUND	FOUND
GOOD	2 1/2" I.P. WITH 3" BRASS CAP	G.L.O. Pg. 140	
22" FIR STUMP SCRIBE MARKS BARELY VISIBLE ON ROTTEN FACE	22" FIR	N. 67° W. 8 1/2 LKS.	G.L.O. Pg. 140
FD. NOW 10" STUMP SCRIBING VISIBLE ON ROTTEN BURNT FACE	12" FIR	S. 58° E. 37 LKS.	G.L.O. Pg. 140

1 SET 10" CONCRETE CYLINDER AROUND FOUND 2" I.P. WITH 3" U.S. CADASTRAL BRASS CAP.

* 72" Hat Section SOUTH 19 FEET

* 8" SPRUCE	N. 10° W. 866 FT.	1/4 S10 B-T CS
* 10" SPRUCE	N. 85° W. 184' FT.	1/4 S10 B-T CS

COMMENTS: THIS CORNER IS LOCATED ON THE MAIN RIDGE DIVIDING THE KILCHIS AND WILSON RIVER DRAINAGES, AND † 300' WEST OF A GRAVEL SPUR LOGGING ROAD.
